## AVIATION INVESTIGATION REPORT A10Q0019

### CABIN FIRE

**SKYJET M.G. INC.  
BEECH 200 C-FSKQ  
SEPT-ÎLES AIRPORT, QUEBEC  
02 JANUARY 2010**

Report Number A10Q0019

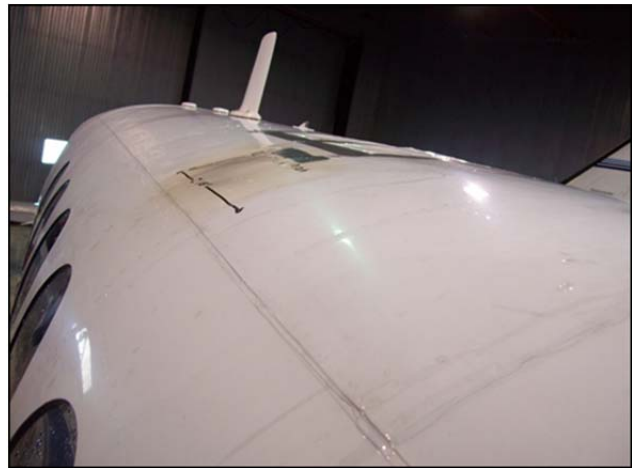
The fire broke out at station 236,<sup>3</sup> on the top left side of the cabin. The skin of the aircraft was significantly damaged between stations 236.25 and 246.75 on the top left side of the cabin. (See photo 1). Following the incident, part of the exterior skin had to be replaced and all the insulation material and fluorescent lighting power supplies were replaced by newer models.

**Photo 1.** Damage as seen from outside aircraft

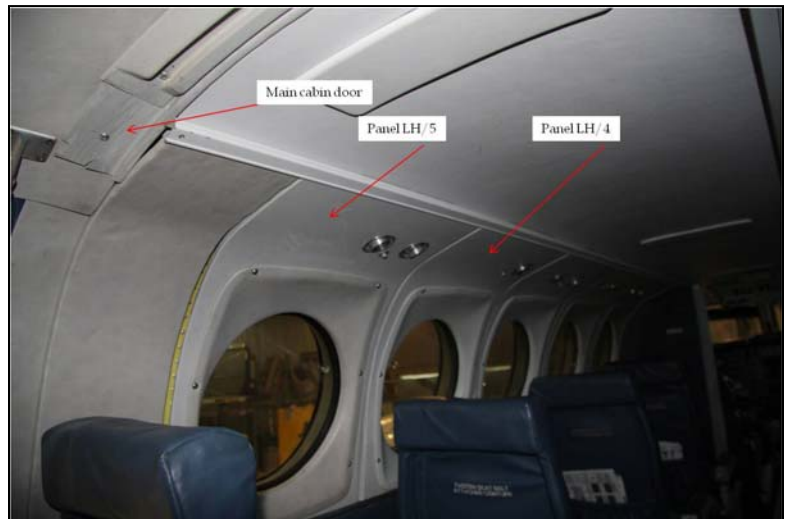
Two interior cabin panels were damaged by fire. The panel identified as LH/5 is located just before the main door on the left side, while panel LH/4 is adjacent to the first, towards the front of the aircraft (see photo 2). The 2 panels were sent to the TSB Laboratory in Ottawa to determine the origin of the fire.

**Photo 2.** Location of undamaged interior cabin panels

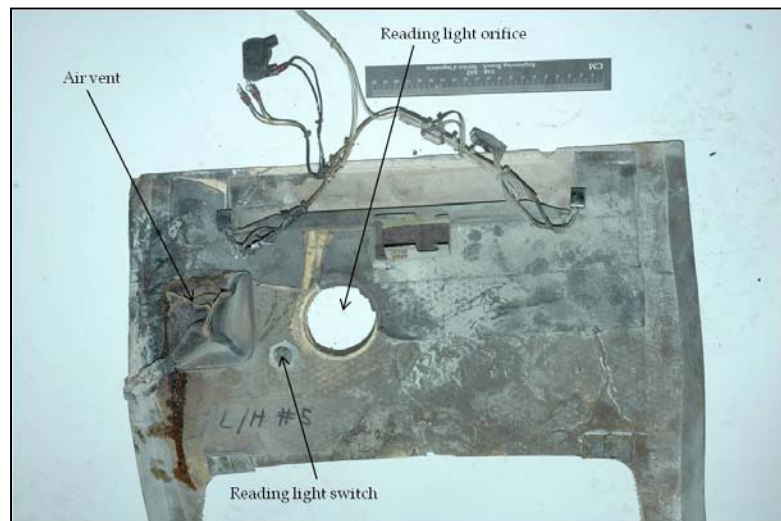
The upper left corner of panel LH/5 was slightly burned. The plastic air outlet housing was completely melted, as was the wire insulating material. There was a deposit of soot over much of the upper section of the panel (see photo 3). A strip of cloth on the top left side was partially burned, and much of the strip at the top of the panel was covered with soot. The front of the panel had no trace of burning. The wiring damaged by the fire showed no evidence of burns caused by electrical arcing.

**Photo 3.** Interior of panel LH/5

The damage to the electrical power supply of panel LH/5 appears to be physical damage, not electrical damage as no evidence of electrical arcing or overheating were found. Since there was no arcing on the wire supplying the power supply, and only dirt on the side near panel LH/4, it is unlikely that the fire originated in panel LH/5.

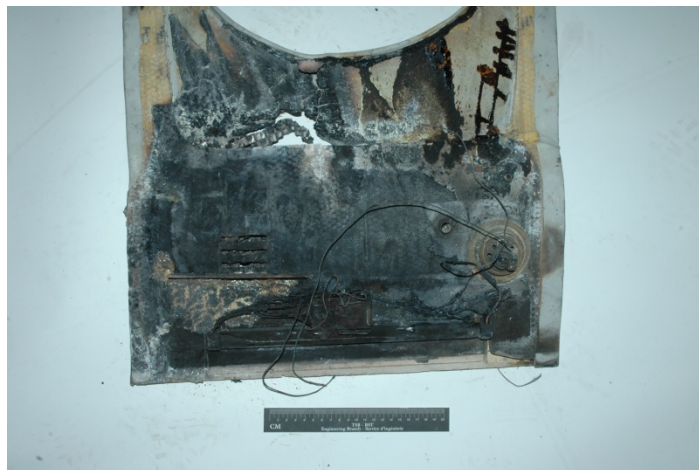
Most of the upper section on the front and back of panel LH/4 was damaged by fire. Some parts were melted to such a degree that perforations were visible in the panel (see photo 4).

The fluorescent light power supply in panel LH/4 was mostly burned and melted. Because of its shape, size and its type of connection, the power supply was found to be similar to the one in LH/5. However, no labelling that could formally identify it was found. The plastic wire connector was melted, but it was still attached to the connector of the fluorescent light power supply. The electrical power supply was removed from its support and the wires were cut in order to be examined. Contacts 1 and 2 were missing, only the fibreglass printed circuit board remained relatively intact while the rest had burned. The metal of contact 1 on the connector had melted into a ball, which is consistent with damage resulting from electrical arcing.

**Photo 4.** Interior of panel LH/4 indicating where the power supply melted and burned

However, arcing between the contacts of the power supply of panel LH/4 and the connector was discovered. It is likely that the fire originated on the connector. There would have been sufficient heat to ignite the strip of fabric located near the power supply. When the strip of fabric ignited, the flames spread to then reach the air outlet, to melt it and to burn it completely.

1. Arcing between the connector and electrical power supply of panel LH/4 produced overheating to the point of igniting the fire.
2. The strip of fabric ignited and spread the fire to the air outlet melted it and burned it completely.
