## AVIATION INVESTIGATION REPORT

**A10Q0070**

**SASAIR INC.**

**CESSNA 172 C-FEAR**

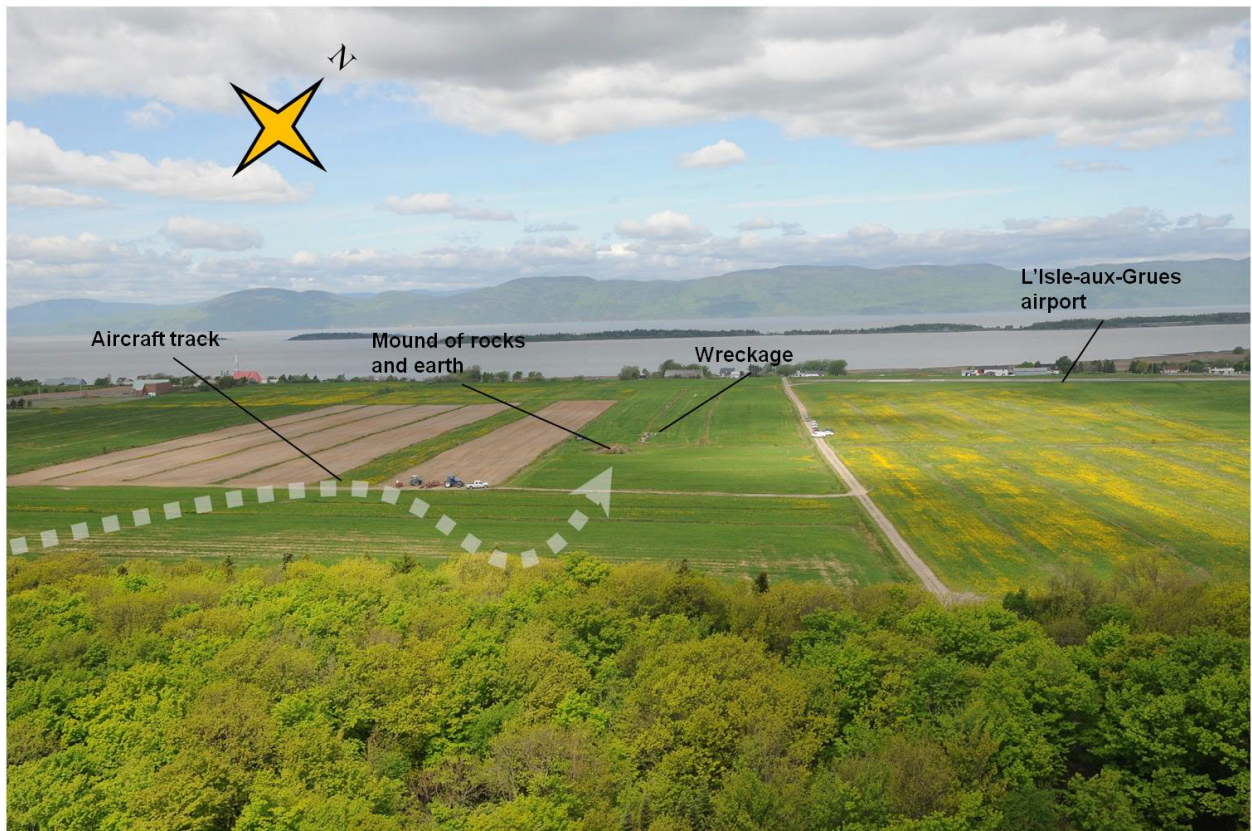
The accident occurred in an alfalfa field. Oriented northwest, the field was not suitable for a precautionary landing. Plant cover was such that obstructions could be hidden, its surface was bumpy, and it contained some ploughed furrows (see Figure 1).

The aircraft struck a mound composed of rocks and earth that was 8 feet high and 30 feet wide and located about 2000 feet south of the runway. It was the only elevated point of terrain in the area. The mound was partly covered with grass and small shrubs. The Cessna 172 was on a heading of 325 degrees magnetic at the time of the collision. The first impact marks indicate that the landing gear of C-FEAR struck the mound about 5 feet from its base. The wings were horizontal or almost horizontal. Two propeller blade marks approximately 14 inches apart were found on the mound. Due to impact forces, C-FEAR partly broke up. The aircraft continued in the air until it crashed on its back in a ditch 255 feet from the initial point of impact. The impact resulted in a fire. There was no evidence found of any pre-impact fire damage.

**Figure 1.** Aerial view of accident site

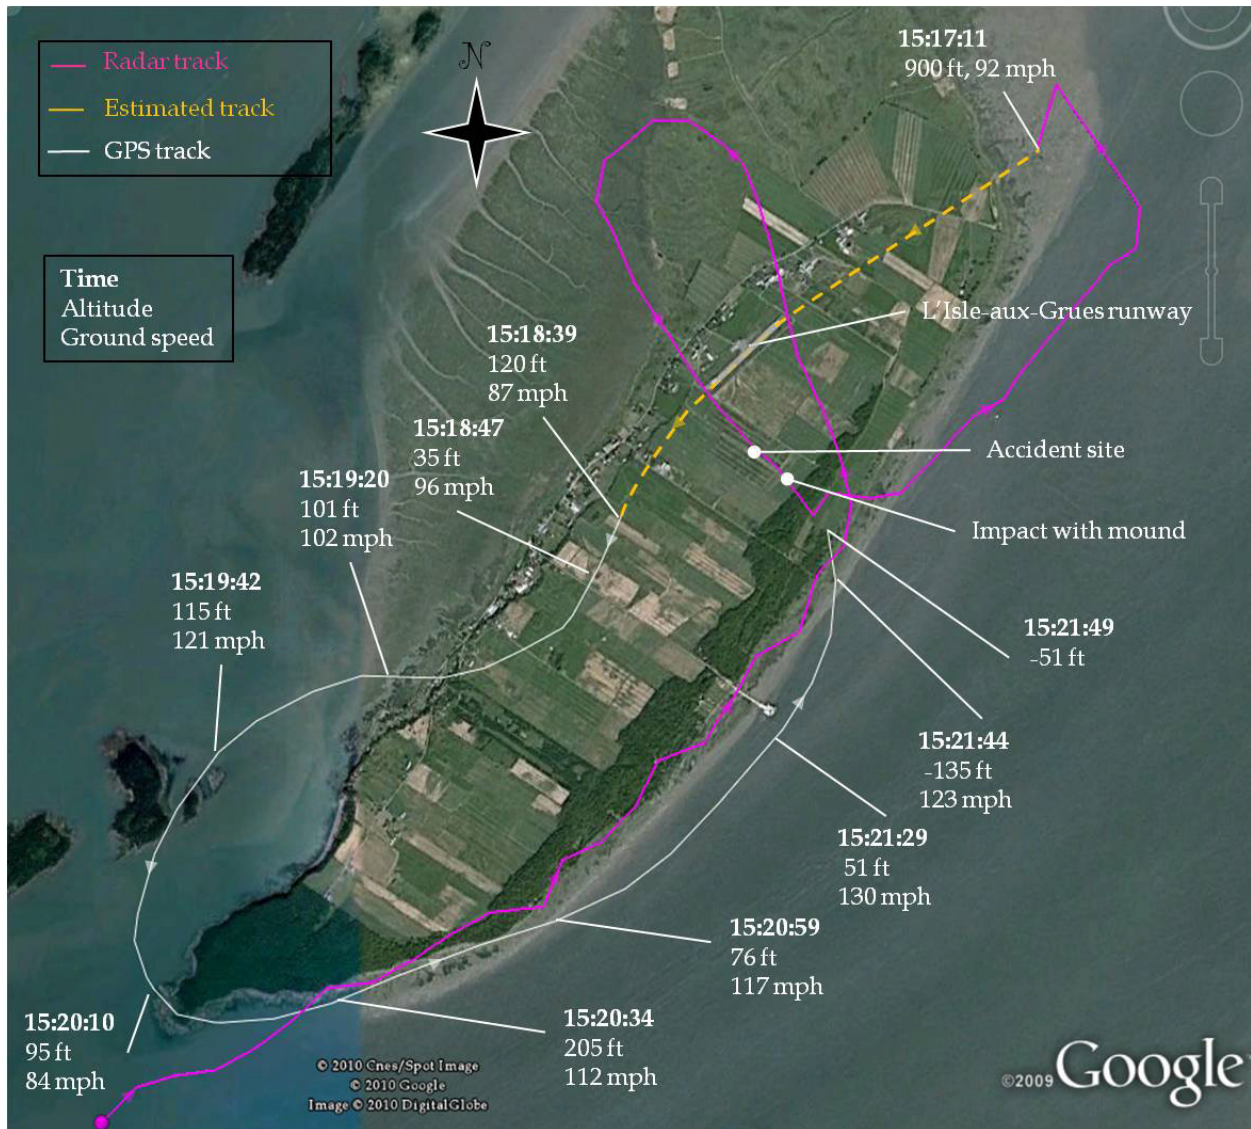
# Annex A – Track based on GPS and radar

The aircraft entered the circuit for runway 25 by initially following the south shore of L'Isle-aux-Grues island (see Annex A – Track based on GPS and radar)<sup>2</sup> to a position abeam south of the airport. The aircraft then proceeded overhead the runway for the left-hand downwind leg. About 1 nm northeast of the runway threshold, the aircraft entered the base leg. At 1517 the aircraft vanished from the radar screen as it commenced its final approach 1 nm from the runway at 900 feet asl.
