**AVIATION INVESTIGATION REPORT
A10Q0111**

CONTROLLED FLIGHT INTO TERRAIN AT CRUISING SPEED

**AIR SAGUENAY (1980) INC.
DE HAVILLAND DHC-2 C-GAXL
LAKE PÉRIBONKA, QUEBEC, 12 NM WSW
16 JULY 2010**

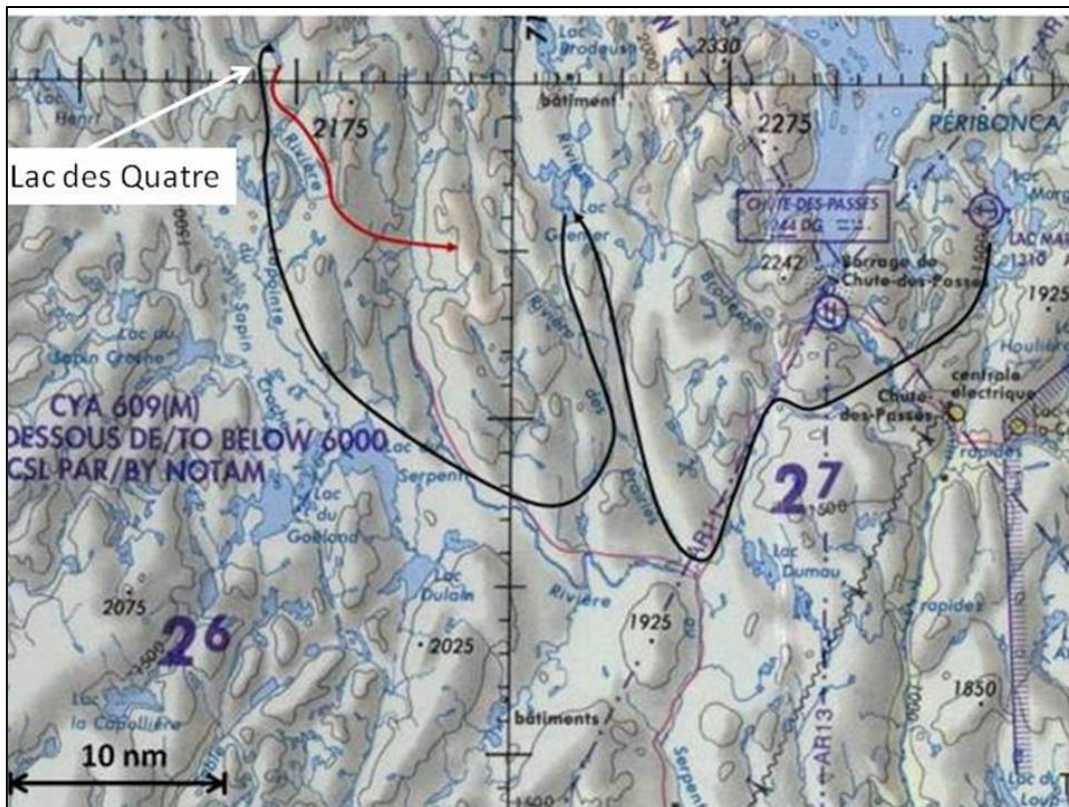
Figure 1. Estimated trajectory

the flight under VFR. This practice is common in the area, since weather observations are limited and conditions can vary considerably from one valley to another. Moreover, the existence of numerous lakes in the area makes this practice convenient (see Figure 1).

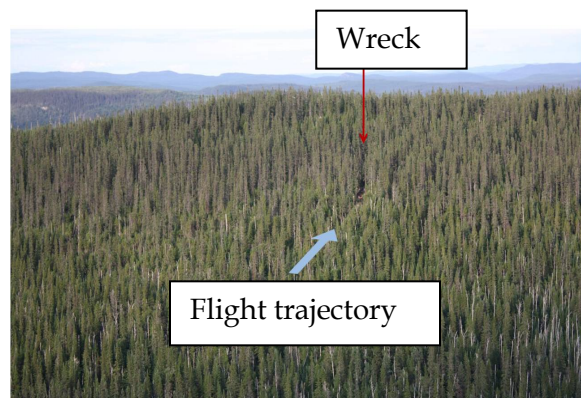
The aircraft hit the side of the mountain while flying straight and level, on a 100° magnetic heading, at an altitude of 2100 feet above sea level (asl), approximately 100 feet below the mountain peak (see Photo 1). The slope of the mountainside is approximately 25°. The wings, empennage, floats and engine all became detached from the fuselage from the force of the impact with the trees and the ground. The gasoline tanks located in the lower part of the fuselage broke, and the fuel quickly caught fire.

Photo 1. Flight trajectory and position of the wreck on the side of the mountain

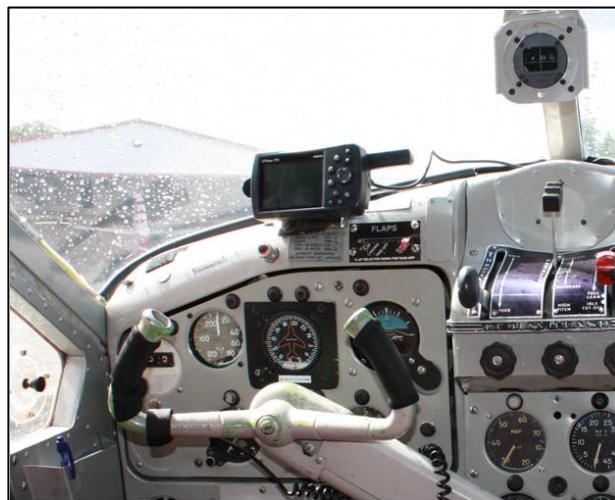
The pilot used his own portable global positioning system (GPS) ⁶ attached to the dashboard (see Photo 2). The GPS enables the pilot to improve the accuracy of navigation or to carry out a diversion efficiently. The GPS complements the maps; it cannot replace up-to-date maps. It lets the pilot know his position at all times.

Photo 2. Similar installation of a GPS on the dashboard

A few moments prior to the impact with the trees, an "X" on a red background was observed on the screen of the GPS attached to the dashboard.
