AVIATION INVESTIGATION REPORT

A10Q0133

COLLISION WITH SEA

BELL 206L (HELICOPTER), C-GVYM

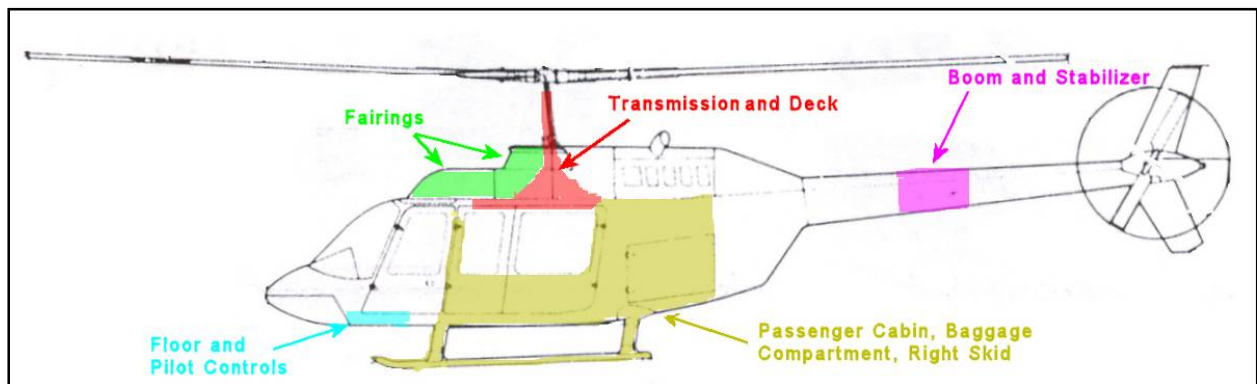
Figure 1. Salvaged helicopter parts

Figure 1 shows the recovered sections of the helicopter. The engine, most of the cockpit, and most of the tail section were not recovered (see Photo 2). The fracture surfaces observed on the recovered sections were attributed to overstress as a result of water impact. The degree of helicopter break-up and damage to the recovered sections indicate an impact at a speed in excess of that associated with an emergency landing.

The fracture surfaces exhibited characteristics that indicate the helicopter hit the water in forward flight with a left bank. The degree of bank could not be determined. No indications of pre-existing fractures were observed on the recovered wreckage.

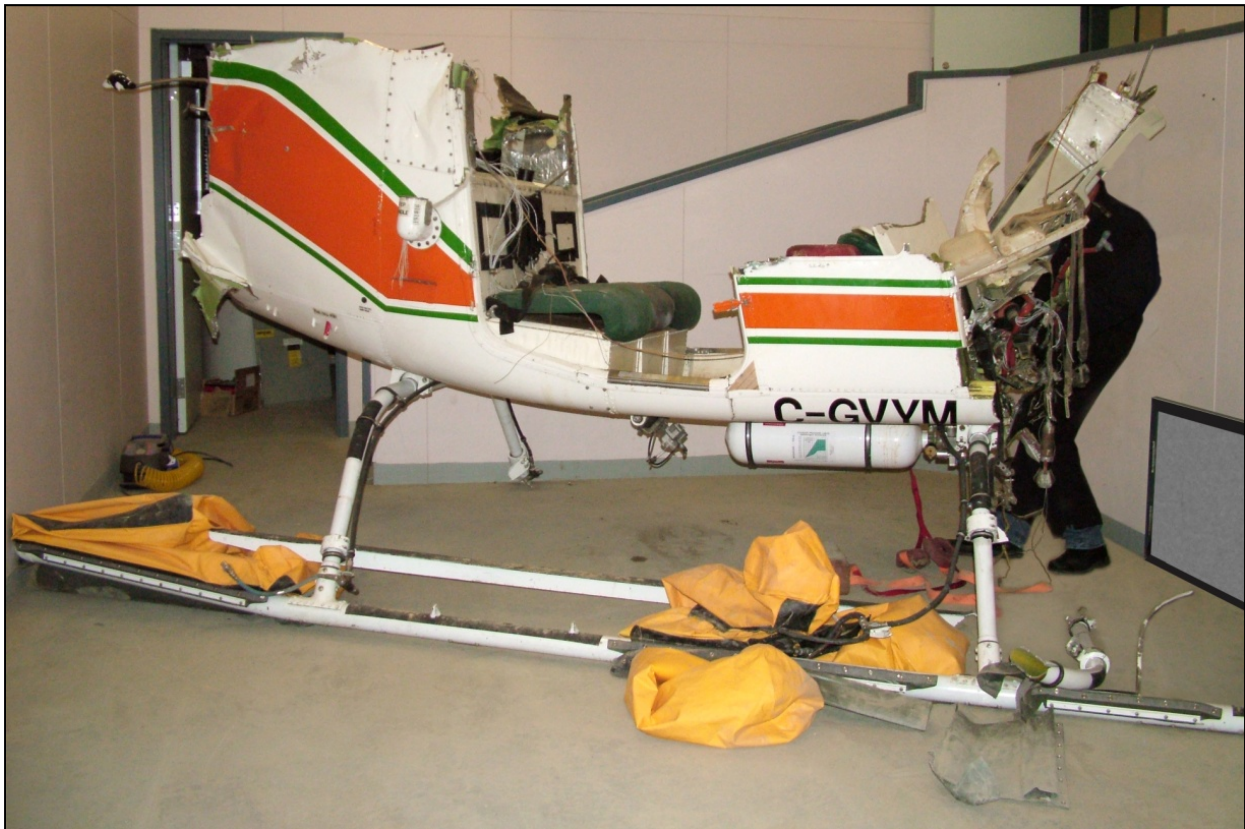
Photo 2. Recovered fuselage

The left landing gear had separated along with its pop-out floats. The direction of the torsional deformation of the left, front crosstube is consistent with the bottom end of the cross tube having been forced aft. The right landing gear was still solidly attached to the fuselage. The pop-out floats on the right skid were found deployed when the wreckage was recovered, and were keeping the wreckage afloat. They were partly torn from the right skid tube. The front bag was torn off the skid and held by its inflating line, the front half portion of the center bag was also torn and the rear bag was not damaged. When the wreckage was recovered by the Coast Guard all bags of the right skid appeared to be normally inflated.

The main rotor transmission and the cabin roof had separated as a single unit. All the structural separations were examined visually, and were found to exhibit features consistent with failure by overstress. Grease was found splattered on the adjacent main transmission support link. The grease came from the coupling that joins the engine to the transmission. This coupling came apart during the break-up, separating the engine from the transmission. The grease was splattered on every component and bulkhead in the vicinity of that coupling, indicating that this coupling was turning at the time of break-up. Examination of the oil filter did not show any sign of metal contamination. One of the chip detectors had not been exposed to sea water and

The tail boom was found fractured just aft of the stabilizer. Both vertical finlets mounted at the tips of the stabilizer were also found fractured. No paint transfer was present to confirm main blade contact; however, the fracture angle of the finlets and the boom corresponded to an angle of rotor blade passage.

The main rotor mast had fractured 22 inches above the collar located just above the boot. The main rotor mast was bent from vertical. The fracture surface exhibited features consistent with failure by torsional overstress and not due to any pre-existing damage. Although the main rotor system was rotating at the time of impact, it could not be determined at what speed the system was turning.
