**AVIATION INVESTIGATION REPORT  
A10Q0148**

**LOSS OF VISUAL REFERENCE -  
COLLISION WITH TREES**

**CANADIAN HELICOPTERS LIMITED  
EUROCOPTER AS350 B-2 (HELICOPTER), C-GHVD  
CHIBOUGAMAU, QUEBEC 12 nm NW  
01 SEPTEMBER 2010**

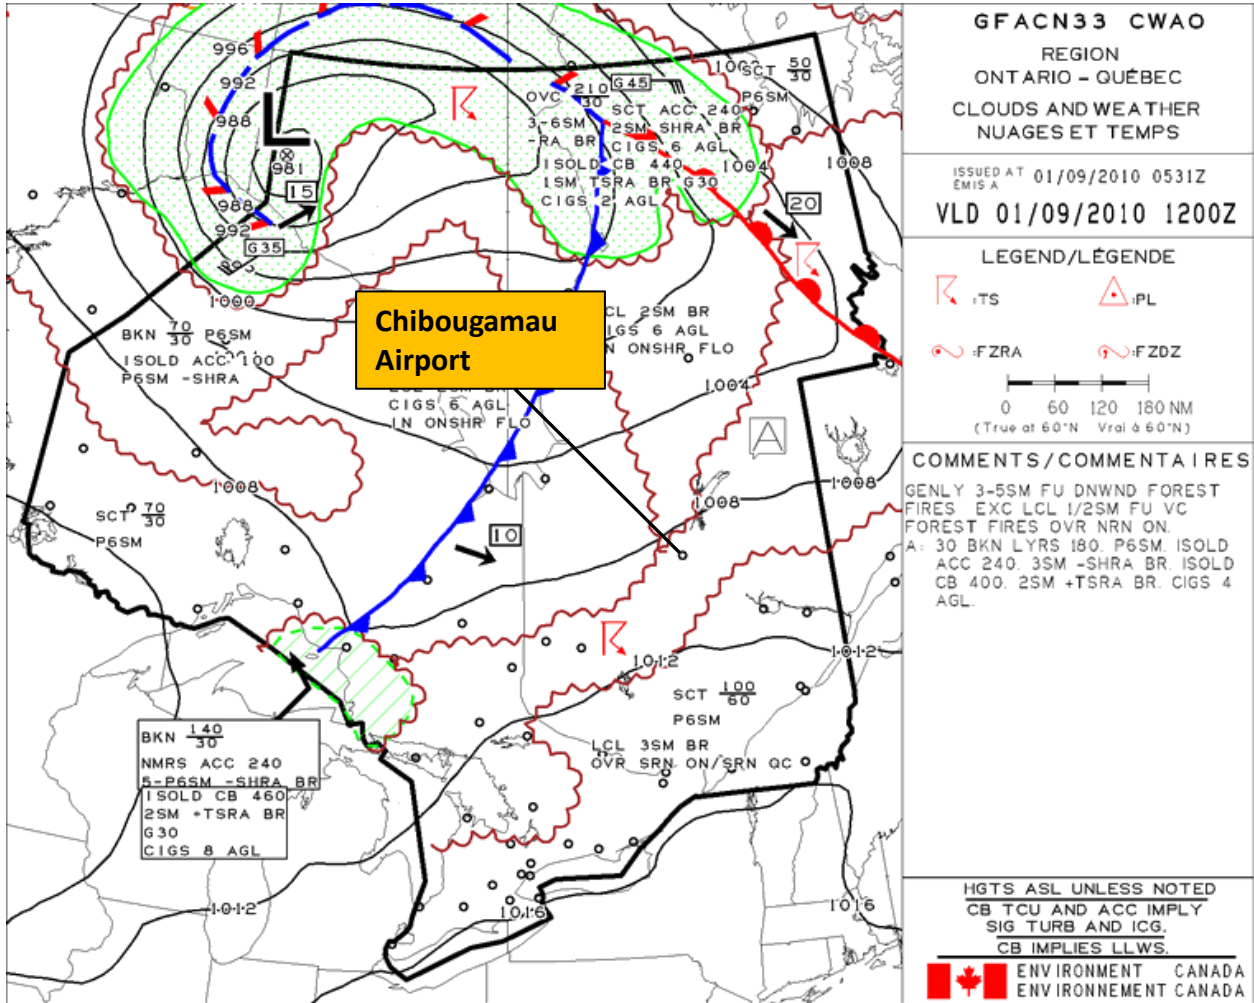
*Appendix A – Graphical Area Forecast (GFA), issued  
01 September 2010 at 0531Z (0131 EDT), valid at 1200Z  
(0800 EDT)*

The GFA issued at 0131 covered a 12-hour period (from 0200 to 1400) in 6-hour snapshots forecast a possibility of thunderstorms for the Chibougamau area in the afternoon. The forecast weather was for broken cloud layers from 3000 feet above sea level (asl) to 18 000 feet asl, plus 6 sm visibility, isolated <sup>6</sup> altocumulus cloud to 24 000 feet asl, 3 sm visibility in light rain showers, mist. Isolated cumulonimbus cloud to 40 000 feet asl, 2 sm visibility in heavy thunderstorms, rain and mist, ceilings 400 feet agl (see Appendices A and B).

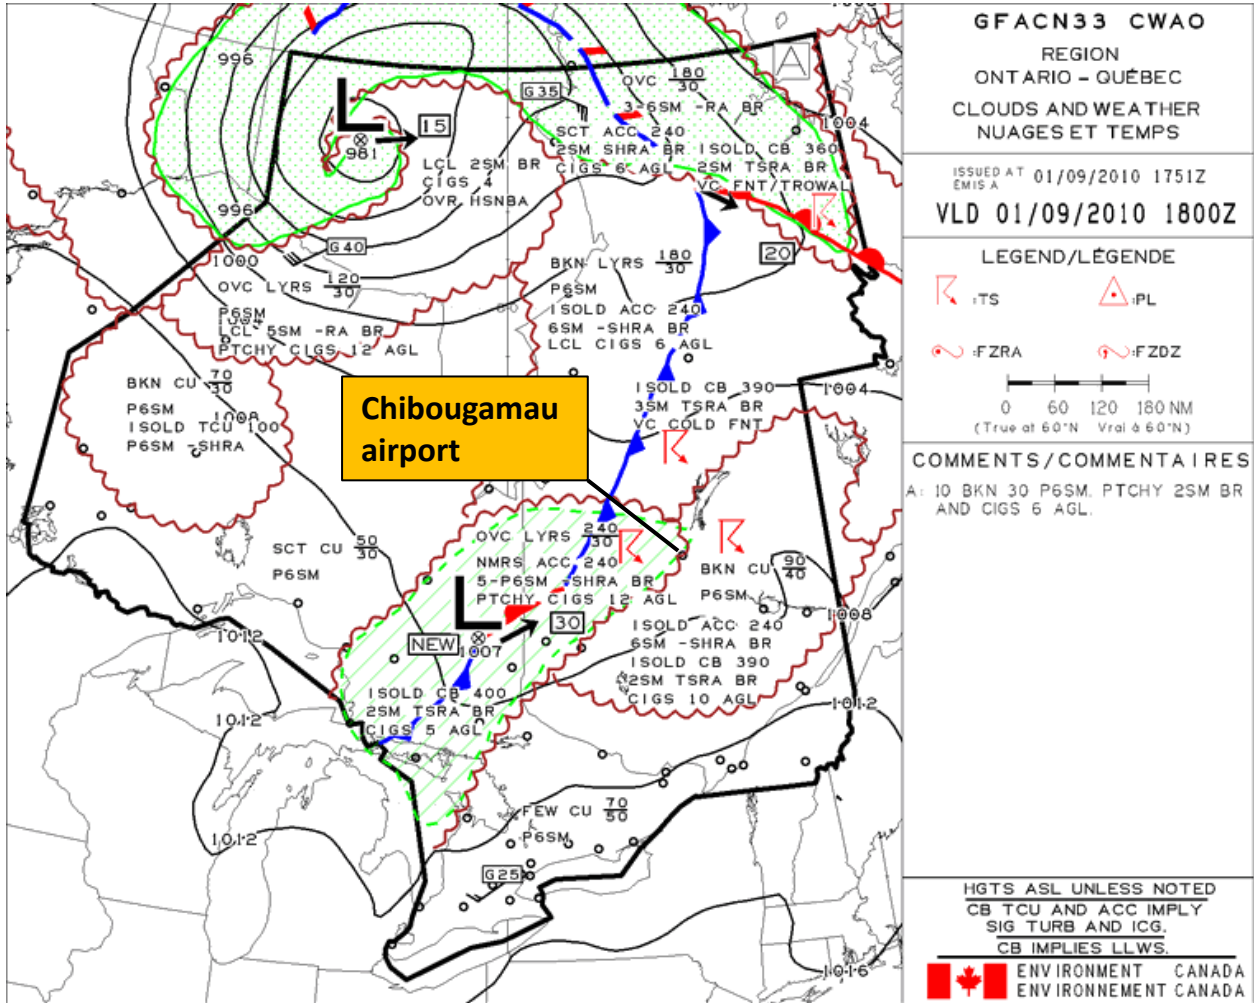
Appendix C- Graphical Area Forecast (GFA), issued  
01 September 2010 at 1715Z (1351 EDT), valid at 1800Z  
(1400 EDT)

The GFA issued at 1331 and valid at 1400 forecast the weather for the Chibougamau area to be overcast cloud layers from 3000 feet asl to 24 000 feet asl, with numerous ACC <sup>7</sup> to 24 000 feet asl, 5 to plus 6 sm visibility in light rain showers and patchy ceilings to 1200 feet agl, isolated

cumulonimbus cloud to 40 000 feet asl, 2 sm in moderate thunderstorms and ceilings to 500 feet agl (see Appendix C). This area of weather had been on the GFA issued at 0131 but was now considerably further northeast and moving faster than previously forecast.
