AVIATION INVESTIGATION REPORT

A10Q0213

RUNWAY EXCURSION

BOEING 737-823, N901AN

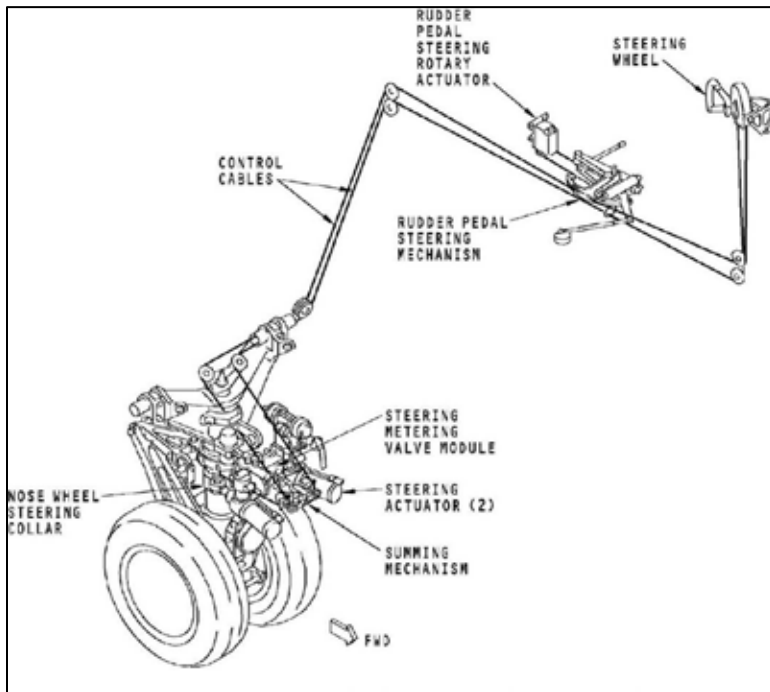
Figure 1. Boeing 737NG nosewheel steering system and summing mechanism (Copyright © 1997 The Boeing Company, unpublished Work. All Rights Reserved.)

A steering summing mechanism, located at the front of the nose oleo, combines steering inputs and nose-gear deflection feedback. It acts upon the metering-valve input lever, thereby initiating a turn, or neutralizing it once the desired amount of deflection has been reached. ¹⁸

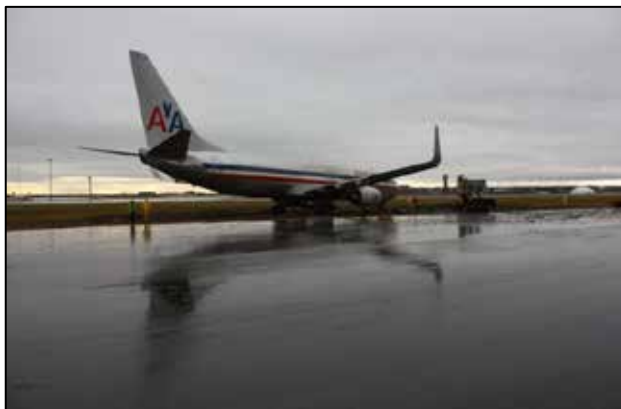
Photo 1. AAL802 Boeing 737 off runway

Once the aircraft veered off the runway, it travelled approximately 485 feet along the side of the runway, coming to a stop on a heading of 212°M in the grass and mud. The nose gear and right main gear were 90 feet and 50 feet, respectively, from the runway pavement edge (Photo 1).

There were no visible white steamed-clean markings on the runway pavement, which would have been indicative of hydroplaning. There were no ground scars, tire-skid marks, or damage to the runway surface. One runway edge light was damaged when the aircraft departed the runway surface.

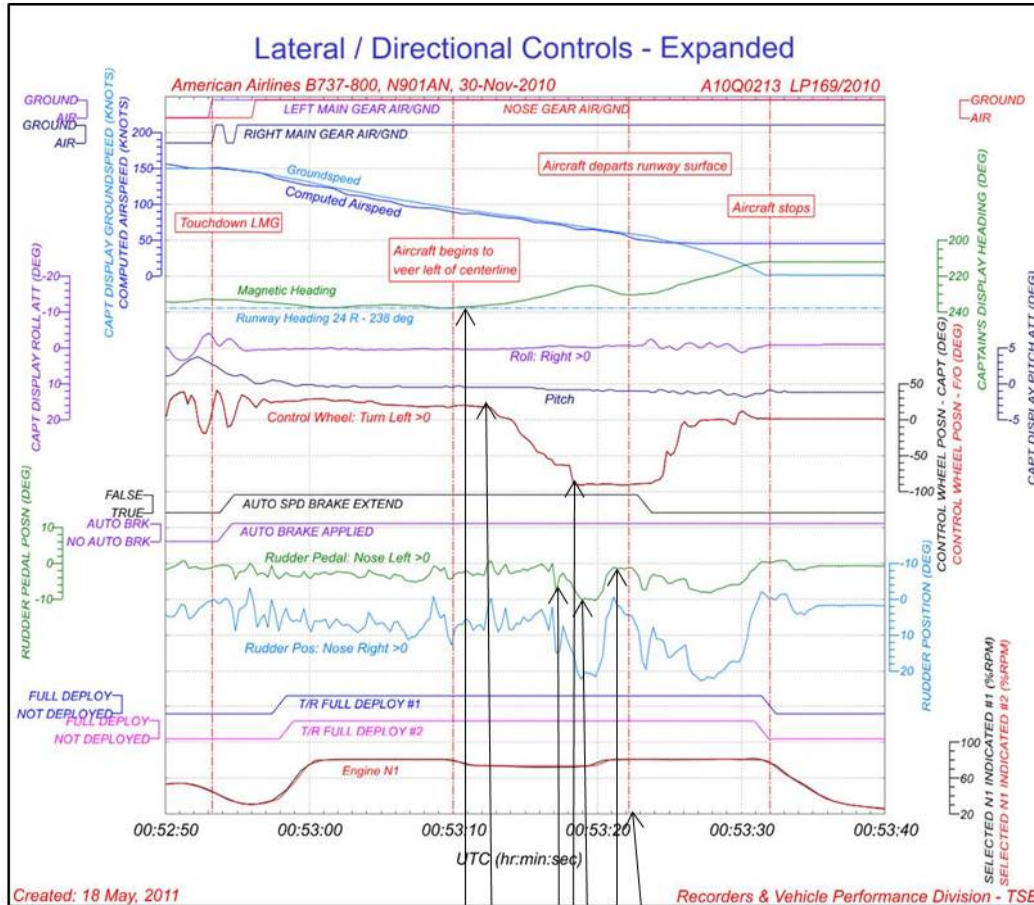
Figure 2. Pilot reaction to uncommanded left veer

1. Heading starts decreasing to the left
2. PF initiates to turn control wheel to the right
3. PF increases input to right rudder pedal
4. Control wheel reaches maximum deflection
5. PF increases right rudder pedal input to approximately 83% of travel
6. PF reduces right rudder pedal input
7. Aircraft crosses edge of runway

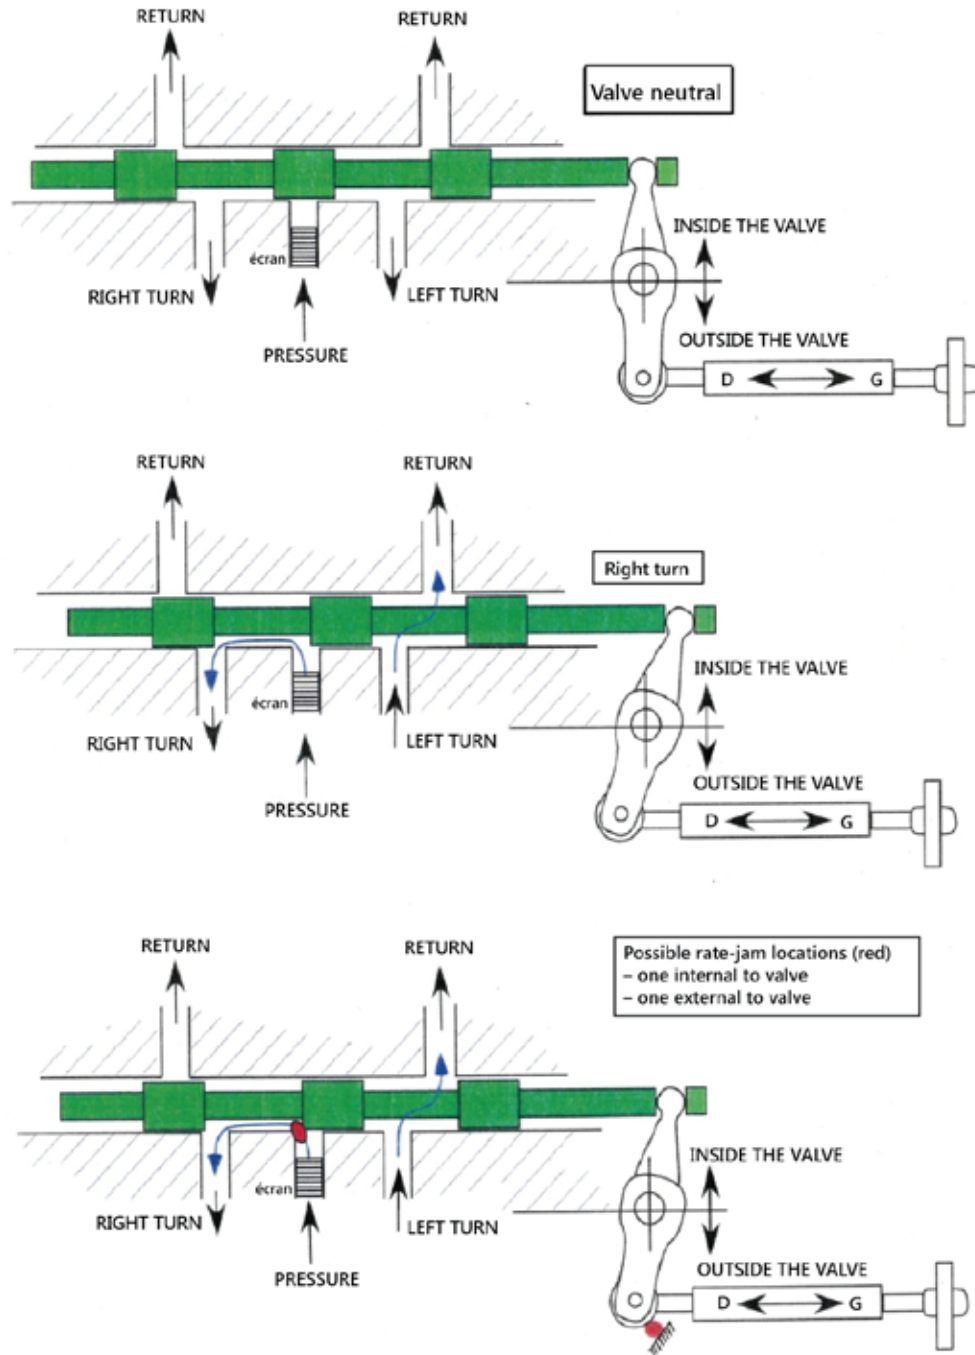
Appendix D – Possible Debris Location for Nose-gear Steering Rate Jam

The second cause of a rate jam is debris, such as ice or stones, becoming lodged in the external linkage that operates the steering valve. A jam of the external summing linkage that operates the input lever to the steering valve will have the same effect (rate jam) as a jam of the valve's internal slide/sleeve. The steering assembly is shielded by a plastic cover,³⁵ but is not sealed and is exposed to environmental conditions while the aircraft is on the ground, when the gear is extended on approach for landing, and until the gear is retracted after take-off. No testing or research has been conducted by Boeing to attempt to replicate a rate jam scenario due to an external linkage jam.

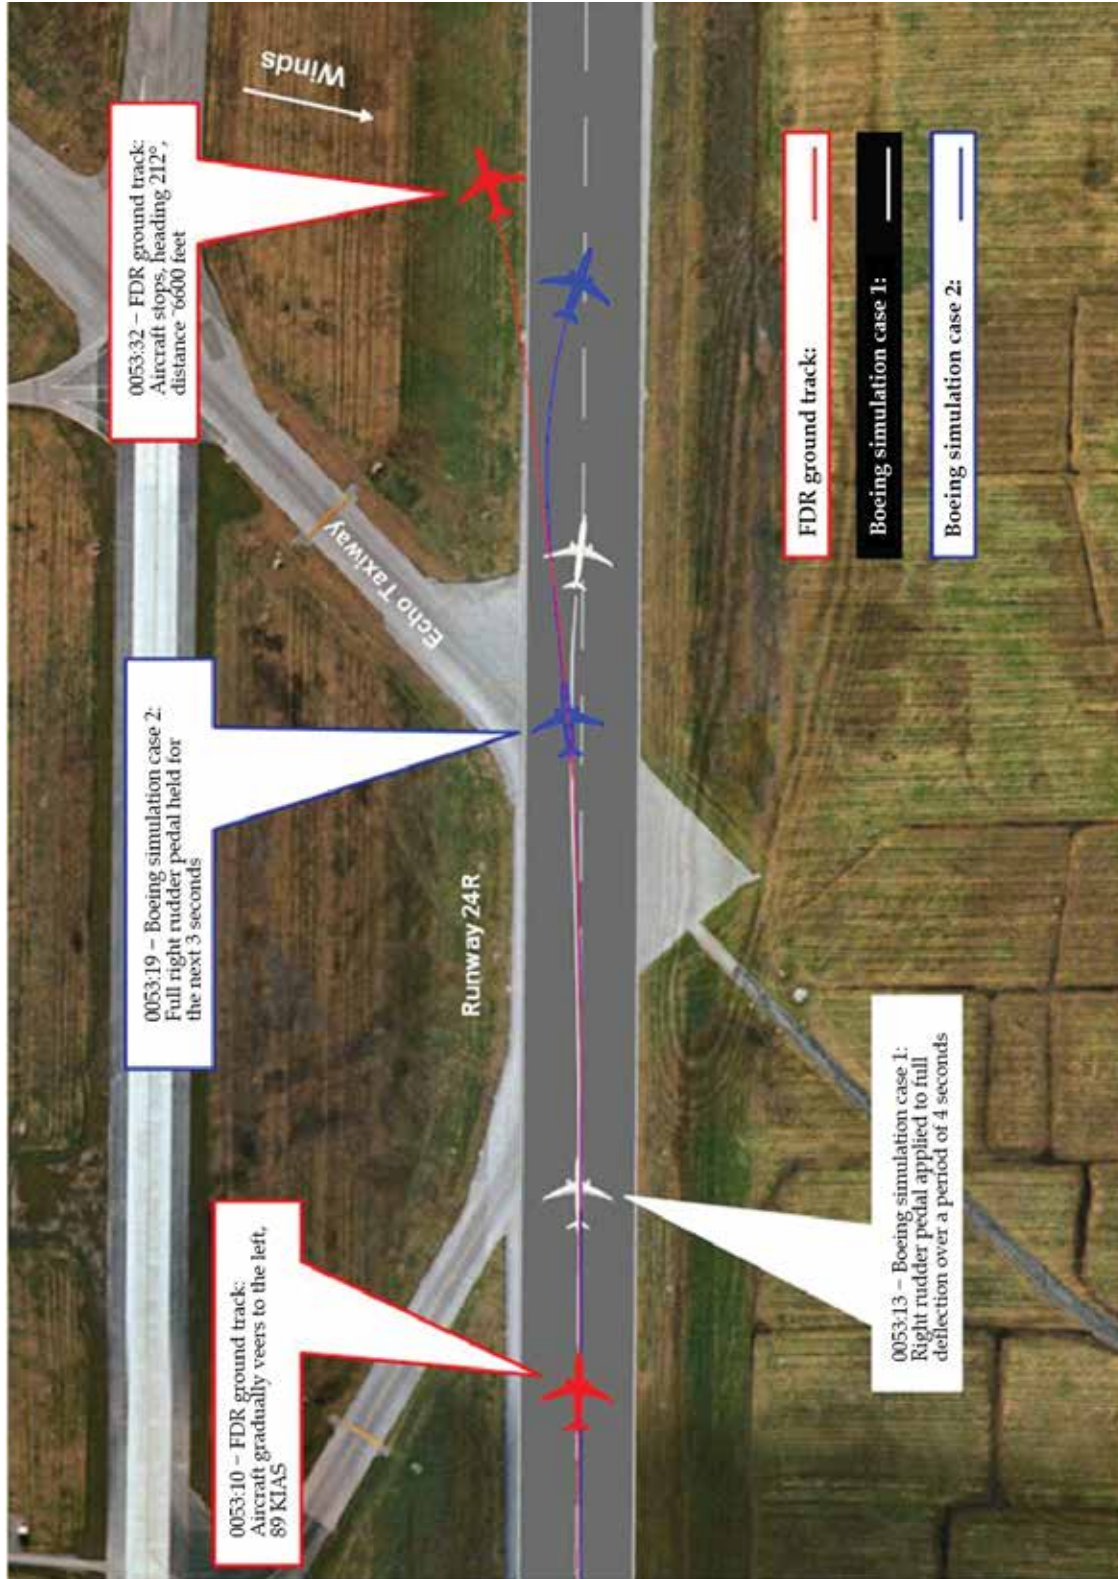
Appendix E – Boeing Simulations of Nose-gear Steering Rate Jam at $\frac{1}{2}^\circ$ per second

These possible causes were simulated by Boeing. Based on the engineering simulations performed, the best match between the simulation and FDR data from all of the possible cases analyzed was determined to be a nose-gear steering anomaly. A nose-gear steering rate jam was the best match, as opposed to a nose-gear steering position jam. Several nose-gear steering rates were studied ($\frac{1}{2}^\circ$ per second, 1° per second, 2° per second and 5° per second);³³ the $\frac{1}{2}^\circ$ -per-second rate jam provided the best match. Boeing believes that the most likely cause of the uncommanded steering input was a temporary, low slew-rate, nose-gear steering rate jam.
