**AVIATION INVESTIGATION REPORT
A11C0079**

**ENGINE POWER LOSS – FORCED LANDING
EXPEDITION HELICOPTERS INC.
EUROCOPTER AS 350 B-2 (HELICOPTER), C-GSSS
BUTLER LAKE, ONTARIO
27 MAY 2011**

Report Number A11C0079

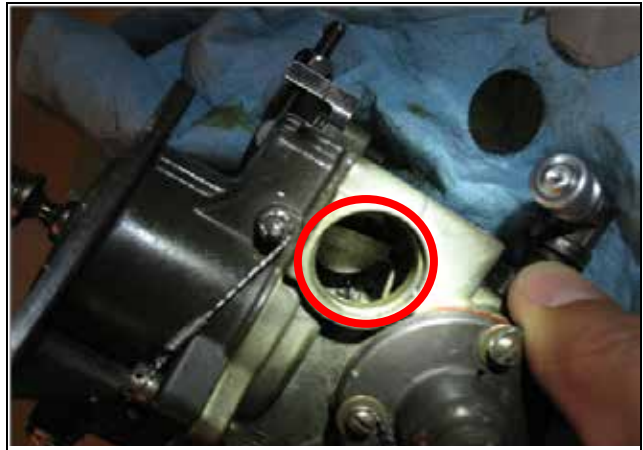
The PT governor that had been removed from the occurrence aircraft's engine (Honeywell, PN 4-301-289-05, serial number 84490007) was taken to a Honeywell facility for teardown. Disassembly of the PT governor revealed that the spool bearing (PN 2523973N) had failed and was completely destroyed. The spool bearing remains were secured and sent to the TSB Laboratory for further analysis. The spool bearing in the occurrence aircraft failed at 228 hours total time since new. The analysis of the failed occurrence spool bearing, completed by the TSB Laboratory, was consistent with the analysis performed by Honeywell on previous failed spool bearings. Photo 1 below shows the PT governor after removal from the engine at the test facility, and the debris found in the PT governor drive body after disassembly.

Examination of the spool bearing's raceways and balls revealed several microscopic diamond particles, deteriorated lubrication properties, and oxidation spots. The microscopic diamond particles are believed to have been left in the bearing's components after the cleaning process, before assembly. Interference of diamond particles between the inner race and balls will result in abrasive wear of the bearing that will increase friction and produce elevated temperatures of the affected components. The elevated temperatures will result in a breakdown of the lubrication qualities of the grease. Continued operation of the bearing in this state will eventually result in failure. A total of 55 days had elapsed between the time of the occurrence and the spool bearing examination. During that time, the spool bearing remains were exposed to ambient conditions. Bearing material that has been subject to such a failure can produce oxidation spots after exposure for a prolonged period of time.

Photo 1. Bearing debris in PT governor (red circle)

1. Diamond particles in the aircraft's PTG spool bearing likely caused the bearing to fail, at approximately 228 hours total time since overhaul. The failure of the spool bearing resulted in a failure of the power turbine governor.
2. The failure of the power turbine governor allowed the engine and rotor to overspeed as the helicopter levelled off, which activated the helicopter's engine overspeed protection system and caused it to cycle.
