**AVIATION INVESTIGATION REPORT
A11H0001**

INADVERTENT DESCENT DURING DEPARTURE

**COUGAR HELICOPTERS INC.
SIKORSKY S-92A (HELICOPTER), C-GQCH
ST. JOHN'S, NEWFOUNDLAND AND LABRADOR, 200 NM E
23 JULY 2011**

Report Number A11H0001

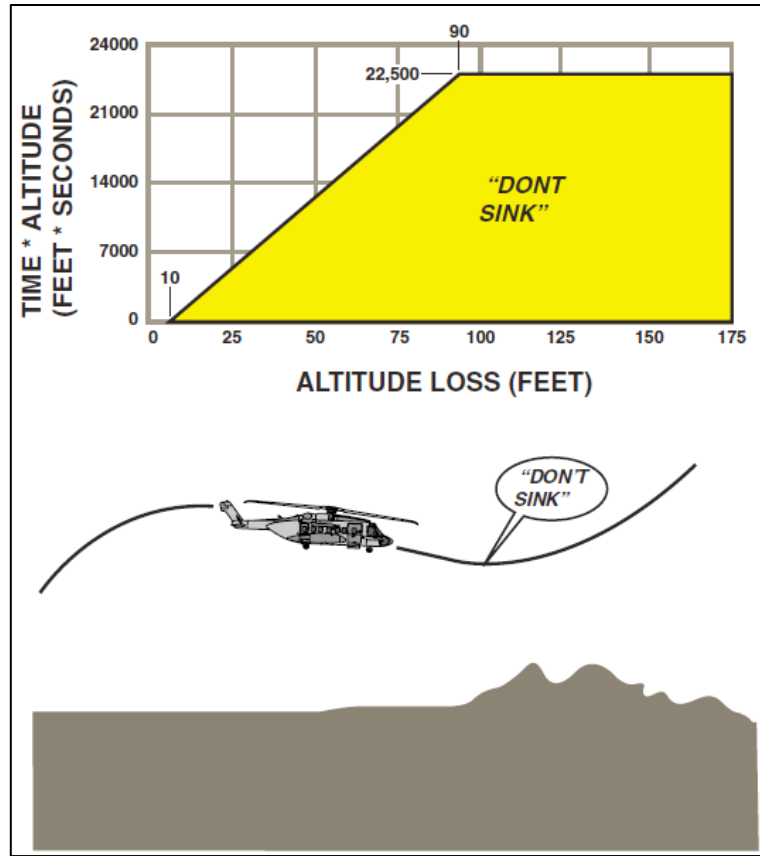
Figure 2. Mode 3 - Inadvertent descent after take-off envelope (Source: S-92A Rotorcraft Flight Manual [2011])

In this occurrence, Mode 3 of the EGPWS detected the inadvertent descent and issued the “Don’t sink” aural alert and yellow caution on the PFD. The inadvertent descent commenced as the airspeed reached a maximum value of 67 KIAS, with the gear in the up position. In addition, Mode 4 issued the “Too low gear” aural alert, as well as the corresponding caution and warning indications on the ADI and the master warning panel, when the helicopter descended below 150 feet asl with the gear still in the up position.

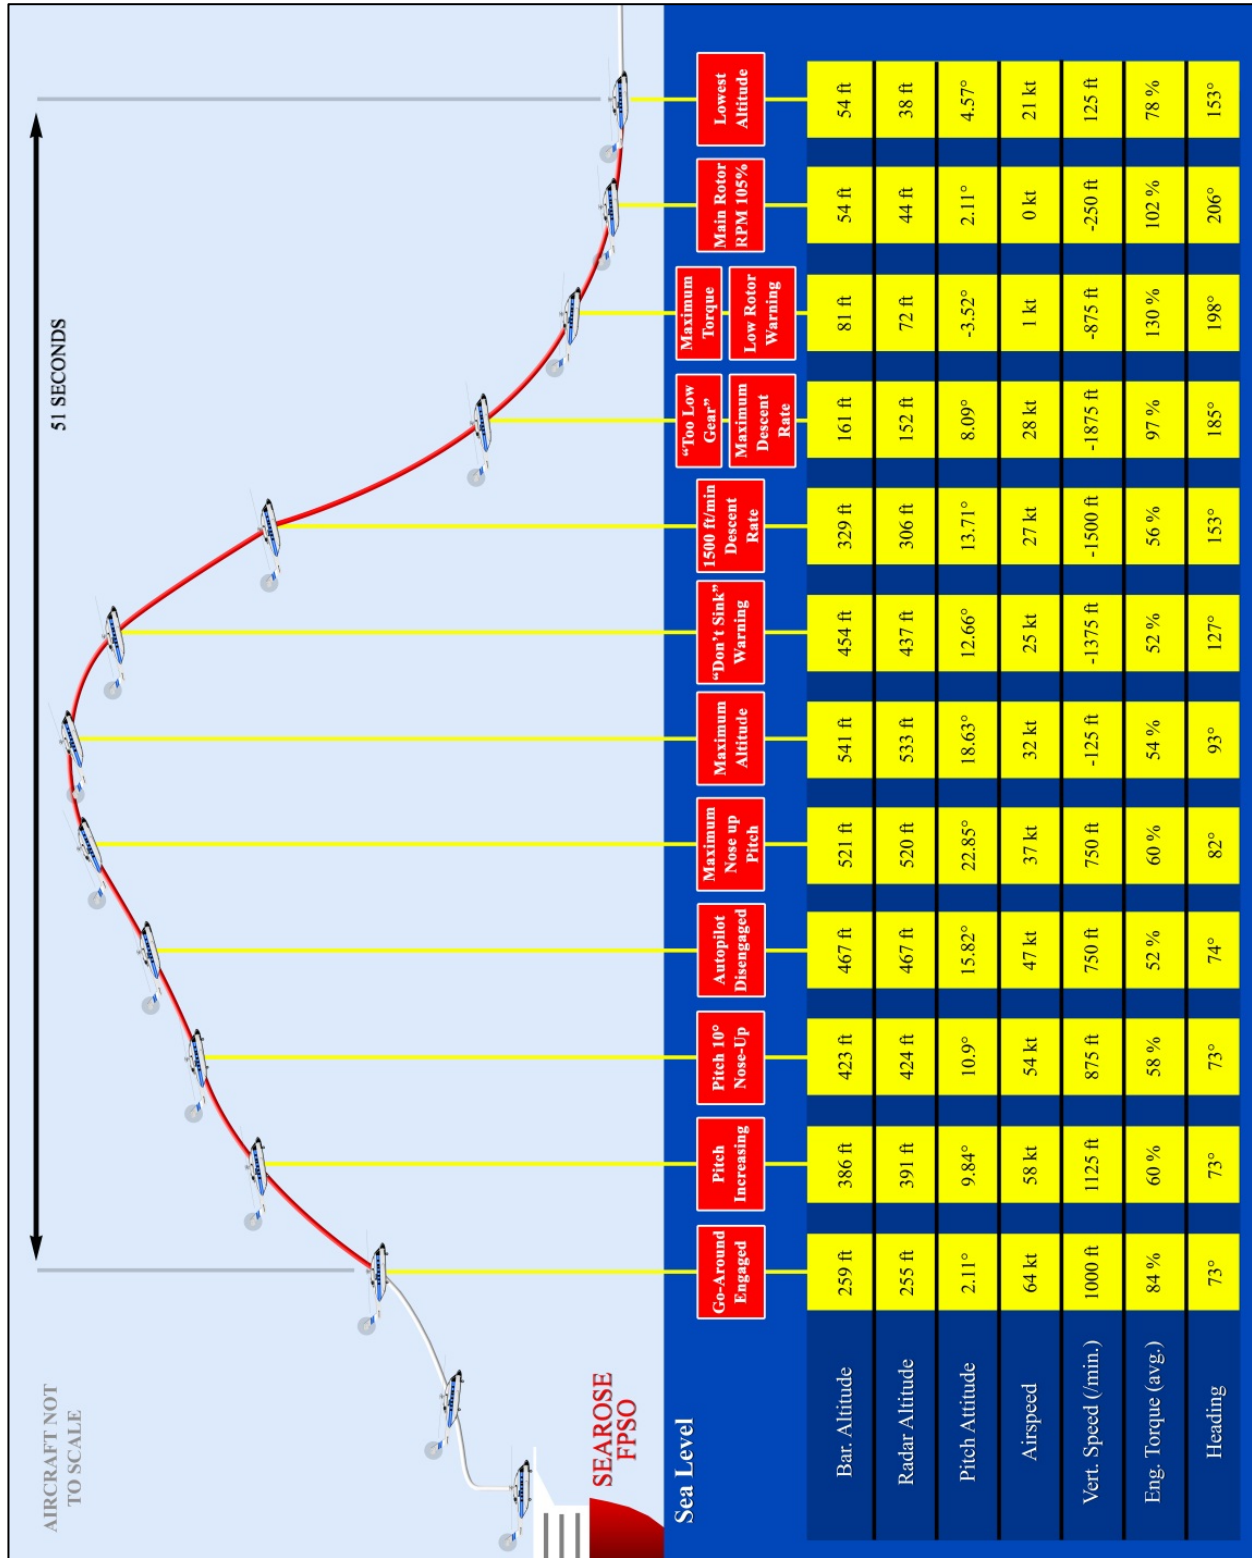
Appendix B – Departure Profile (Derived from FDR Data)

1. During the departure procedure, the captain made a large, rapid aft cyclic input just before the cyclic trim button was released and the go-around mode was engaged, which caused the helicopter to enter a nose-high, decelerating pitch attitude.

3. As the airspeed of the helicopter decreased to within 5 knots of the minimum control speed in instrument meteorological conditions (V_{MINI}), the captain momentarily pressed the cyclic force trim release button and made an aft cyclic input. This caused the helicopter's airspeed to decrease below V_{MINI} , and the helicopter to enter a 23° nose-high unusual attitude.
