**AVIATION INVESTIGATION REPORT  
A11O0239**

**LOSS OF CONTROL – COLLISION WITH TERRAIN**

**CESSNA CARDINAL 177A, C-FEFQ  
OTTAWA/MACDONALD-CARTIER INTL, ONTARIO 1.9 NM W  
14 DECEMBER 2011**

Report Number A11O0239

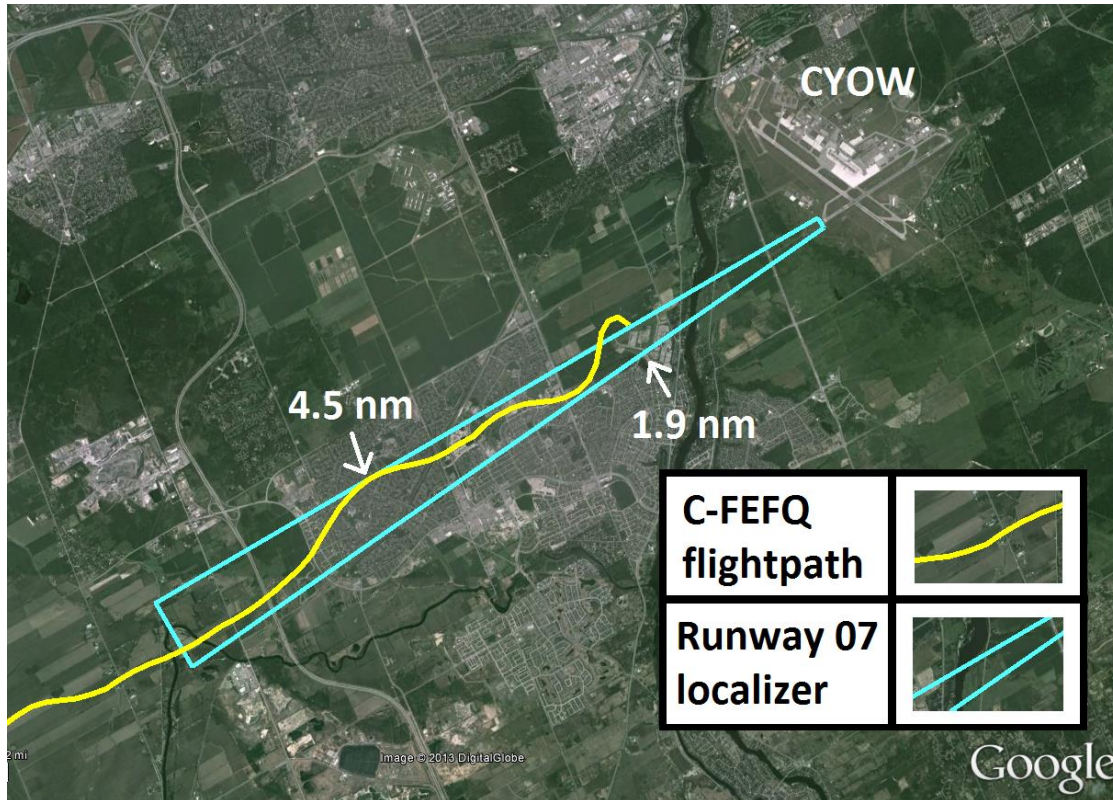
Figure 1. Final aircraft flight path

Radar data shows that, while on the approach, the aircraft twice deviated significantly from the localizer to a point that would have caused the localizer indications on the aircraft instruments to go to full deflection. Airspeed on the approach was maintained above 100 knots until the loss of control (Figure 1).

While on the ILS approach into Ottawa in unfamiliar night IMC conditions, the pilot had significant difficulty maintaining the localizer. During the approach, the tower controller twice advised the pilot that the aircraft was deviating from the approach course. During the second attempt to regain the localizer, the pilot most likely made a steep right turn, which quickly developed into a rapid descent and loss of control.
