**AVIATION INVESTIGATION REPORT  
A11P0073**

**LOSS OF SEPARATION**

**NAV CANADA – VANCOUVER TOWER  
VANCOUVER INTERNATIONAL AIRPORT  
RICHMOND, BRITISH COLUMBIA  
15 APRIL 2011**

Report Number A11P0073

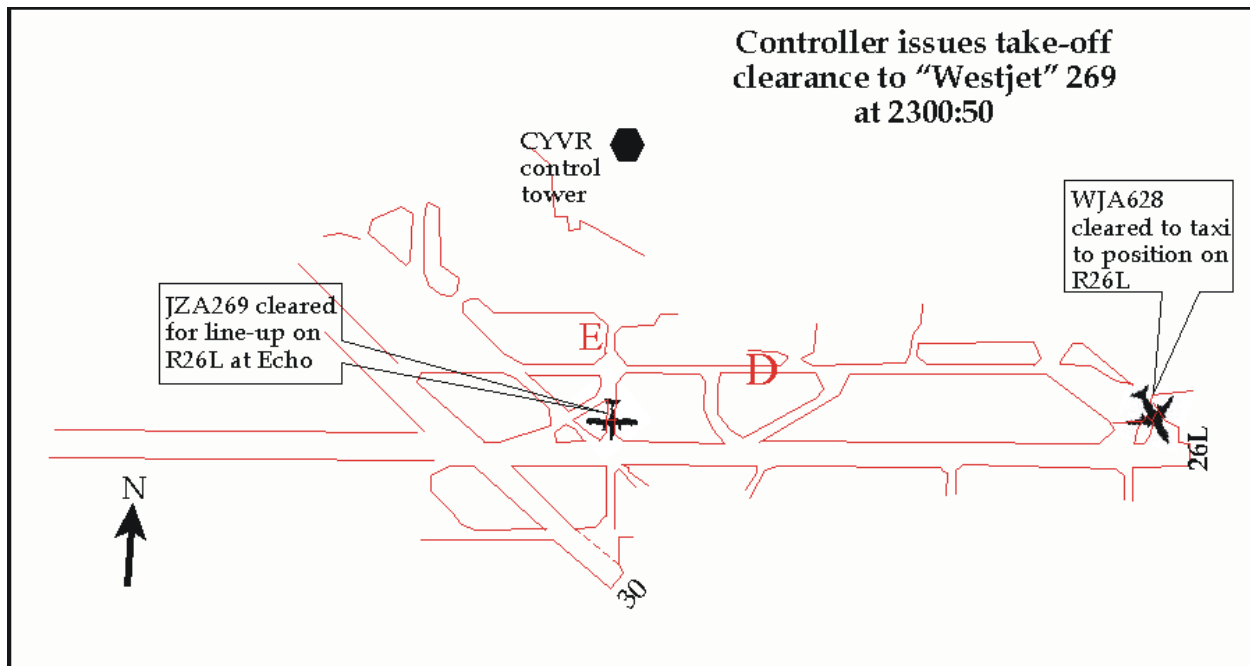
**Figure 1.** Departure positions of JZA269 and WJA628 at 2300:50 (drawing not to scale)

At 2300:50, as both WJA628 and JZA269 taxied into position on Runway 26L, the airport controller issued a take-off clearance (Figure 1). The aircraft cleared for take-off was identified as "Westjet 269," and the clearance included the instruction to fly the Richmond 1 SID. The clearance did not name the taxiway/runway intersection, as required by the NAV CANADA *ATC Manual of Operations* (ATC MANOPS). At 2300:58, the flight crew of WJA628 read back the take-off clearance and questioned the change in SID from the previously issued Georgia 2 SID to the Richmond 1 SID. The Richmond 1 SID is designed for use by non-jet aircraft only. Five seconds later, the flight crew of JZA269 advised that JZA269 was lined up on Runway 26L. The airport controller, realizing that a mistake had been made, then cleared JZA269 for take-off, and instructed WJA628 to hold position. The take-off clearance for JZA269 did not include the

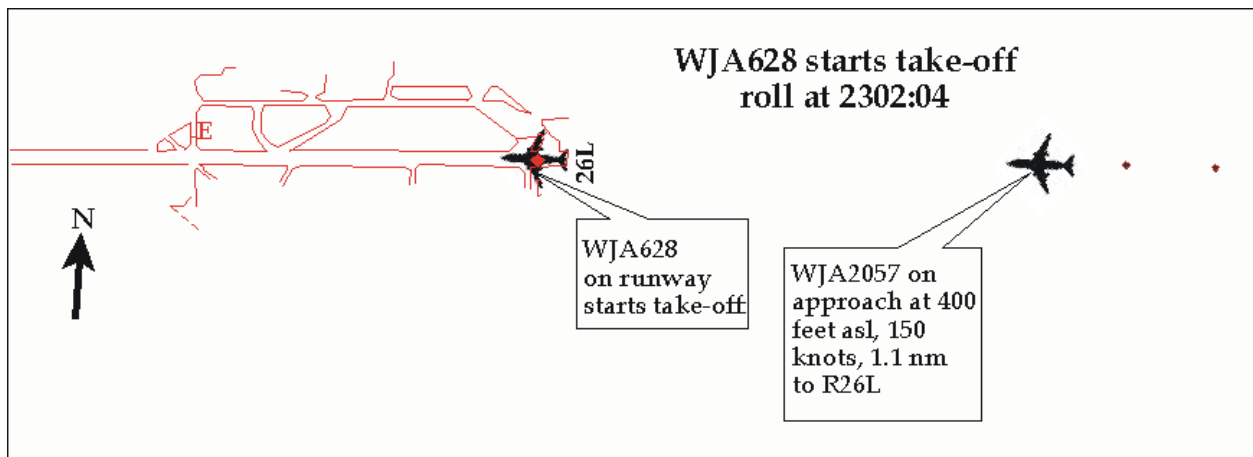
Figure 2. WJA628 starts take-off roll at 2302:04 (drawing not to scale)

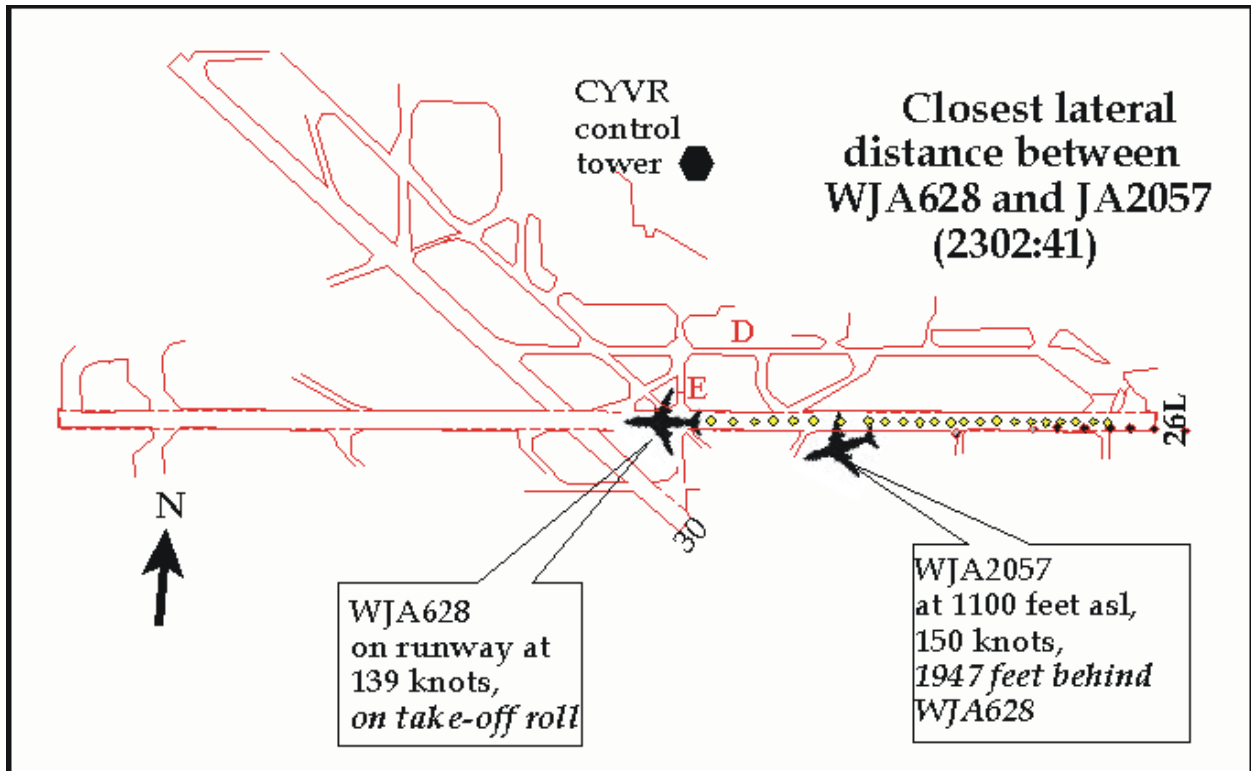
1100 feet asl (Figure 3). No traffic or sequencing information was provided to either WJA628 or WJA2057. Although the flight crew of WJA2057 saw WJA628 on the button of Runway 26L during the approach, they lost visual contact with WJA628 when they commenced the missed approach. The crew of WJA628 did observe a target corresponding to WJA2057 on the traffic collision-avoidance system (TCAS) display in the cockpit. WJA628 was ahead of WJA2057, and did not acquire WJA2057 visually.

Figure 3. Closest lateral distance between WJA2057 and WJA628 (drawing not to scale)

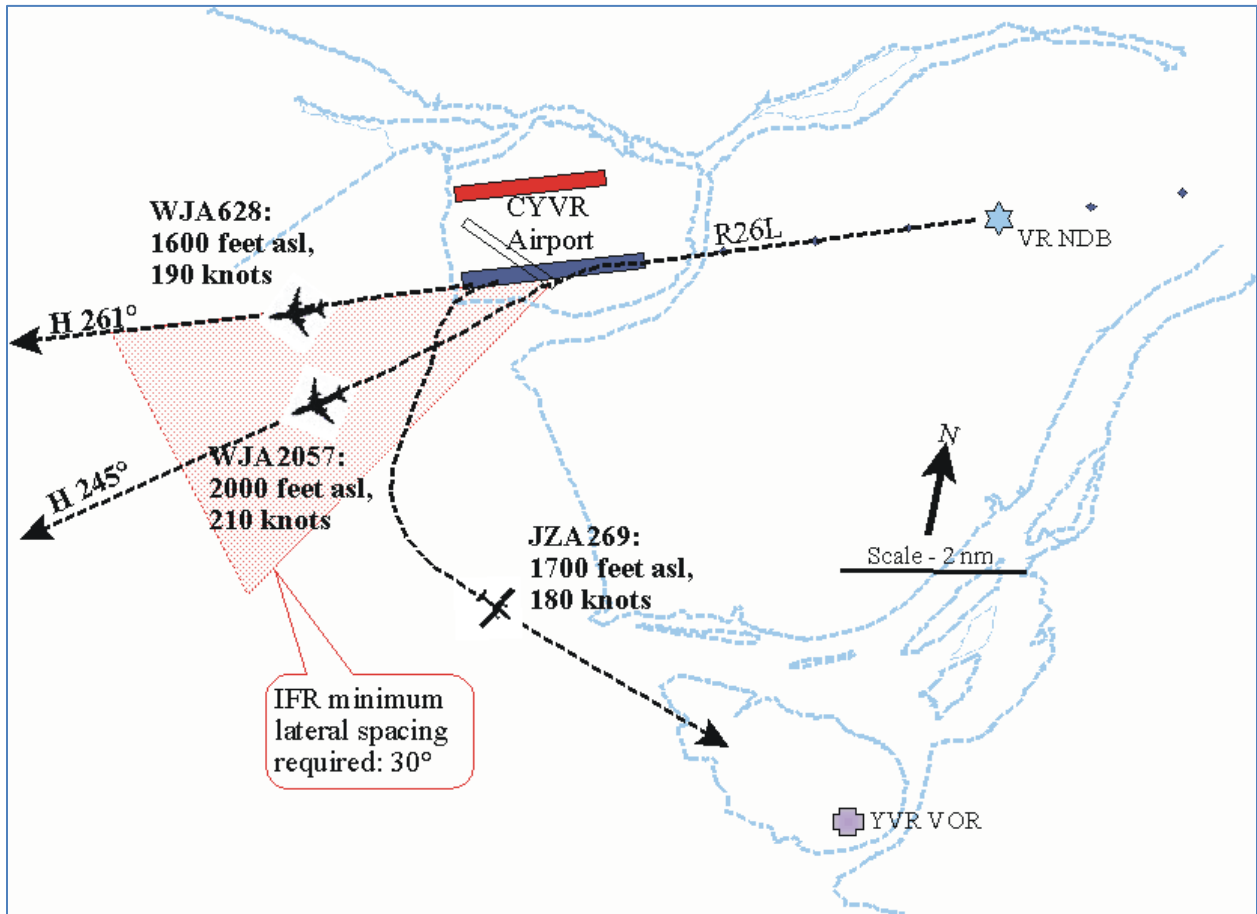
At 2303:36, the airport controller, intending to instruct JZA269 to contact departure control, again used the wrong call sign – “Westjet 269” (Appendix A). Several transmissions between the airport controller and JZA269 were required to clarify the instruction, after which JZA269 acknowledged the change in frequency. While intending to transfer WJA2057 to the departure frequency, the airport controller again confused the aircraft call signs and used “Jazz 2057.” This instruction was not acknowledged, and WJA2057 remained on the airport controller’s frequency. At 2304:13, the airport controller instructed WJA628, now 3.8 nm from the departure end of Runway 26L and climbing through 2700 feet, to contact departure control. At this point, WJA2057 and WJA628 were 1.6 nm laterally and 700 feet vertically apart. This distance did not provide the minimum instrument flight rules (IFR) separation required by ATC MANOPS. The minimum separation required would have been 3 nm lateral, or 30° heading difference, until 1000 feet vertical was achieved. At 2304:23, WJA628 was climbing through 3200 feet asl to its cleared altitude of 7000 feet asl.

Appendix A – Aircraft Positions on Hand-off of WJA628 to Terminal at 2303:35 PDT
