**AVIATION INVESTIGATION REPORT
A12O0071**

LOSS OF CONTROL AND COLLISION WITH WATER

**COCHRANE AIR SERVICE
DE HAVILLAND DHC-2 MK.1, C-FGBF
LILLABELLE LAKE, ONTARIO
25 MAY 2012**

Report Number A12O0071

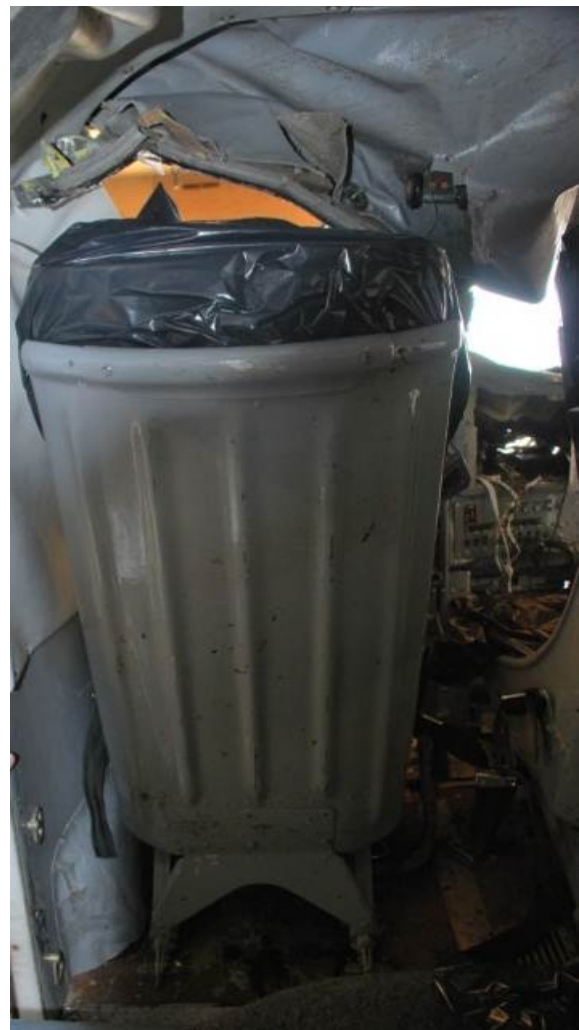
Photo 1. C-FGBF pilot seat after the accident

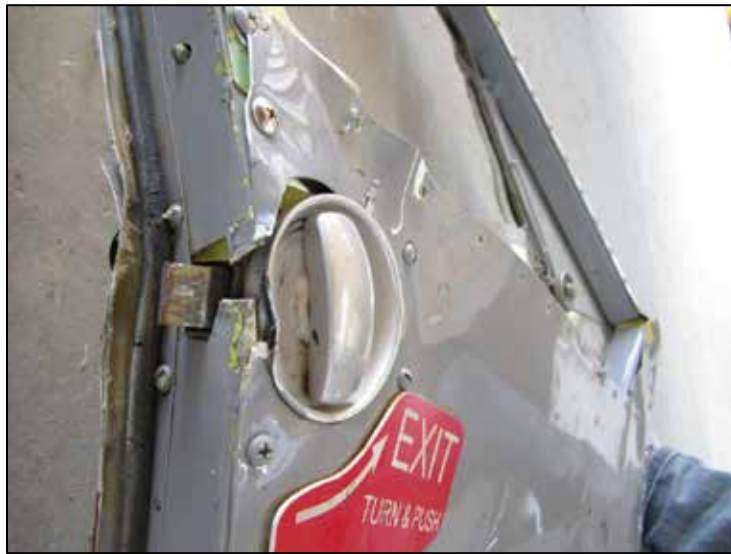
Photo 2. Pilot's door mechanism

Due to the damage to the pilot's door, significant torque on the handle was required to open it. As well, the original small recessed rotary interior door handles of this aircraft had not been replaced with ones that are more accessible and easier to operate. Either of these factors may have prevented the pilot from opening the door. The pilot survived the impact, but was unable to exit the aircraft, possibly due to difficulties finding or opening an alternate exit. The pilot subsequently drowned. Commercial seaplane pilots who do not receive underwater egress training are at increased risk of being unable to exit the aircraft following a survivable impact with water.
