**AVIATION INVESTIGATION REPORT
A12O0138**

COLLISION WITH TERRAIN

**WATERLOO-WELLINGTON FLYING CLUB
CESSNA 172S, C-FNET
MOOREFIELD, ONTARIO
24 AUGUST 2012**

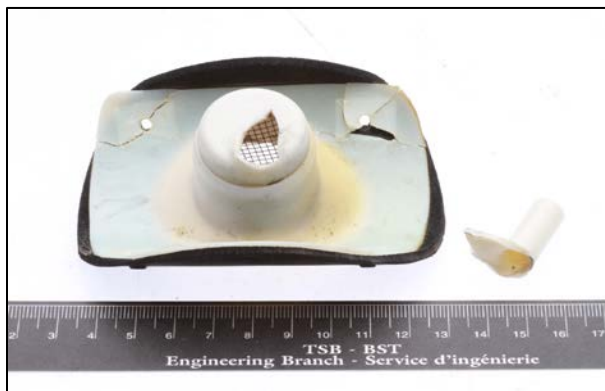
The stall warning system includes a stall warning horn and a scoop assembly. The stall warning horn is found on the inside of the cabin, behind the doorpost moulding and to the outboard side of the pilot on the fuselage rib. The scoop assembly is installed on the leading edge of the left wing at wing station (WS) 91.25. The scoop is operated by airflow over the surface of the wing. An internal reed in the stall warning horn sounds when the airspeed is approximately 8 to 15 knots greater than the airplane stall speed.³ The scoop is attached to the wing leading edge by 4 fasteners. Cracks were found in the scoop flange at all fastener locations. The pipe at the back of the scoop was fractured from the scoop at its base (Photo 1).

During subsequent examination at its regional facility, the Transportation Safety Board (TSB) found that the scoop of the stall warning system was cracked. The system was sent to the TSB Laboratory for further examination. Examination of the fracture under a microscope revealed an area that had been previously cracked; this was made evident by the discoloration of the fractured surfaces. Another area of the fracture showed a more recent break (Photo 2), which was determined to be the result of impact forces. According to the manufacturer's maintenance procedures, inspection of the stall warning system, including its operation, is performed during every 'A' check (50-hour inspection). The previous inspection had been performed 40 hours prior to the occurrence; the stall warning system was serviceable at that time.

Photo 1. Rear view of scoop, fractured at its base

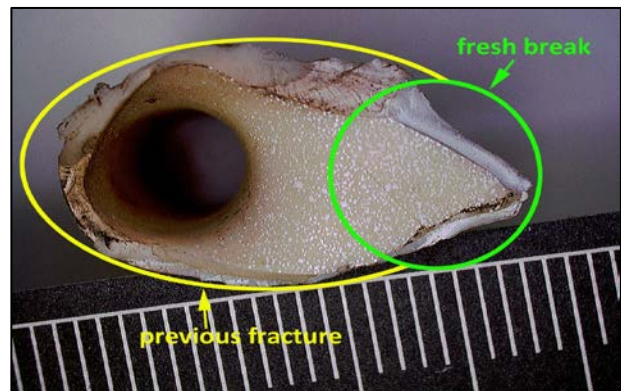
Photo 2. Fractured surfaces of the pipe

The scoop was made of acrylonitrile-butadiene-styrene (ABS) plastic. It failed in a brittle, progressive mode, consistent with environmental stress cracking,⁴ weathering⁵ and thermal

degradation. This degradation would have further contributed to the embrittlement of the scoop material. The crack initiation date and rate of progression could not be determined.

The stall warning system was tested in the TSB Laboratory to determine the effects of a potential breach on the system. It was observed that a breach in the plastic tube was sufficient to silence the horn. This reduction of airflow through the reed would have the same effect as a lower angle of attack and would adversely affect the operation of the stall warning system.

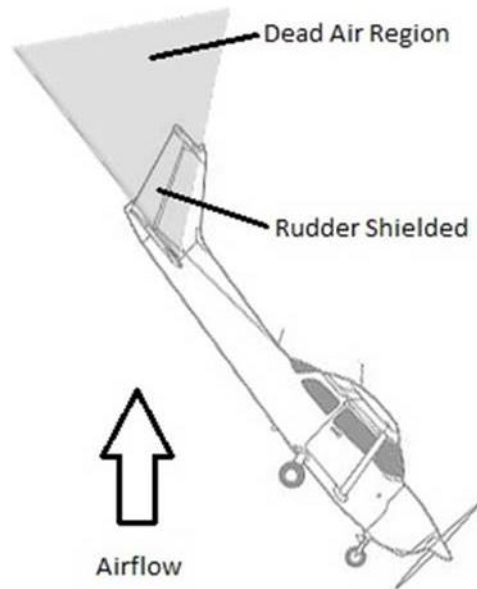
[D]uring a spin, much of the rudder usually is in the stalled wake of the horizontal tail and sometimes the wing, over which the dynamic pressure is low or abnormal airflow conditions exist. [...] This figure [Figure 1] illustrates the dead-air region over much of the vertical tail, which is caused by the stalled wake of the horizontal tail and which seriously decreases the effectiveness of the rudder. ⁷

Figure 1. Dead air region caused by horizontal tail (Reproduced from NASA Technical Note 6575, p. 28)

During the spin, the angle of attack increased due to an aft CG. As a result, the horizontal tail likely blanketed the airflow over the rudder, reducing its efficiency and delaying spin recovery. In the normal category, the aircraft is certified to recover from a one-turn spin in less than one additional turn, assuming the proper control inputs are applied.

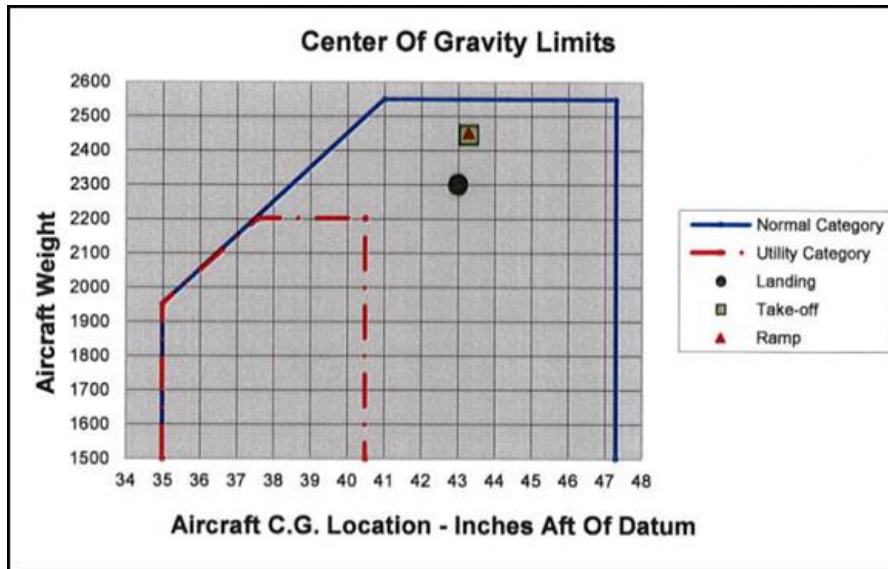
Figure 2. C-FNET calculated weight and balance chart (Source: Waterloo-Wellington Flying Club)

The aircraft departed with a take-off weight of 2446 pounds and a CG located approximately 43.25 inches aft of datum.¹³ The foreseen landing weight was 2300 pounds and CG location, 43 inches aft of datum. The aircraft was operated in the normal category for the entire flight (Figure 2).

1. The aircraft entered a spin in a weight and balance configuration for which spins were not authorized; the pilot did not recover from the spin prior to ground impact.
