**AVIATION INVESTIGATION REPORT  
A12W0004**

**RUNWAY OVERRUN**

**1263343 ALBERTA INC. (DBA ENERJET)  
BOEING 737-700, C-GDEJ  
FORT NELSON, BRITISH COLUMBIA  
09 JANUARY 2012**

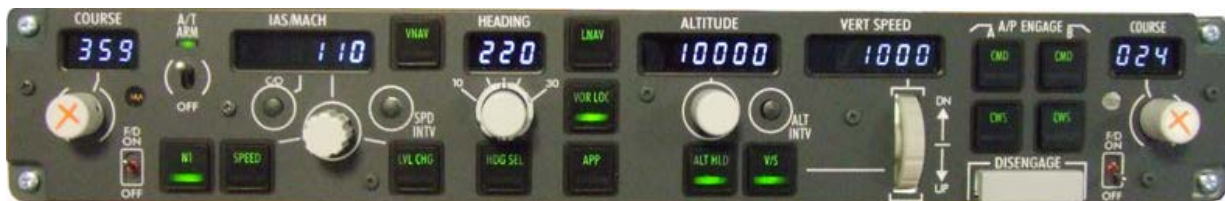
**Photo 1.** Exemplar mode control panel

Seventeen minutes before touchdown, air traffic control cleared ENJ401 to track inbound to the Fort Nelson very high frequency omnidirectional range (VOR) via the 133° radial and to descend to 12 000 feet asl. Approximately 9 minutes later, ENJ401 requested and was cleared for a visual approach onto Runway 03 in Fort Nelson. At this time the captain requested that the first officer enter the initial approach fix, BOXEX, into the FMC and proceeded to navigate to that fix. In addition, the captain entered field elevation, 1300 feet asl, into the autopilot flight director system (AFDS) mode control panel (MCP) ALTITUDE window. (Photo 1).

Although Enerjet standard operating procedures (SOPs) allowed for this, it was not a usual practice for the captain to enter field elevation; rather, he would enter field elevation plus 1000 feet.

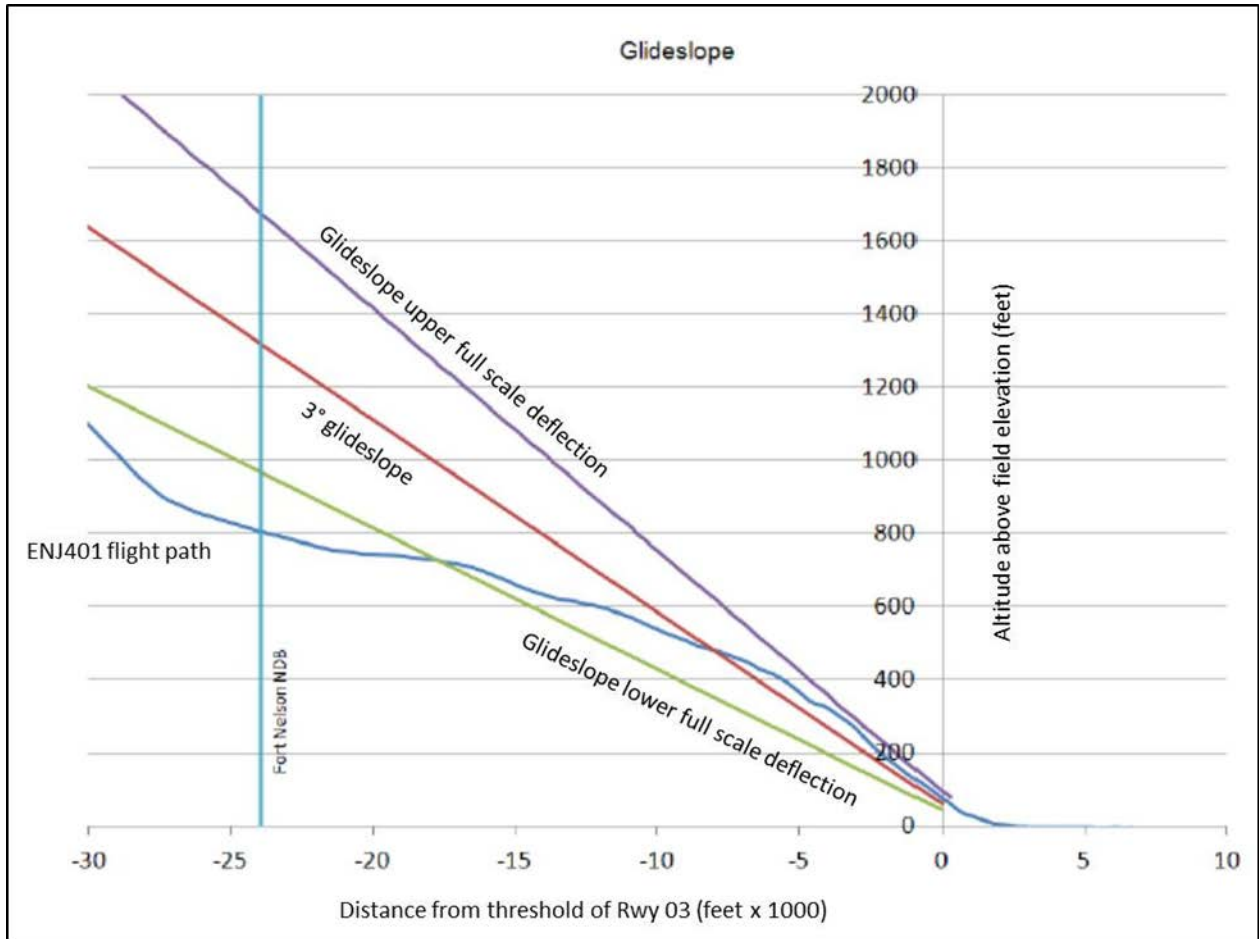
## Appendix B – Glideslope Deviation

ENJ401 intercepted the glideslope 40 seconds before touchdown at 420 feet agl. At this time the flight directors were cycled off and then on. Turning off the flight directors switches results in the pitch and roll command bars to disappear on the primary flight display and the AFDS modes currently selected to be turned off, in this case, G/S capture and VOR/LOC respectively. Turning the flight director back on results in the pitch bars returning and defaulting to a selected altitude, in this case ALT ACQ and 1900 feet, and the roll bar to the current heading. The AFDS remained in ALT ACQ with no lateral mode and the A/T was in MCP SPD mode. The aircraft was experiencing a tailwind component of 10 knots, which was decreasing. As the descent continued, the aircraft got a dot high on the glideslope. In response, the captain pitched

the nose down and the aircraft's speed increased to 142 KIAS; the vertical descent speed increased to 975 feet per minute (Appendix B).

According to the Enerjet definition of a stabilized approach, ENJ401 was not stabilized during the final approach as it did not achieve a 3° glideslope. The flight crew acknowledged this condition after the enhanced ground proximity warning system (EGPWS) provided 2 aural glideslope warnings. The crew elected to continue as the aircraft's speed was stable, the vertical path was trending towards the glideslope, and flap settings were moving towards the landing configuration. The approach appeared to the crew to be salvageable.

3. On short final the captain pitched the aircraft nose-down in an attempt to capture the glideslope which was below their flight path. The nose-down attitude increased the airspeed resulting in a longer flare and a touchdown beyond the recommended 1000-foot mark, thus reducing the amount of available runway for stopping.

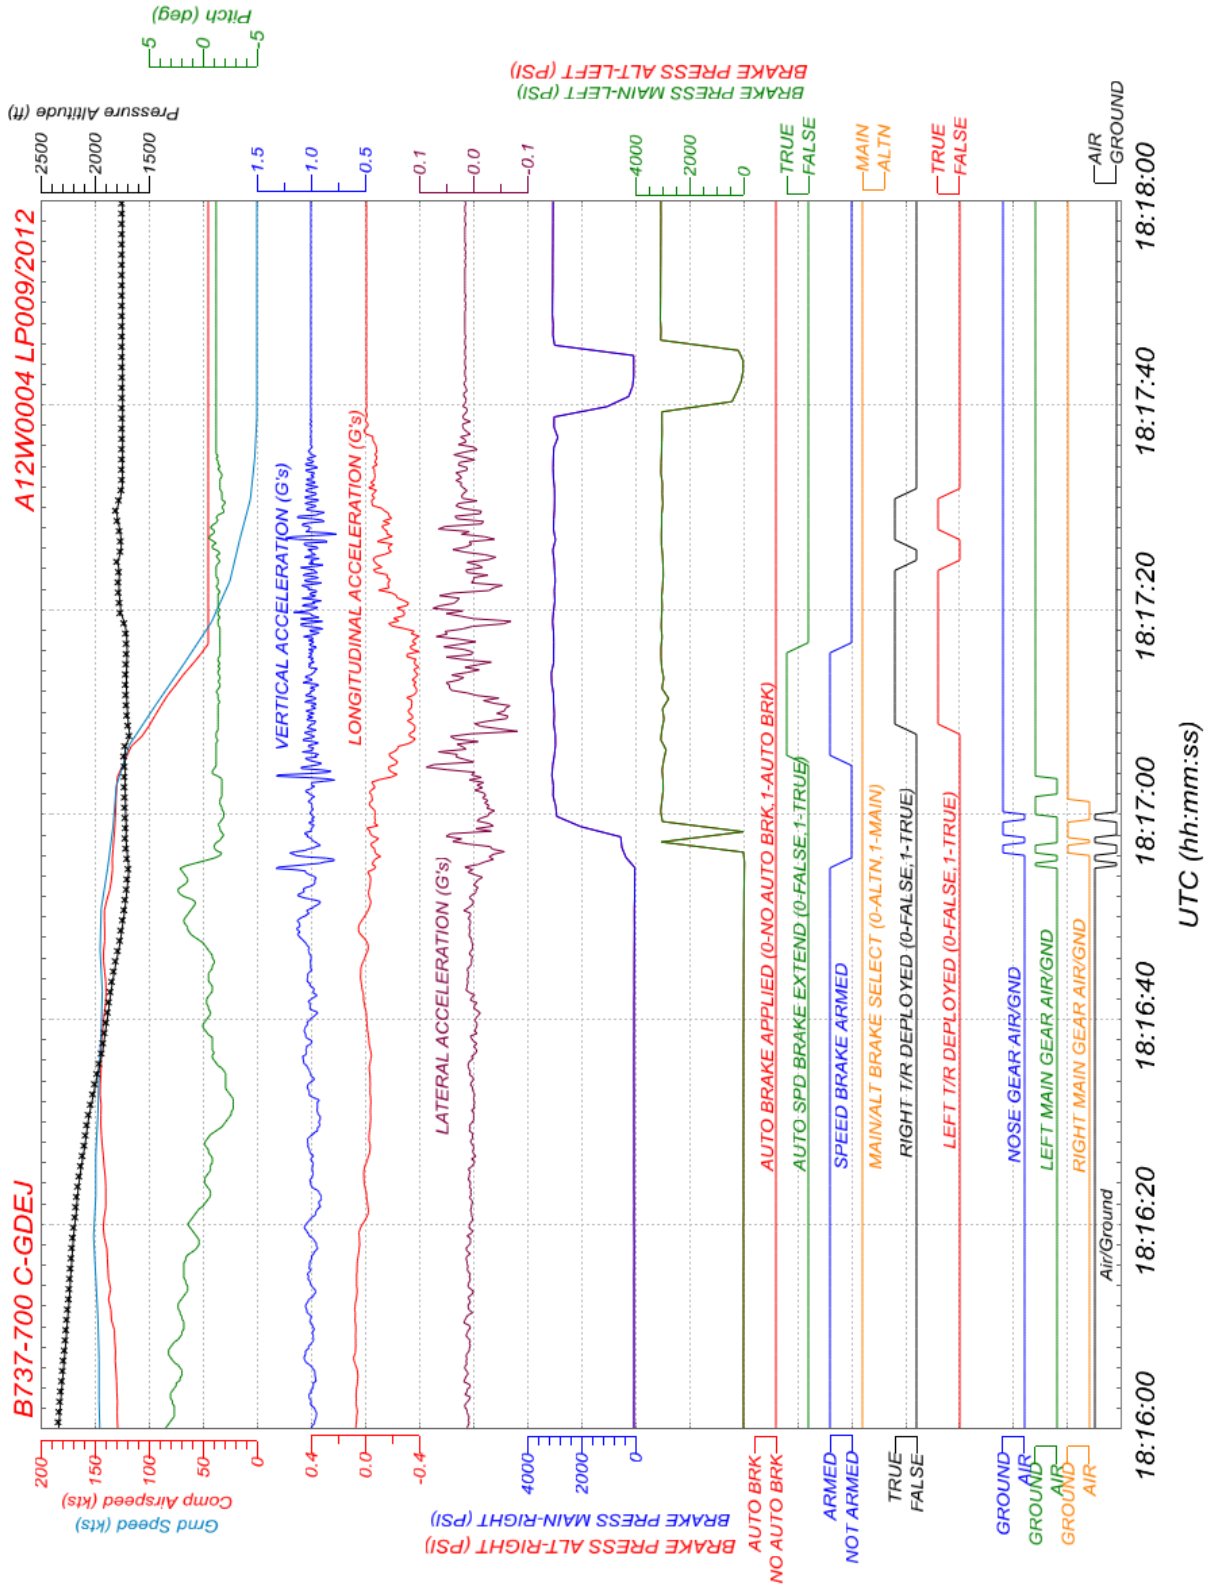
# Appendix C – Flight Data Recorder Plot of Landing Rollout

The EGPWS radar altitude countdown sounded "... 50, 40, 30, 20, 10" but the captain did not disarm the A/T at 50 feet agl in accordance with standard operating procedures. The aircraft touched down at 134 KIAS, 1800 feet from the threshold with 4602 feet remaining. When the captain moved his hand to actuate the thrust reversers, the A/T advanced the thrust levers in order to maintain the selected speed of 133 knots. This action prevented the extension of the speed brakes. The captain repositioned his hand on the thrust levers and brought them to flight idle while disconnecting the A/T. Contrary to Enerjet standard operating procedures, the first officer did not call out "no speedbrake", "no reverse", or "autobrake disarm" during the initial roll-out.

Deceleration began about 5 seconds after touchdown with approximately 2500 feet of runway remaining. At this time full manual braking was being applied with reverse thrust and speed brakes deployed. The longitudinal deceleration force averaged -0.35 g which is consistent with a bare and dry runway (Appendix C). The aircraft exited the end of the runway at approximately 10 to 15 knots and came to a full stop 230 feet from the end and approximately 20 feet left (north) of the extended runway centre line. The main landing gear was on frozen soil and the nose gear was in approximately 18 inches of snow.
