## AVIATION INVESTIGATION REPORT A13C0150

**LOSS OF ENGINE POWER - COLLISION WITH TERRAIN**

**BEARSKIN LAKE AIR SERVICE LP (BEARSKIN AIRLINES)**

**FAIRCHILD SA227-AC METRO III, C-FFZN**

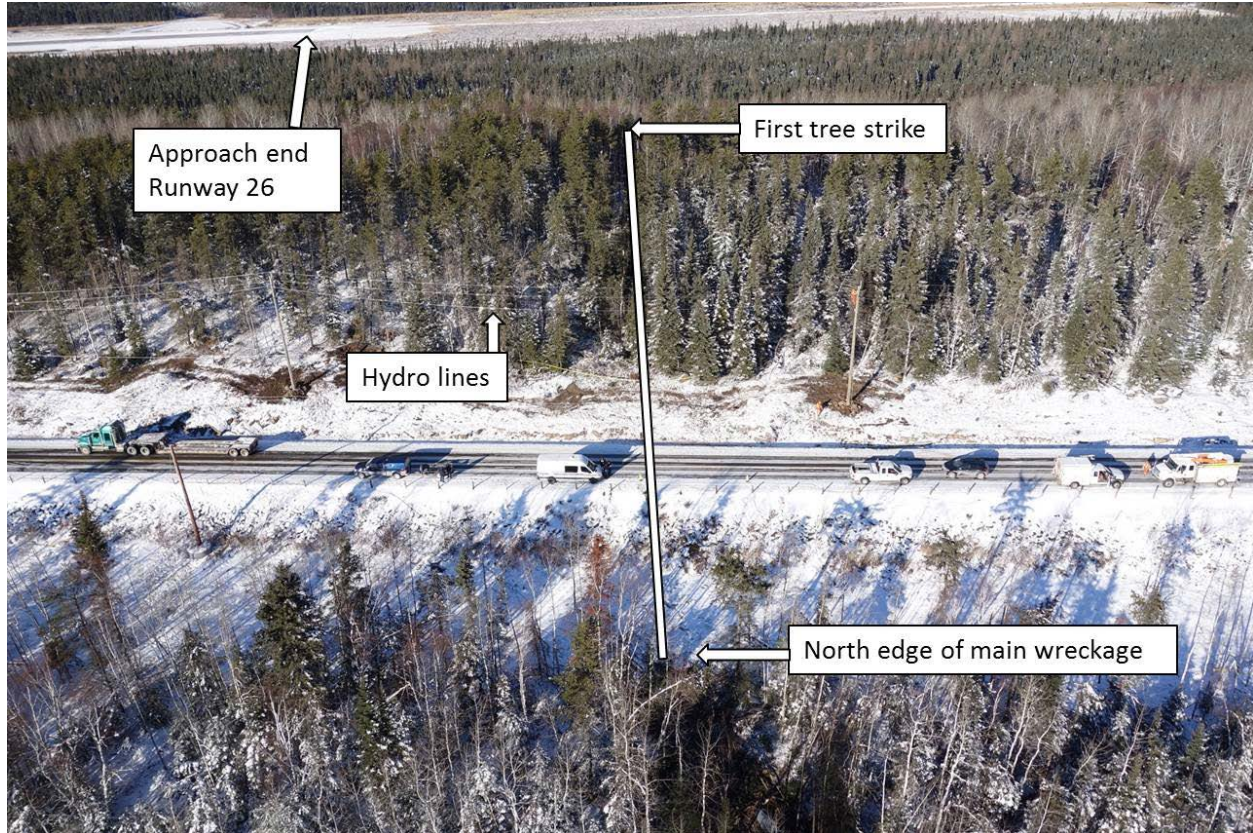
Photo 2. Accident impact points (Source: Ontario Provincial Police Identification Unit, with TSB annotations)

The aircraft struck trees while in a steep left-wing-low attitude approximately 2300 feet south of the approach end of Runway 26 (Photo 2).

The outboard 8-foot section of the left wing was torn off, and the aircraft travelled approximately 375 feet before striking hydro lines that paralleled Ontario Highway 125 leading to the airport. The aircraft contacted the south edge of the highway road bed, at which point the left engine and propeller separated from the aircraft. The aircraft cartwheeled and slid tail first coming to rest 150 feet from the highway in an area of trees. The left engine came to rest underneath the tail section. The right engine and wing broke off during the impact sequence. Both propellers had detached from their respective engines. The front of the aircraft forward of the wing main spar was severely crushed and deformed; the cabin area aft of the wing trailing edge remained largely intact. Most of the aircraft was consumed by the post-crash fire (Photo 3).

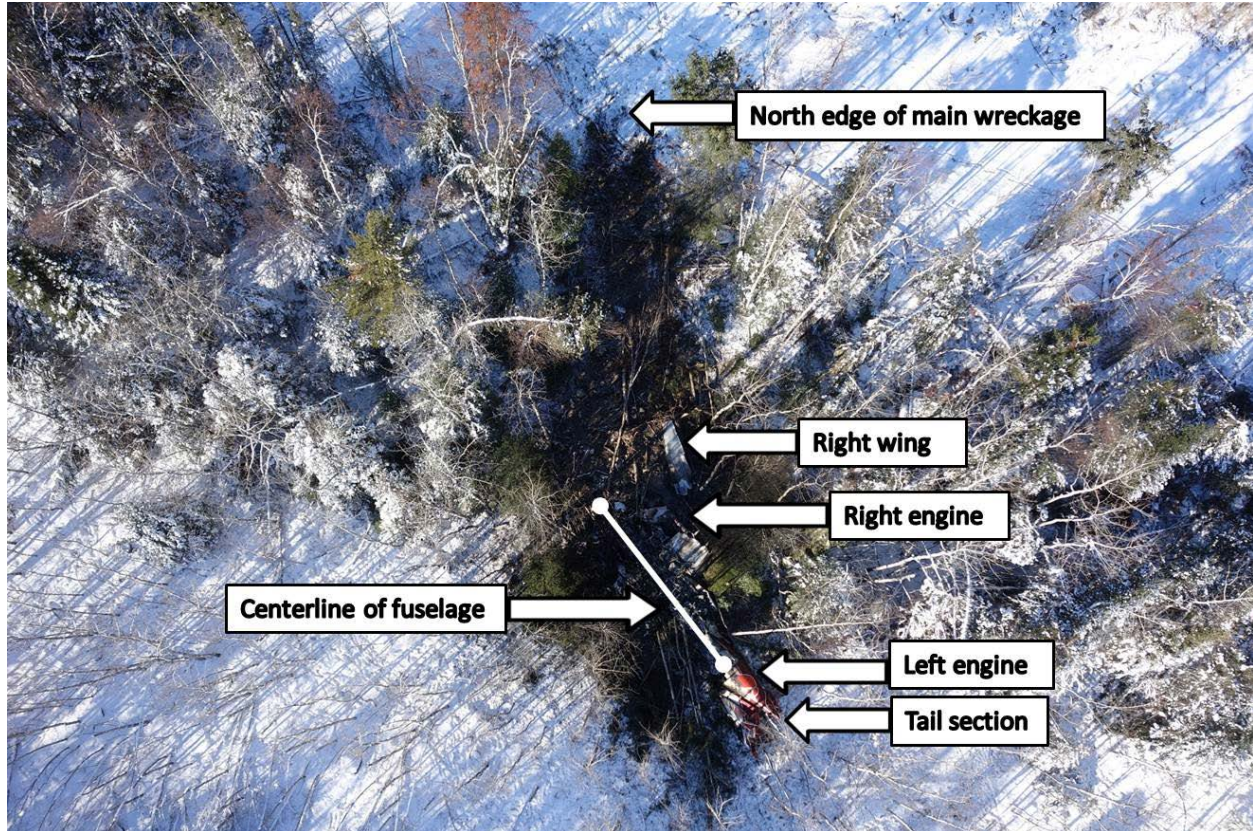
Photo 3. Main wreckage site (Source: Ontario Provincial Police Identification Unit, with TSB annotations)

Both wing fuel tanks were ruptured during the impact sequence, and a post-crash fire ensued which consumed most of the aircraft.

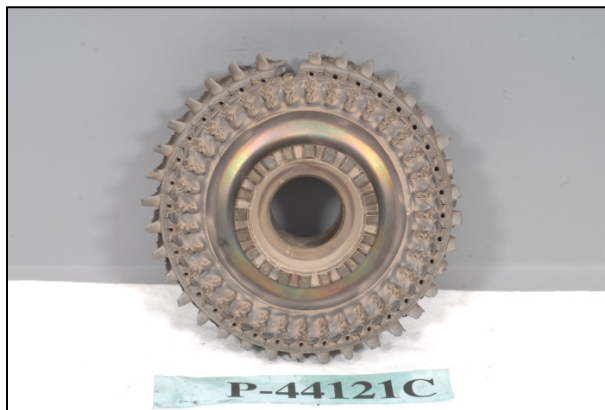
Photo 4. First-stage turbine wheel

The first-stage wheel (Photo 4, Photo 5 and Photo 6) was stripped of all blades down to the blade roots with 1 blade failing at the fir tree<sup>11</sup> blade root area. The area of failure exhibited a distinct fatigue zone near the trailing edge of the blade and was sent to the TSB Laboratory for metallurgical examination. The examination concluded that the blade failure occurred as a result of high-cycle fatigue in an area of high porosity.

In summary, the manufacturer's contributing cause analysis determined that the first-stage turbine wheel failed because of high-cycle fatigue which was the result of the following factors:

- Substandard porosity of the turbine blade material which resulted in inadequate fatigue capability and the creation a favourable location for crack initiation.
- A minor increase in the mean stress in the blade fir tree region due to blade platform contact.
- Stator burn-through which resulted in an uneven vibration on the first-stage turbine wheel assembly and heat stress on the turbine blades.

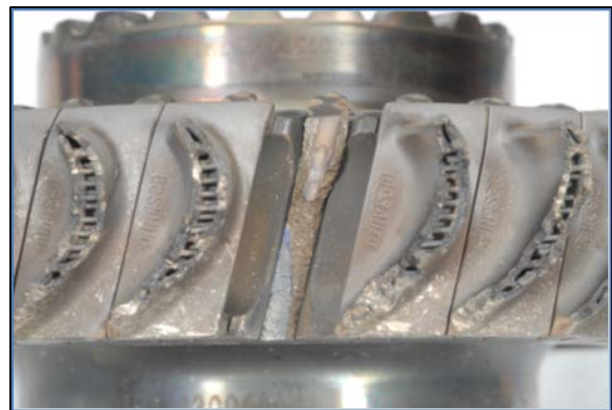
Photo 5. First-stage turbine wheel failure

The material blade characteristics were examined for defects that could lower the fatigue capabilities of the turbine blade material. The failed blade microstructure was normal; however, porosity was measured to be higher than the allowable material requirements in the areas associated with the crack initiation. Porosity of the material can create a favourable location for a crack to initiate if stressors are present, and was assessed as a contributing cause.

The examination of the engine concluded that, in this occurrence, the failure of the first-stage turbine blade by itself would not have caused the engine to lose all power. However, its failure caused damage to the remaining turbine blades, which reduced the efficiency of the engine and would have greatly reduced the power output of the engine to drive the propeller.

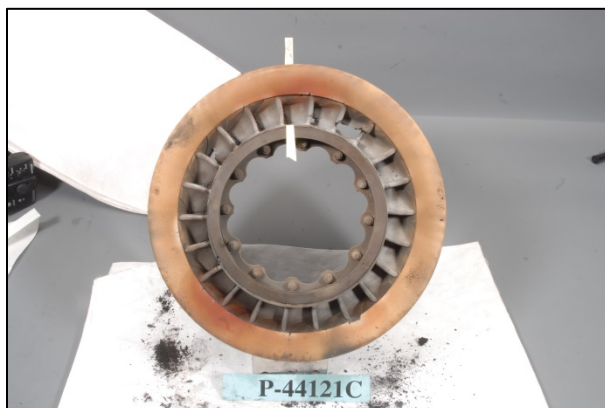
Photo 7. First-stage stator (nozzle) and liner assembly

The first-stage stator (nozzle) assembly (Photo 7 and Photo 8) was examined and burn-through was noted on one of the stationary nozzle vanes. Several other nozzle vanes showed areas of cracking, material loss and heat distress. The stationary first-stage stator assembly is upstream of the first-stage turbine wheel and directs hot combustion air onto the rotating turbine wheel.

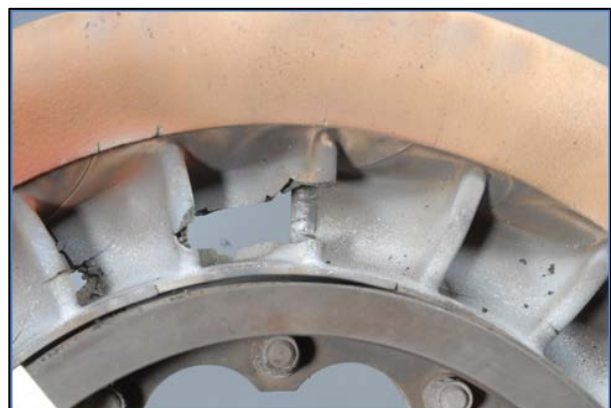
Photo 8. Stator vane burn-through

The engine manufacturer indicated that there had been previous incidents of first-stage turbine wheel blade failures and stator burn-through. At times, the 2 failures occur in conjunction with one another and at other times only the turbine blade fails. The turbine blade failures have been attributed in some instances to porosity issues in the casting process and/or fatigue issues caused by excessive turbine distress due to stator vane burn-through. A burn-through in the

stator vane will produce a vibrational response (one per revolution) in the blades that can lead to the blades separating in a high-cycle fatigue mode. Stator vane burn-through has been attributed to streaking fuel nozzles or the blockage of the first-stage stator cooling tubes which could cause hot spots on the stator vane.

Engineering experience has shown that air gusts through the failed (burnt-through) stator portion will increase the alternating stress experienced by the blade, and stator burn-through was assessed as a contributing cause. Research indicates that stator burn-through could be caused by hot starts and over-temperature operation, a blocked stator vane cooling flow, or streaking fuel nozzles. No evidence of a hot start, an over-temperature condition, or a pre-blocked stator vane cooling flow was found. The cracked fuel nozzle could not be tested for
