**AVIATION INVESTIGATION REPORT
A13H0003**

RUNWAY INCURSION AND RISK OF COLLISION

**NAV CANADA
OTTAWA CONTROL TOWER
OTTAWA/MACDONALD-CARTIER INTERNATIONAL
AIRPORT
OTTAWA, ONTARIO
01 DECEMBER 2013**

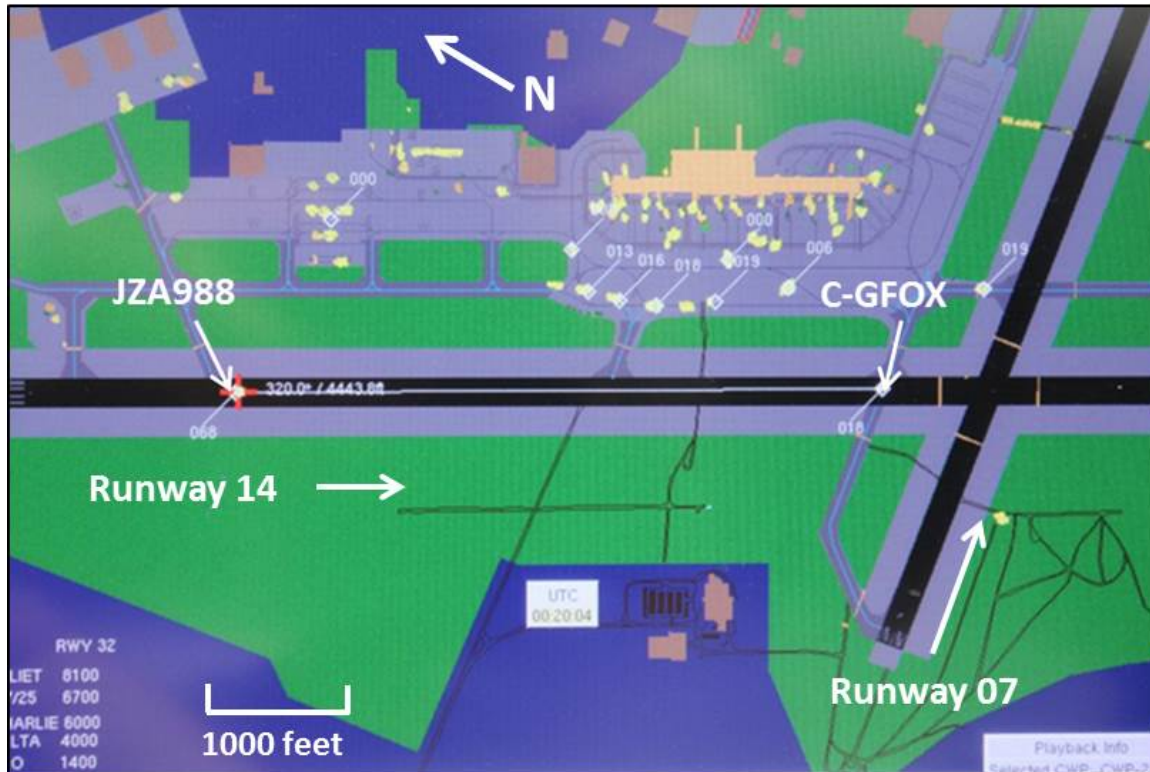
when C-GFOX was near the middle of Runway 14, the horizontal distance between the 2 aircraft was approximately 4400 feet (Figure 1). The ground controller noticed the runway incursion and estimated that C-GFOX would be clear of the runway by the time JZA988 reached the intersection of Taxiway C. Thus, no call was made for JZA988 to abort the takeoff, and the flight continued without further incident, unaware of the runway incursion.

Figure 1. Ottawa/Macdonald-Cartier International Airport ASDE (airport surface detection equipment) display at 0020:04 UTC (1920:04 EST) (Source: NAV CANADA, with TSB annotations)

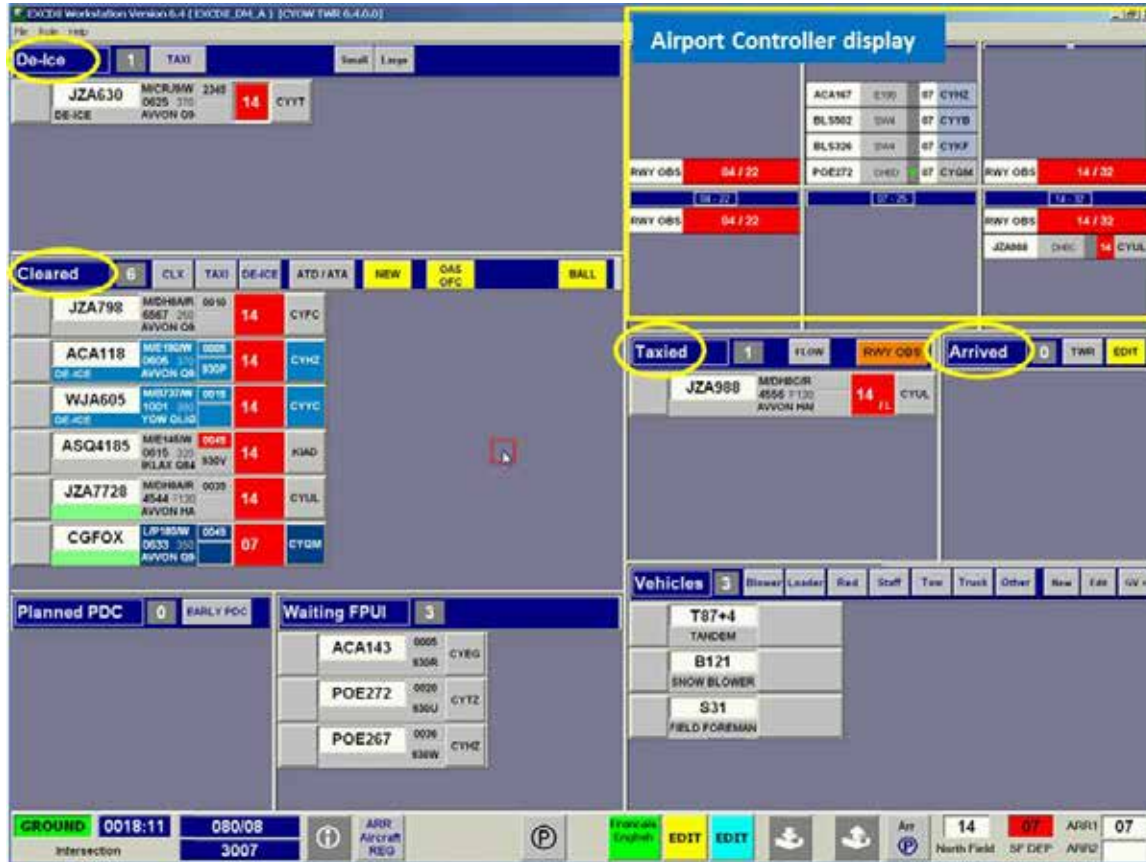
planned runway; and destination. In addition, various colours are used to communicate information to the controller. For example, in Figure 2, the light green highlighting on an FDE indicates aircraft communicating in French, while red runway highlighting designates aircraft for which a departure release is required from the terminal controller,⁷ who is located at the Montréal area control centre.

Figure 2. Capture of the ground controller's Extended Computer Display System display screen at 0018:11 UTC (1918:11 EST), immediately prior to transfer of responsibility for Runway 14/32 (Source: NAV CANADA, with TSB annotations)

At the time the responsibility for Runway 14 was transferred to the airport controller, the ground controller was responsible for 8 aircraft and 3 sets of vehicles (Figure 2). Six aircraft were in the Cleared panel and, of these, 2 were highlighted in light blue to indicate that they had pushed back, and 1 was highlighted in dark blue (C-GFOX) to indicate that it was taxiing. There was 1 aircraft in the De-Ice panel and 1 aircraft in the Taxied panel (JZA988). The situation with the vehicles was changing quickly, with a number of vehicles entering and exiting the field, which required a number of radio communications and EXCDS updates. There were some slight delays observed in completing EXCDS updates during this period, but tasks were carried out as soon as the controller could do so. There were no indications of task

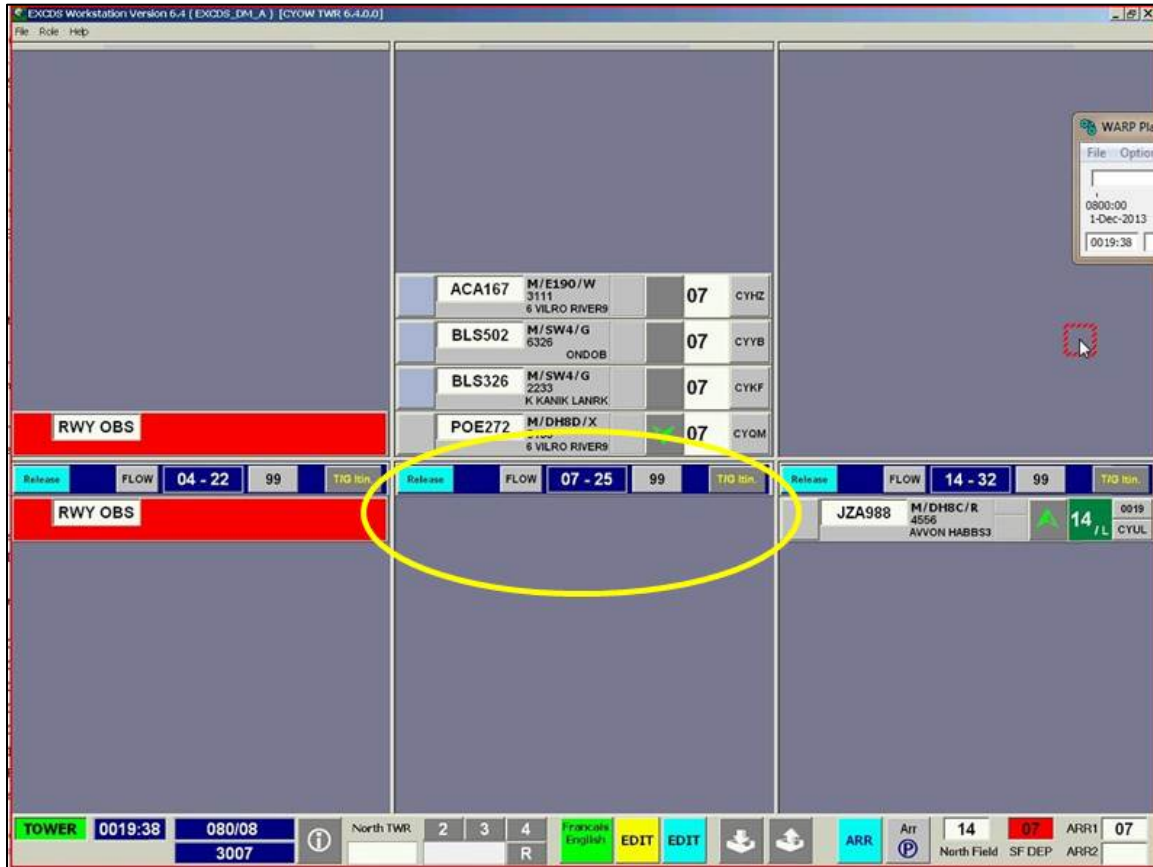
It was the ground controller's practice to delay forwarding the FDE until aircraft were closer to the departure runway. The FDE was left in the Cleared panel, and C-GFOX was highlighted in dark blue as a reminder that some action was required. Following the issuance of taxi instructions to C-GFOX, the ground controller did not initially forward the FDE from the

Cleared panel to the Taxied panel, and therefore the airport controller's EXCDS did not indicate that C-GFOX was taxiing for Runway 07 (Figure 3).

Figure 3. Capture of airport controller's Extended Computer Display System display screen showing no aircraft taxiing for Runway 07 (Source: NAV CANADA, with TSB annotation)

The airport controller was unaware that C-GFOX was taxiing for Runway 07 when the take-off clearance was issued to JZA988 at 1919:28.
