**AVIATION INVESTIGATION REPORT  
A13W0120**

**ENGINE FAILURE AFTER TAKEOFF AND  
COLLISION WITH TERRAIN**

**BUFFALO AIRWAYS LTD.  
DOUGLAS DC-3C, C-GWIR  
YELLOWKNIFE AIRPORT, NORTHWEST TERRITORIES  
19 AUGUST 2013**

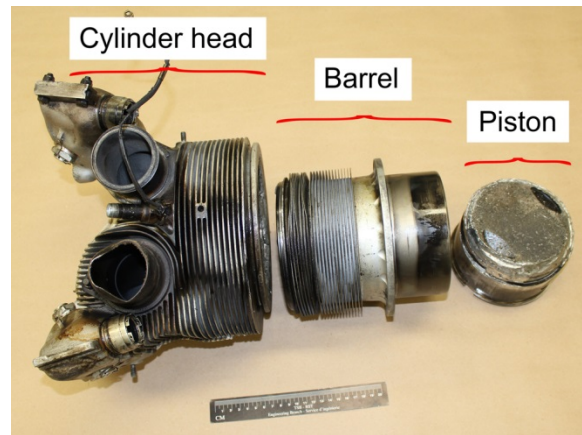
Photo 1. Failed cylinder assembly from C-GWIR

C-GWIR right engine cylinder number 1 head and barrel were found separated due to a fracture of the barrel at the threaded joint with the head assembly (Photo 1). The cylinder head, barrel and piston were forwarded to the TSB laboratory for examination. A pre-existing fatigue crack was discovered in a thread groove on the outer mating surface of the barrel assembly. The cause of the fatigue crack could not be determined due to post-separation damage in the area of the point of origin.

The right engine number 1 cylinder failed as a result of a pre-existing fatigue crack located in a thread groove on the outer mating surface of the barrel assembly. The resulting separation of the head assembly and induction pipe would have allowed supercharged air/fuel mixture and engine oil to be discharged into the engine compartment where spark ignition of the failed cylinder or hot exhaust pipes in the immediate area caused the engine fire.

The location of the fatigue crack point of origin on the failed cylinder was not readily accessible for any direct inspection prior to the occurrence. The fatigue crack had not progressed through the barrel wall, and disassembly of the cylinder would have been required to inspect the inner surface. Cylinder differential pressure checks would also not have detected this crack as the surrounding cylinder head would have prevented the crack from opening. Fatigue is the mode of failure not the reason for failure. Due to post-separation surface damage of the fatigue crack point of origin, the cause could not be determined.

2. The right engine number 1 cylinder failed during the take-off sequence due to a pre-existing fatigue crack, resulting in an engine fire.
3. After the right propeller's feathering mechanism was activated, the propeller never achieved a fully feathered condition likely due to a seized bearing in the feathering pump.

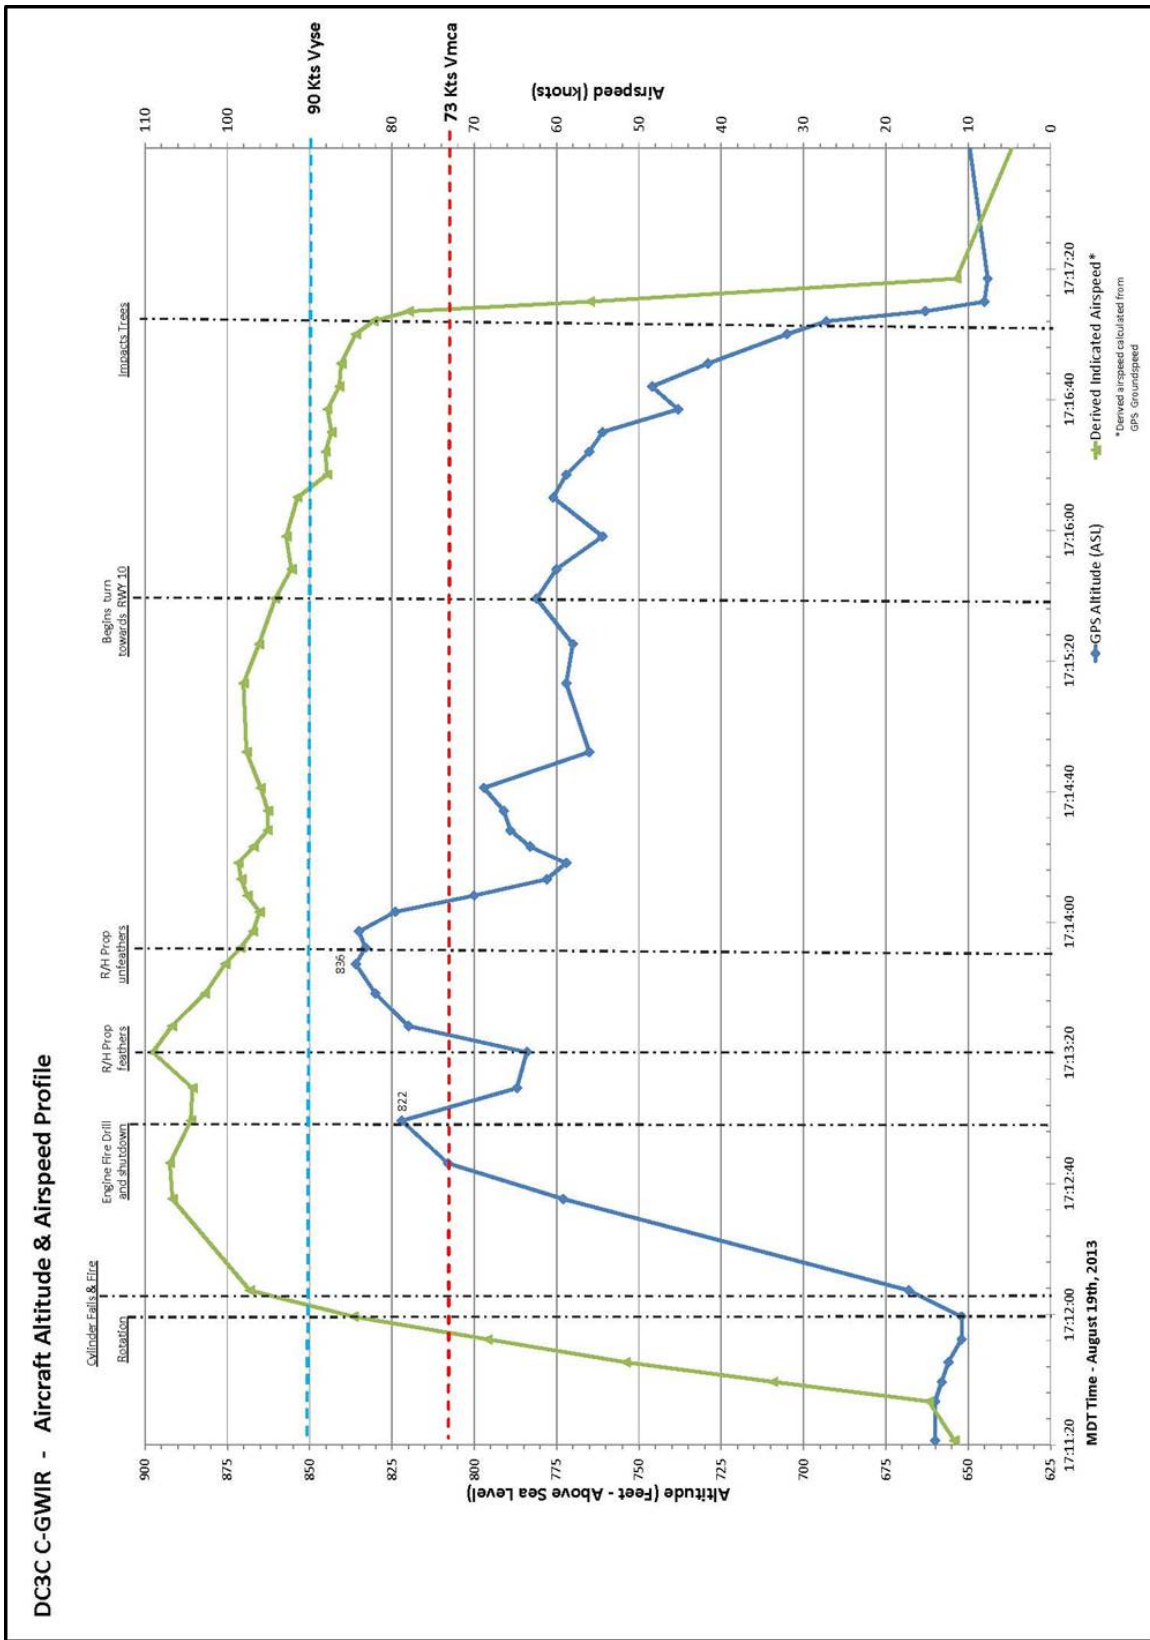
Appendix C - Derived indicated airspeed vs altitude

It should be noted that the performance figures in Table 1 are predicated on the most adverse engine inoperative condition. Failure of the left (i.e., critical) engine will produce the more pronounced yaw/roll condition, which would require greater flight control inputs to counteract these forces. As a result of these control inputs, the aircraft will be exposed to greater drag, which will in turn negatively affect the aircraft's performance. Conversely, failure of the non-critical engine may not result in as great a decrease in performance, but a loss in climb performance will still be experienced. Appendix C illustrates the relationship

between airspeed and altitude on the occurrence flight after the the failure of the right engine and subsequent unfeathering of the right propeller.

4. The windmilling right propeller caused an increase in drag which, combined with the overweight condition, contributed to the aircraft's inability to maintain altitude, and the aircraft collided with terrain short of the runway.
