Transportation Safety Board
of Canada

**AVIATION INVESTIGATION REPORT
A14H0002**

RUNWAY INCURSION AND RISK OF COLLISION

**7506406 CANADA INC.
AGUSTA AW 139 (HELICOPTER), C-GYNM
AND
FEDERAL EXPRESS
AIRBUS 300B4-622R N748FD
OTTAWA MACDONALD-CARTIER INTERNATIONAL
AIRPORT, OTTAWA, ONTARIO
05 JUNE 2014**

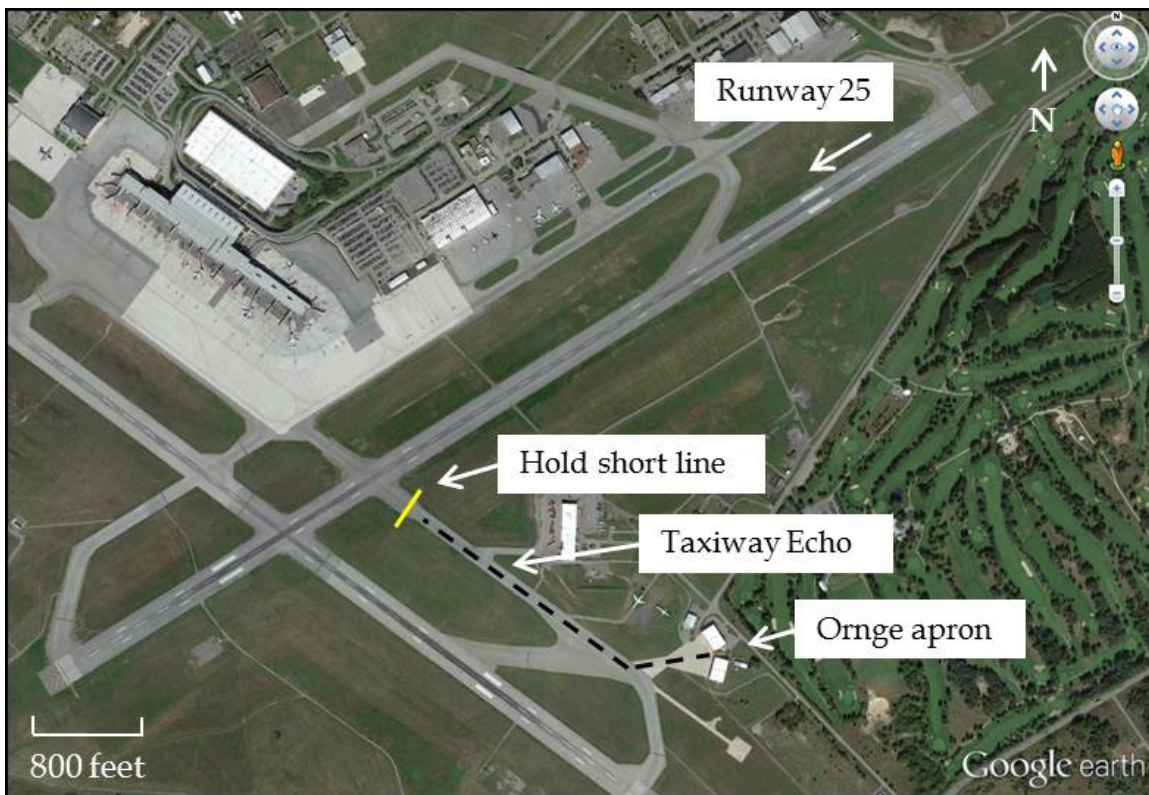
Figure 1. Ottawa Macdonald-Cartier International Airport (Source: Google Earth, with TSB annotations)

After receiving an IFR clearance² from the clearance delivery controller,³ LF 4 Medevac requested taxi instructions to taxi from the apron where Ornge Rotor Wing has its hangar (hereafter called Ornge apron) located at the south end of Taxiway Echo (Figure 1). At 0845:46,⁴ LF 4 Medevac received instructions to taxi via Taxiway Echo to Runway 25, and to

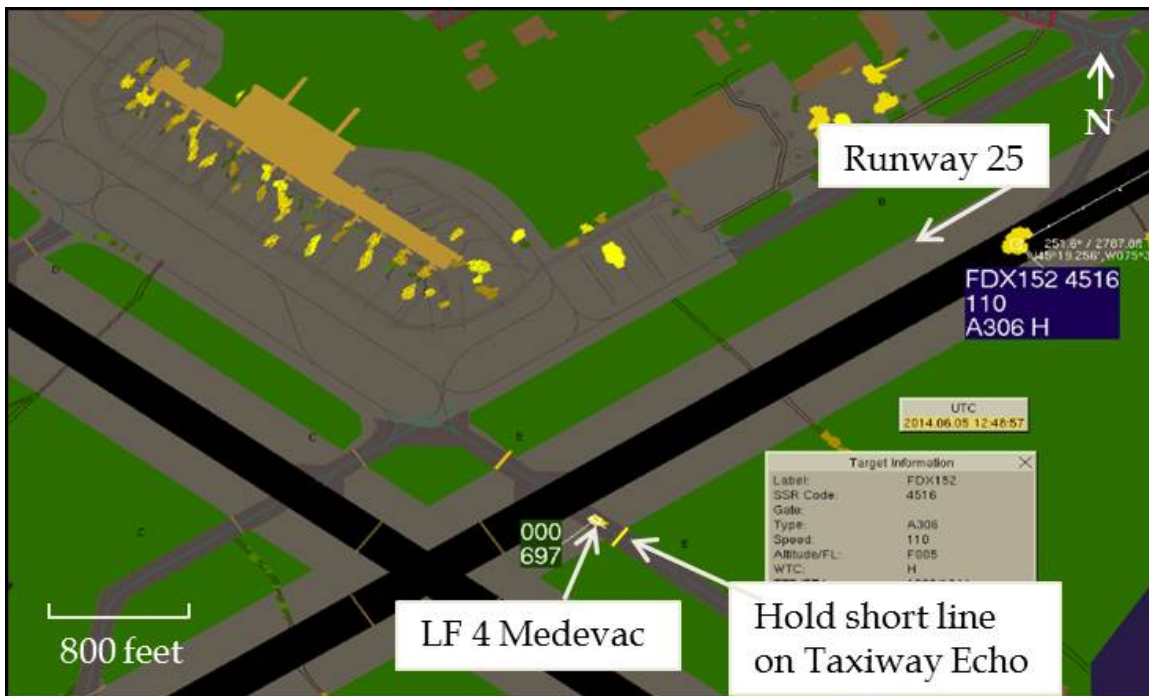
Figure 2. Ottawa Macdonald-Cartier International Airport airport surface detection equipment (ASDE) display (Source: NAV CANADA, with TSB annotations)

The airport surface detection equipment (ASDE)¹¹ display indicated that as FDX 152 Heavy was on short final approaching the threshold of Runway 25, LF 4 Medevac was taxiing over the hold short line, accelerating through a ground speed of 5 knots, to eventually reach a ground speed of 7 knots before stopping.

When LF 4 Medevac stopped taxiing, FDX 152 Heavy had landed and was decelerating through a ground speed of 110 knots, approximately 2600 feet from the intersection of Runway 25 and Taxiway Echo (Figure 2). The ASDE display showed LF 4 Medevac beyond the hold short line on Taxiway Echo. The helicopter was, however, not on Runway 25; it had stopped just adjacent to it. Approximately 30 seconds had elapsed from the time when the LF 4 Medevac PNF had contacted the tower to when they stopped taxiing.
