**AVIATION INVESTIGATION REPORT
A14O0217**

COLLISION WITH TERRAIN

**FLYBLOCKTIME INCORPORATED
CESSNA 150M, C-GJAO
WHITNEY, ONTARIO, 8 NM S
11 NOVEMBER 2014**

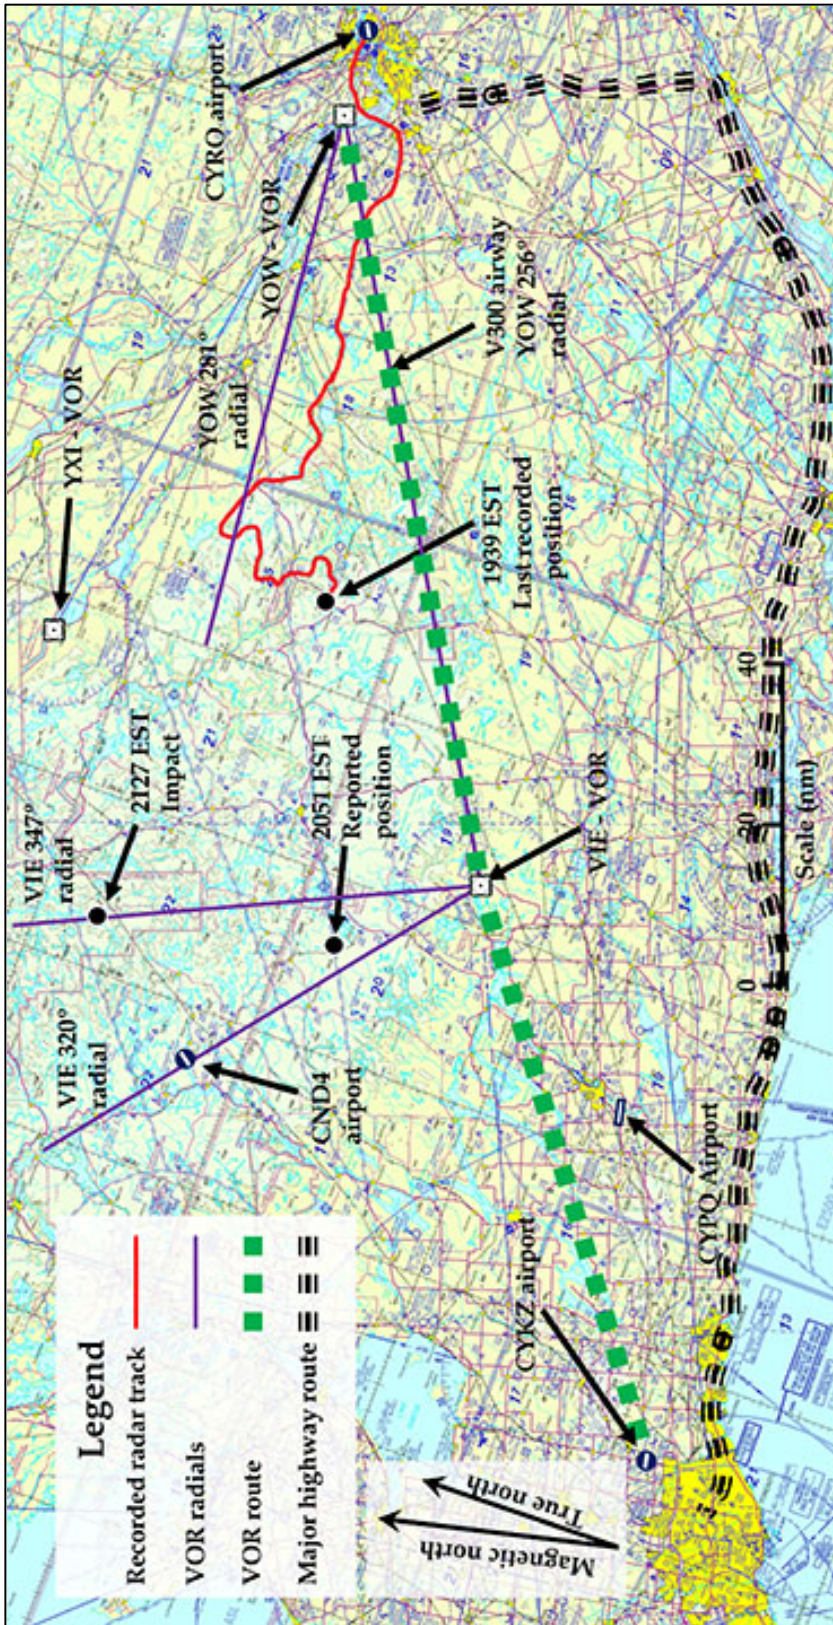
Figure 1. Depiction of the occurrence overlaid on a visual flight rules (VFR) navigation chart (Source: NAV CANADA, with TSB annotations)

The recorded radar track of the occurrence aircraft for the first 96 minutes following departure (Figure 1) indicates that, once clear of the lights of the Ottawa–Gatineau area, the pilot chose to follow the V300 airway. However, the track varied significantly in an area between the 256° and the 281° radials outbound from Ottawa/Macdonald-Cartier International Airport (YOW).

The recorded radar track ended at approximately 1939, when the aircraft moved out of range of the Ottawa-based radar. On the recording, the aircraft's cruise altitude varied between 2500 feet and 3900 feet. The final 98 minutes of the flight were not recorded on radar and, as a result, the aircraft's flight path during this period is uncertain.

In these unfamiliar conditions, with limited visual reference, the pilot had difficulty holding aircraft heading. This difficulty was evident in the significant and relatively rapid deviations in the recorded radar track as well as in the later report of unexplained heading variation between 180° and 240°.

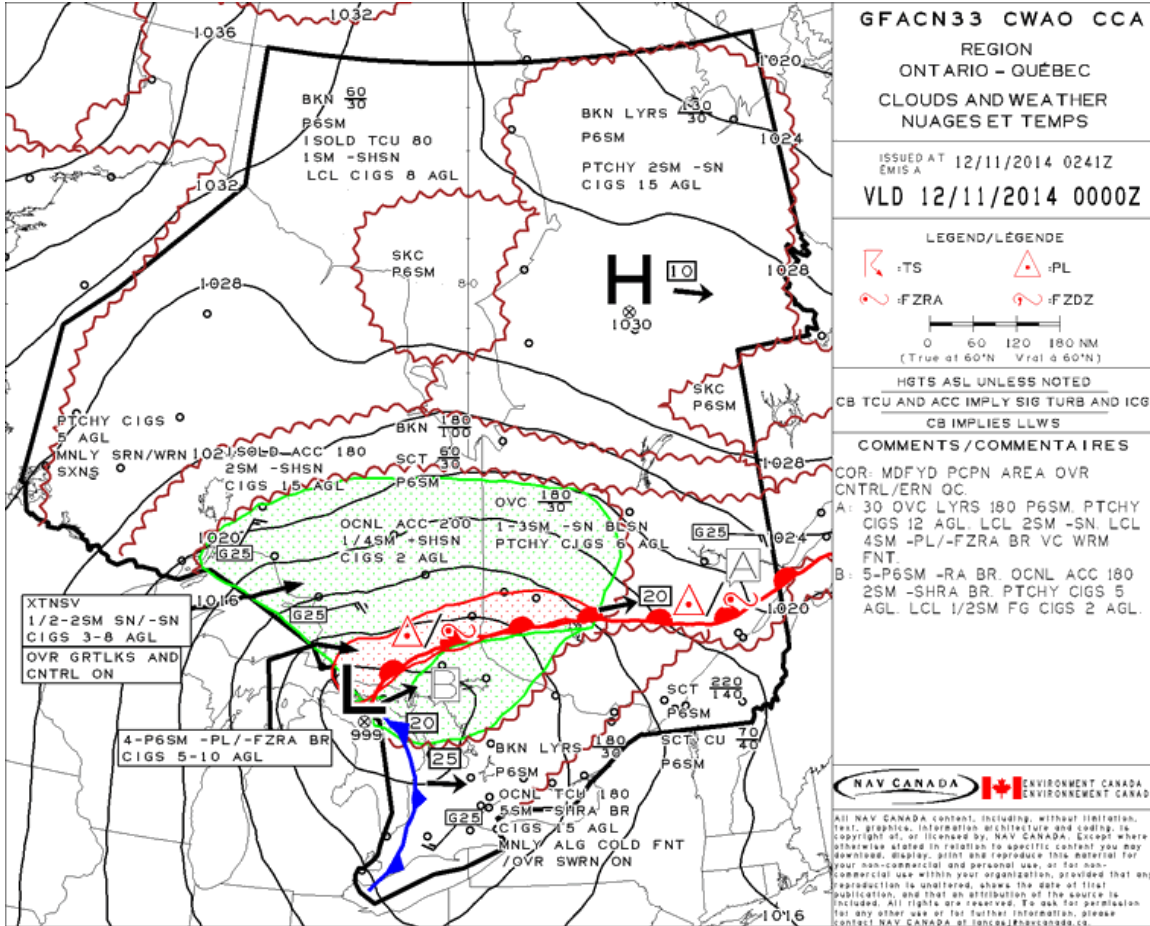
Appendix A – Graphic area forecast

The pilot was aware of a warm front with associated frontal clouds and precipitation that was forecast between Muskoka and Petawawa, Ontario, but this area was a significant distance north of the planned route. A cold front was forecast to advance from the west later in the day, although at the time of the weather briefing it was not assessed as significant to the planned route of flight (Appendix A).

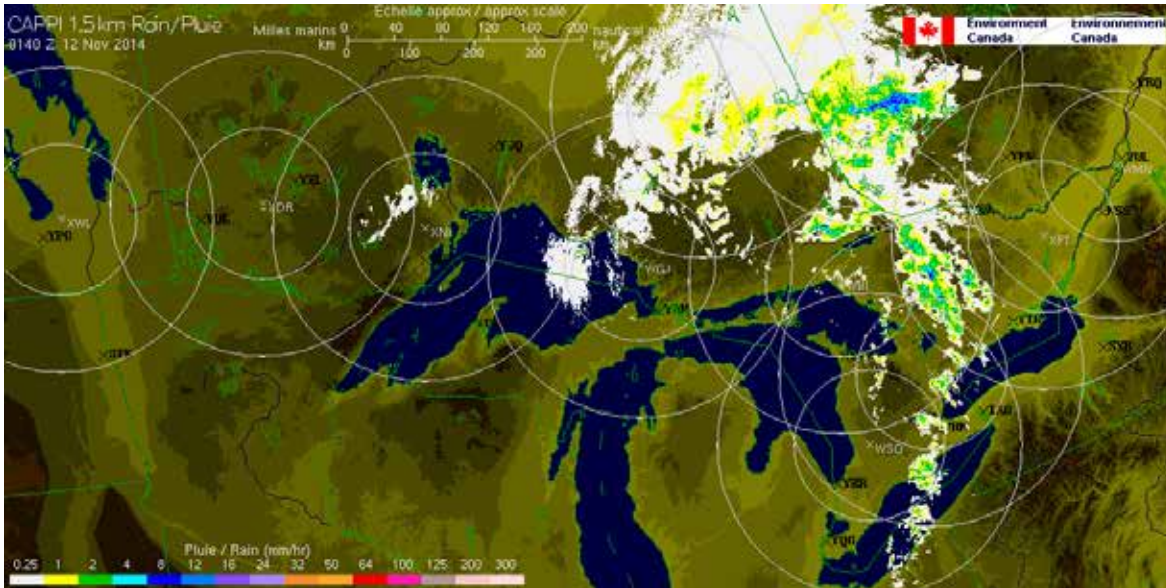
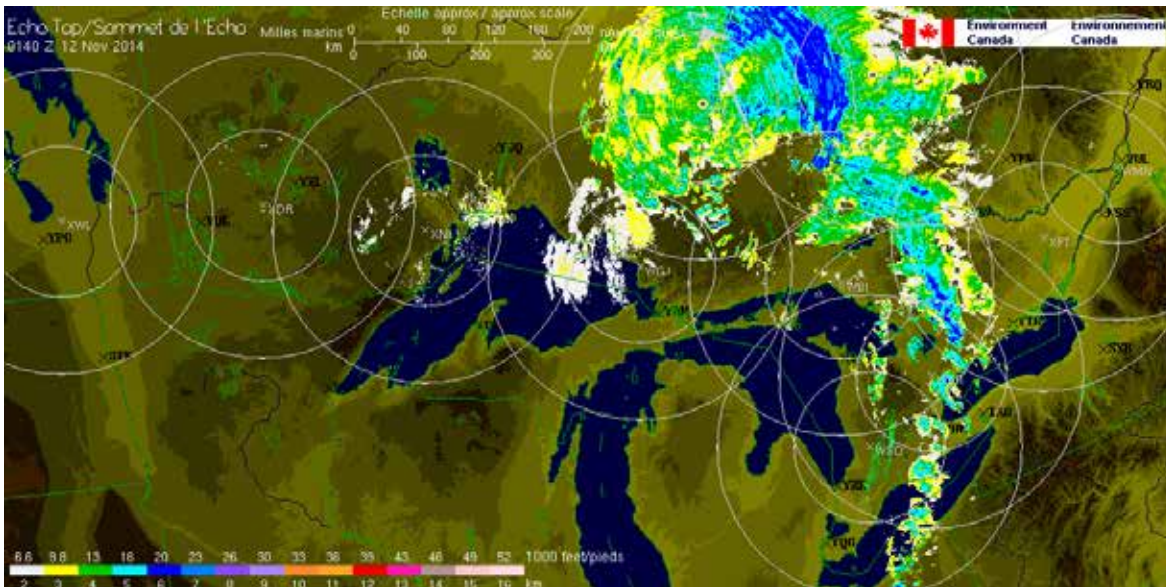
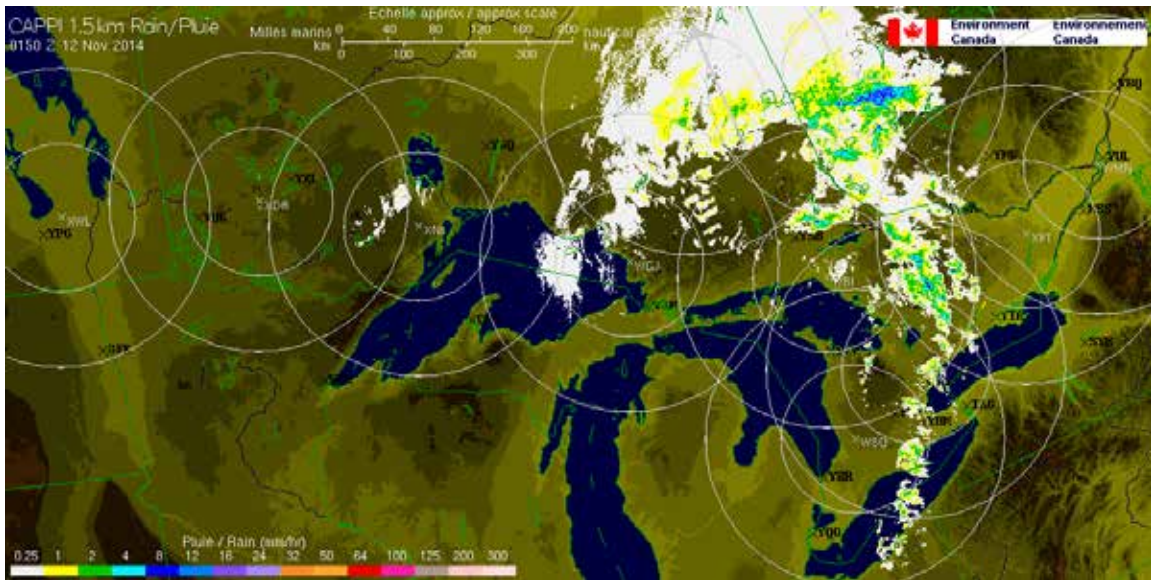
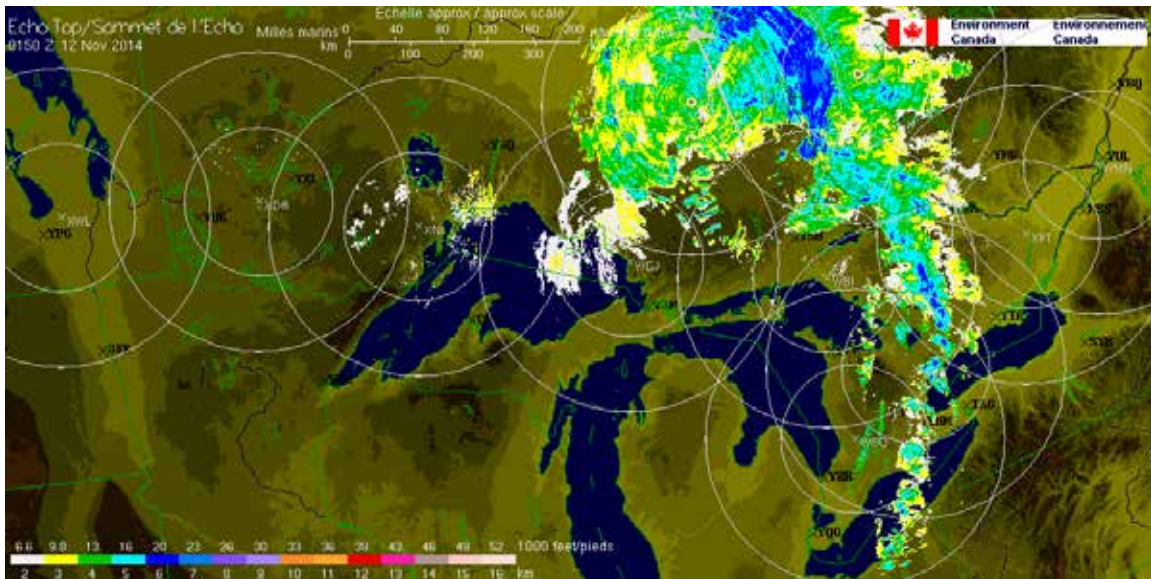
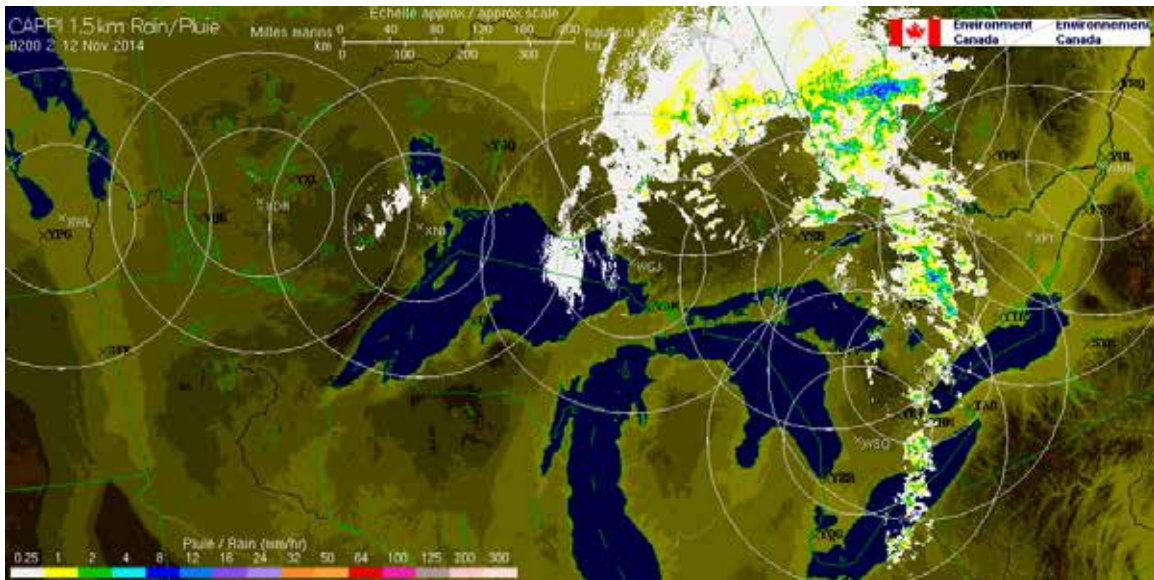
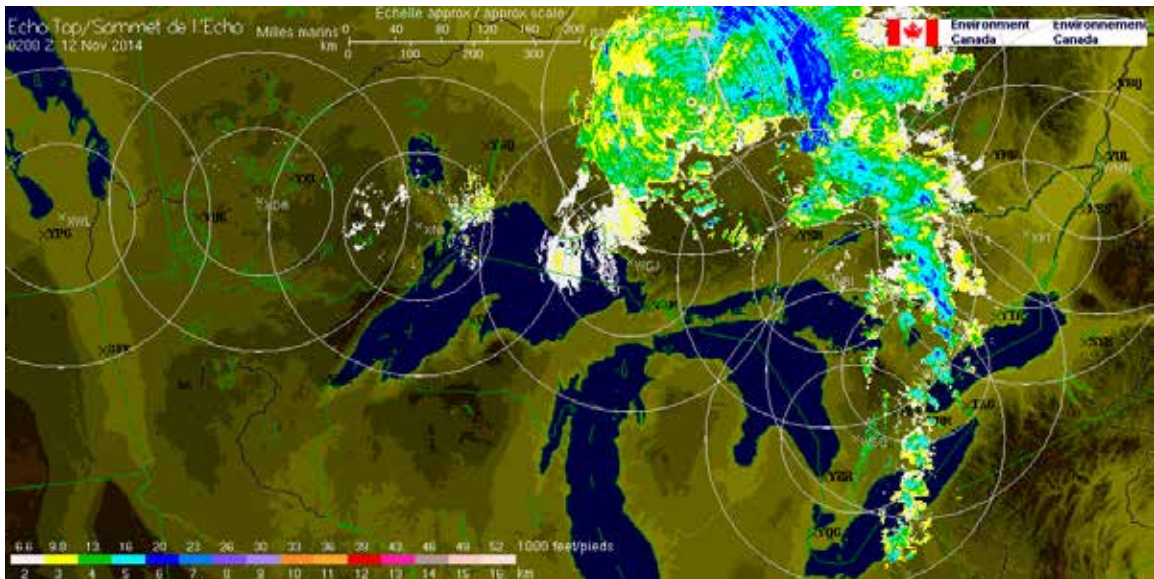
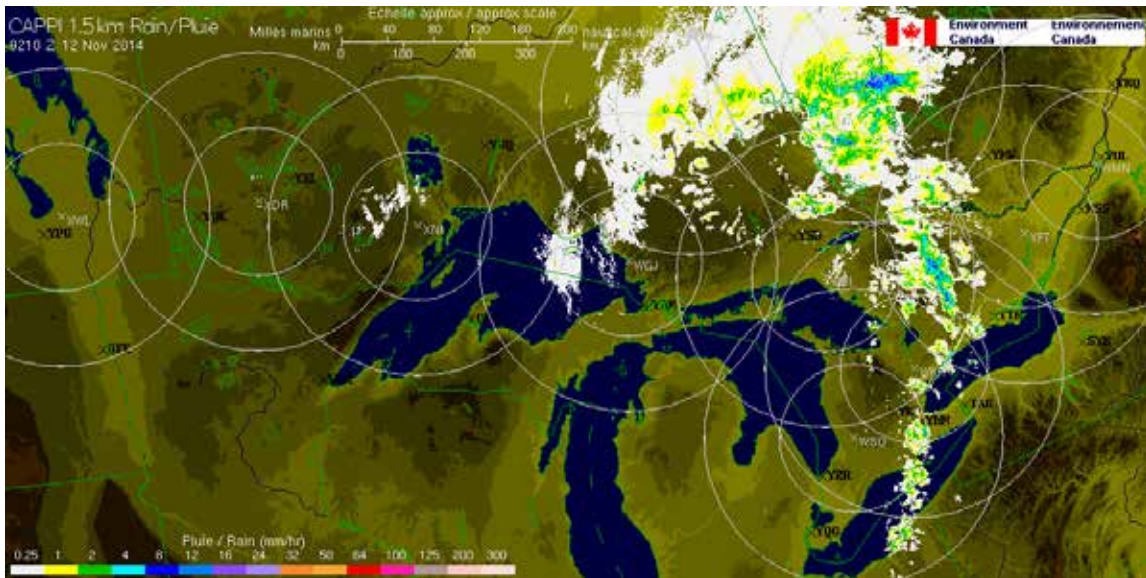
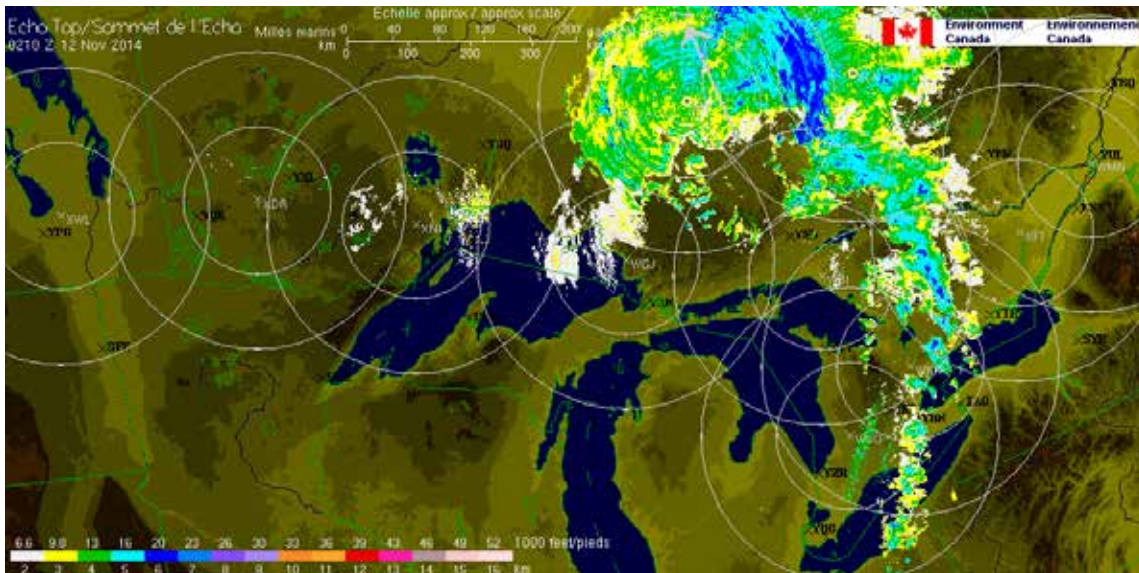
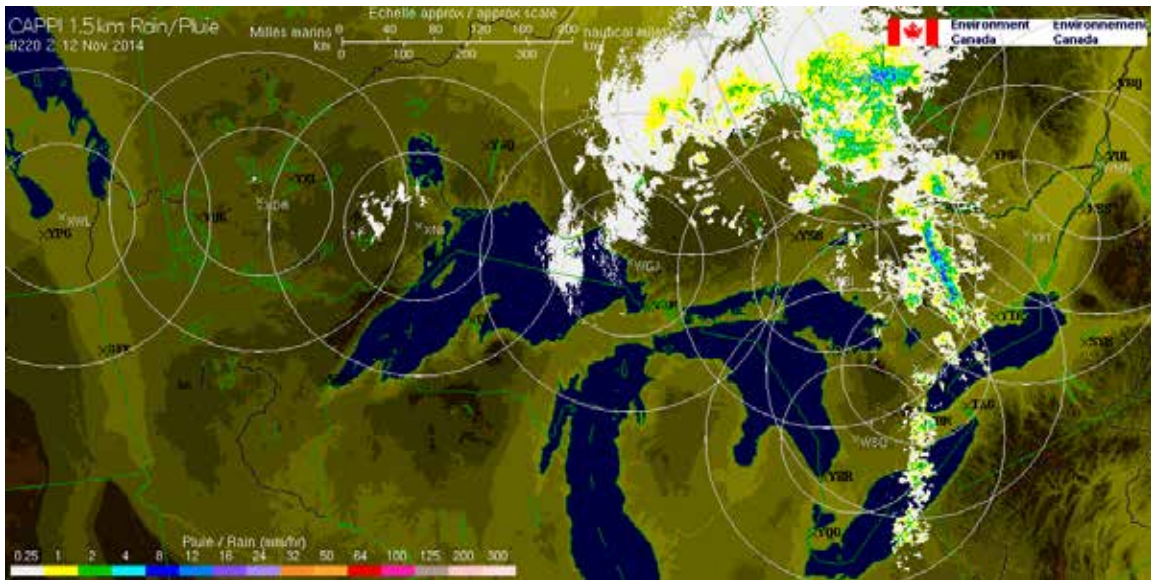
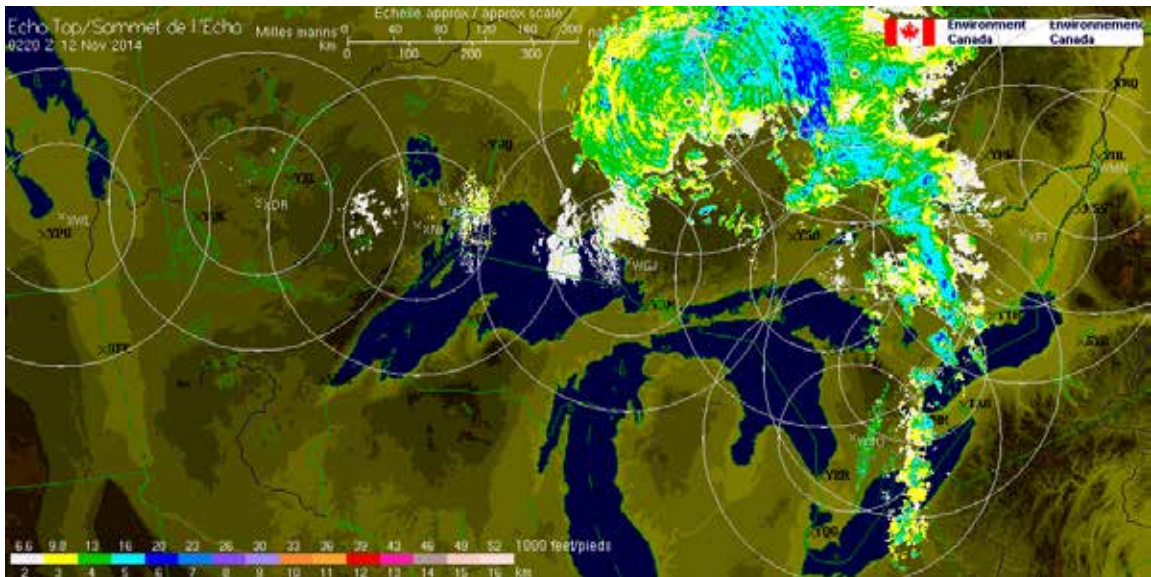
Appendix B – Weather radar imagery

The in-flight conditions further deteriorated in the 15 minutes directly before the accident. During this time, the ceilings decreased to as low as 500 feet agl, with visibility as low as 2 sm in rain showers (Appendix B).
