AVIATION INVESTIGATION REPORT A14Q0011

RUNWAY EXCURSION

**PIPER MALIBU MIRAGE PA-46-350P, C-GSSA
ALMA, QUEBEC
23 JANUARY 2014**

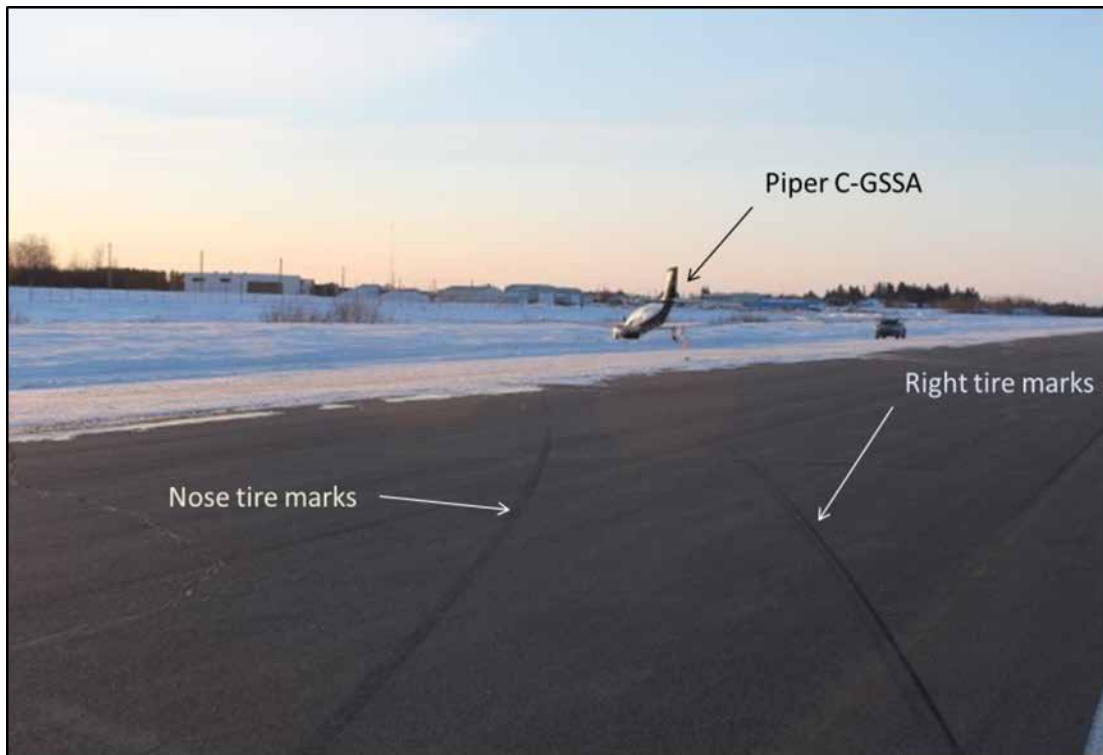
Photo 1. Piper Malibu Mirage C-GSSA runway marks

The aircraft touched down on the centreline of the runway at 1002:03 at a ground speed of 74 knots. During the landing roll, at 1002:14, as the nose wheel contacted the dry runway surface, the aircraft veered momentarily to the right, and at 1002:16 uncontrollably to the left, exiting the runway. Once off the runway, the nose gear collapsed causing substantial aircraft damage. The aircraft came to a stop in a compacted snow bank at 1002:23. Neither the pilot nor the passenger sustained any injuries.

The data analysis showed that during the landing roll, as more weight came to bear on the nose gear, the aircraft started to turn left which the pilot attempted to correct with the rudder pedals and right brake. The tire marks from both the nose tire and the right main tire were clearly visible on the runway after the occurrence (Photo 1).

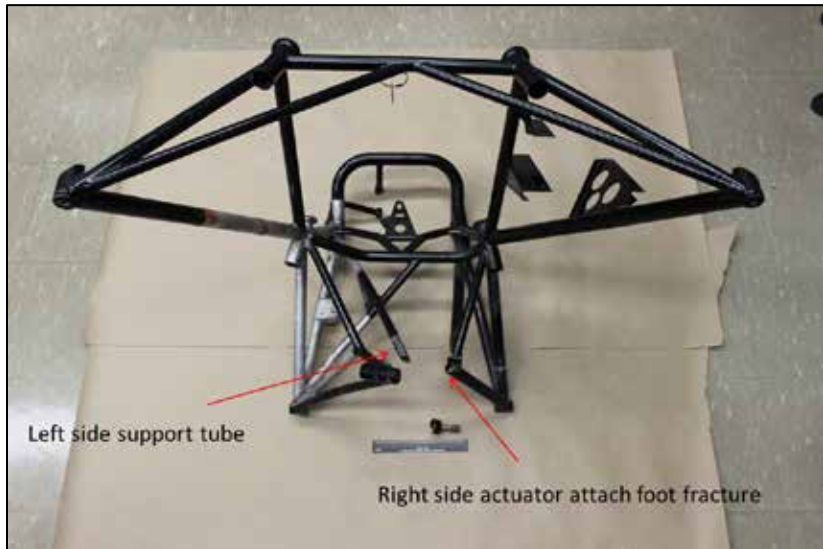
Photo 2. Engine mount from C-GSSA as received

C-GSSA was equipped with the original engine mount installed at the time of manufacture. The investigation revealed that the right side actuator attach foot fractured mainly in overstress from a pre-existing fatigue crack located at the toe of the weld which attaches the right side actuator foot to the support tubes (Photo 2).

The pre-existing fatigue crack measured approximately 13 mm in length and 0.25 mm at its deepest point. No metallurgical anomalies were observed in the engine mount that could have contributed to the formation of the fatigue crack. It could not be determined if the pre-existing fatigue crack was present at the time of the non-destructive testing (NDT) inspection, performed during the annual inspection 35 hours prior to the NLG actuator attach foot failure.

The failed engine mount has structures common to the landing gear system, and it was a landing gear component that failed. The structural integrity of the engine mount was not compromised with respect to engine/airframe attachment.

The sequence of events in this occurrence is consistent with a failure of the engine mount's nose landing gear actuator attach foot which prevented the nose gear from extending fully forward and the nose wheel/tire from completely aligning with the airplane's longitudinal axis. Therefore, the analysis will focus on aircraft components that played a role in the occurrence, and mitigation measures taken by the aircraft manufacturer.

The investigation determined that a crack may appear before the original inspection criterion of 740 hours. Piper Aircraft Inc. issued SB 1103E on 05 June 2014, changing the inspection period to 200 hours. This new criterion may help discover fatigue cracks. If cracks are found during the inspection, Part 2 of the safety bulletin mandates replacement with a new strengthened engine mount, which is also recommended by the FAA through the Special Airworthiness Information Bulletin issued on 14 July 2014. However, if the requirements prescribed in SB 1103E are not made mandatory for operators in Canada, then there is a continued risk that fatigue cracks may not be discovered in a timely manner to prevent a similar occurrence.

1. If the requirements prescribed in Service Bulletin 1103E are not made mandatory for operators in Canada, then there is a continued risk that fatigue cracks may not be discovered in a timely manner to prevent a similar occurrences.

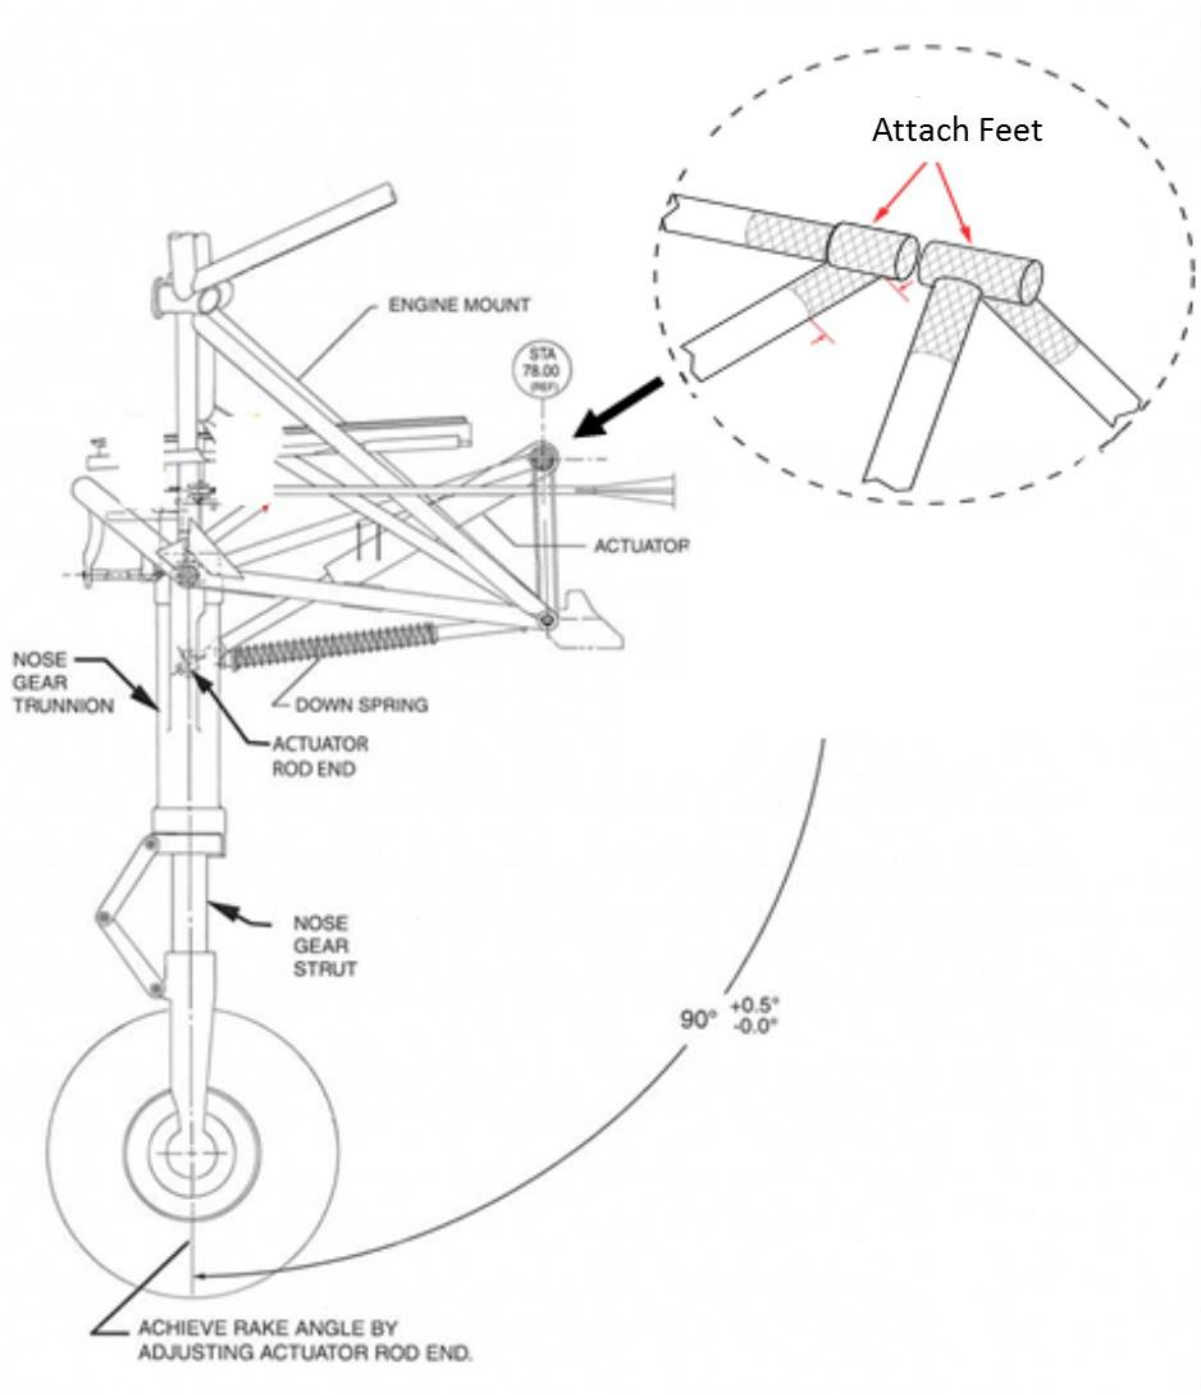
Appendix A – Engine/Nose landing gear mount

The nose landing gear (NLG) actuator on Piper-46-350P airplanes is bolted via 2 attach feet to the lower aft engine mount, which is constructed of welded tubes. The NLG actuator extends down and forward from the attach feet (Appendix A) and attaches to the NLG. During taxi, takeoff, and landing, the attach feet transmit loads from the NLG to the engine mount, thus creating repetitive stress in the engine mount attach feet areas and, in some cases, leading to fatigue cracking. Mounted on top of the nose gear trunnion are 2 nylon rollers which are used to translate the rotation of the steering arm from rudder pedals movements into rotation of the nose wheel.

The nose gear down lock switch is integral to the NLG actuator. A failure of the NLG actuator attach feet area could prevent the NLG from extending fully forward and the nose wheel from completely aligning with the longitudinal axis of the aircraft. It could also provide the pilot with a nose gear fully extended indication, not simply an actuator fully extended position. FAR23.729 and CARs 523.729 stipulate that switches must be located and coupled to the landing gear mechanical system in a manner that prevents an erroneous indication of down and locked position.
