**AVIATION INVESTIGATION REPORT
A14Q0068**

**UNCONTAINED TURBINE ROTOR FAILURE
BOMBARDIER INC.
BD-500-1A10 (C SERIES CS100), C-FBCS
MONTRÉAL INTERNATIONAL (MIRABEL) AIRPORT, QUEBEC
29 MAY 2014**

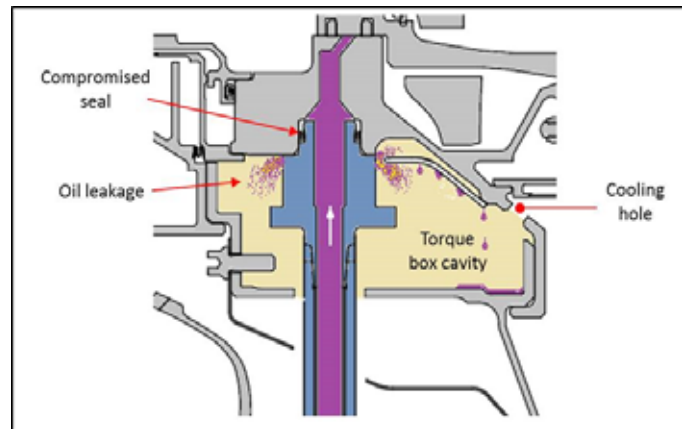
Figure 13. Cutaway view of oil leakage in torque box

While running at 74% N_1 , oil under pressure began leaking into the torque box cavity from the mating surface between the flange of the oil feed tube for the No. 4 bearing and the TIC assembly. From that point, the leaked oil merged with the cooling airflow. The cooling air and the leaked oil transited through the torque box, through the nearby cooling holes, and into the rotor cavity (Figure 13).

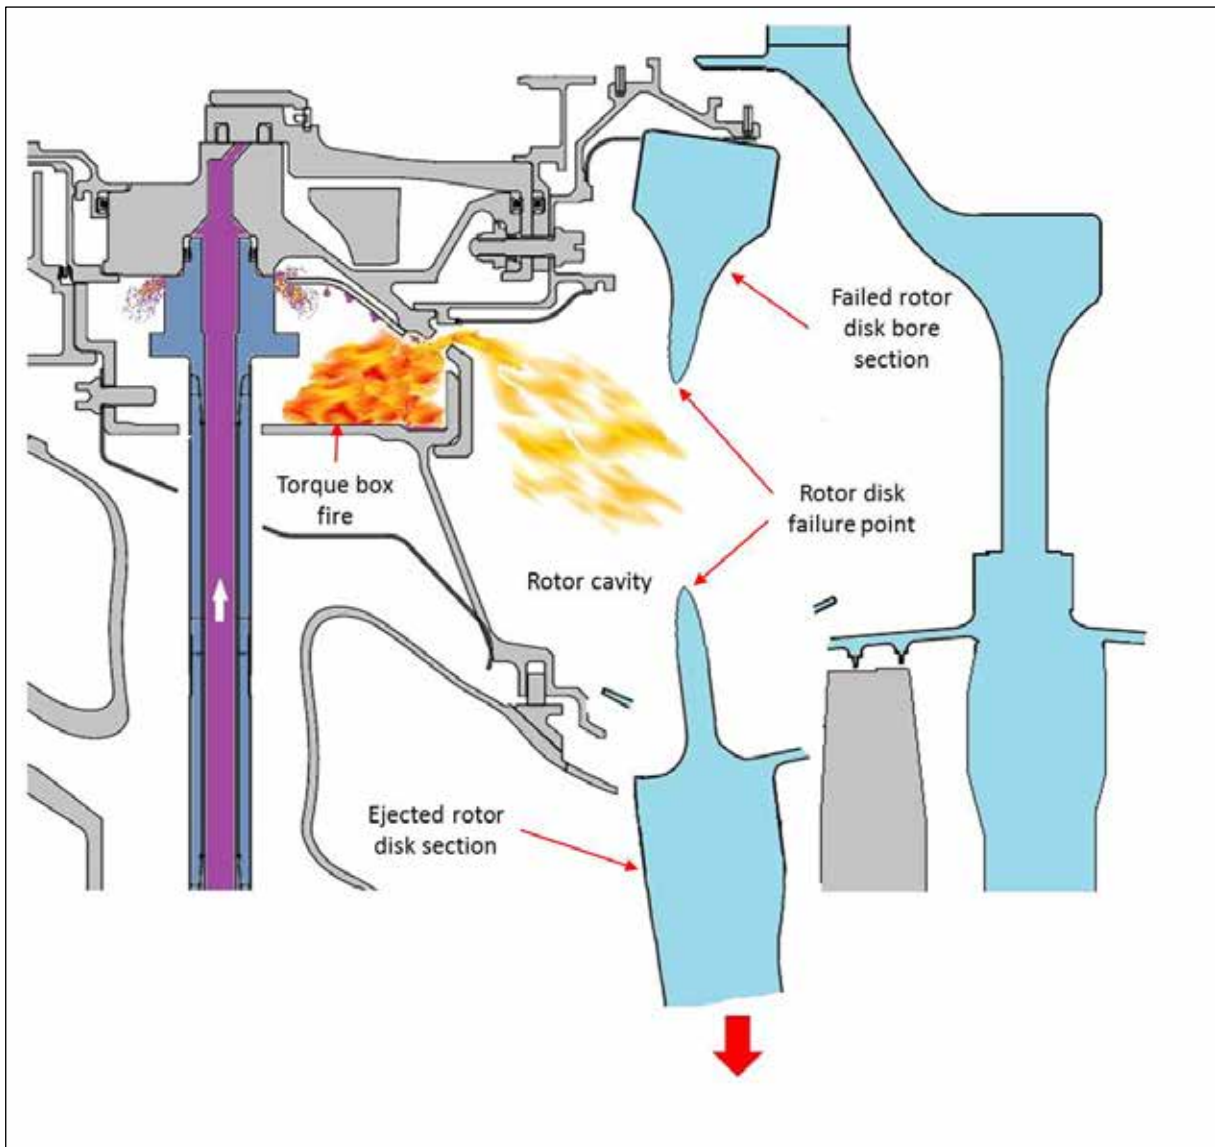
Figure 15. Cutaway view of torque box fire and resulting rotor disk failure

The temperature of the air in the torque box cavity was below the auto-ignition point of the leaked oil during the 15 minute and 8 second stint at 60% N_1 . As the engine reached 74% N_1 ,

the cooling air temperature in the torque box rose, as it was expected and designed to do, as a result of being exposed to the hotter flow of the gas path as it made its way down and around the TIC rods (Figure 14). When the temperature in the torque box surpassed the auto-ignition point of the leaked oil, the leaked oil ignited in the torque box. The resulting fire, which was fed in a continuous manner, flowed out into the rotor cavity, following the cooling airflow out the nearest cooling holes, located in the bearing support assembly. The fire then impinged upon the front face of the rotor disk, overheating the web of the disk until centrifugal force led to failure from tensile overload (Figure 15).

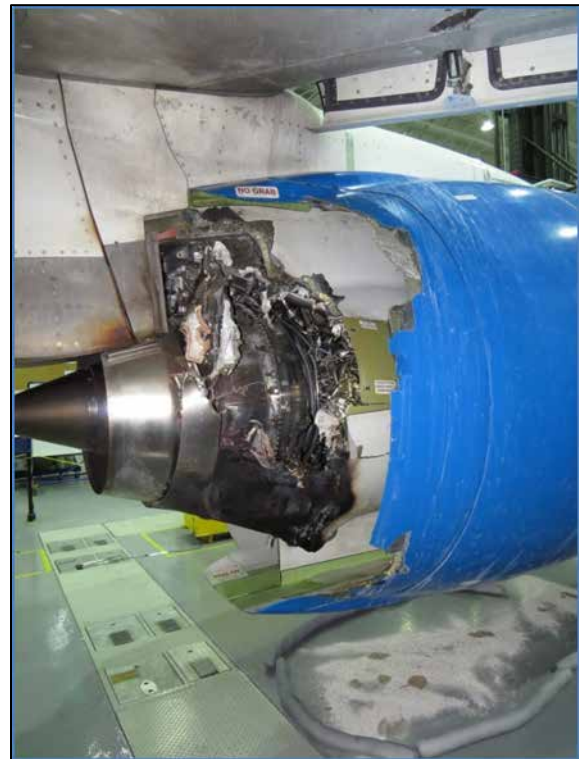
There was substantial damage to the left-engine outboard thrust reverser cowl as debris penetrated the carbon-fibre-composite core fairing section and the aft edge of the translating sleeve at approximately the 10 o'clock position (fuselage station [FS]²⁰ 770). Some soot was also evident around the damaged area.

Photo 2. Left inboard thrust reverser cowl damage (Source: Bombardier Inc.)

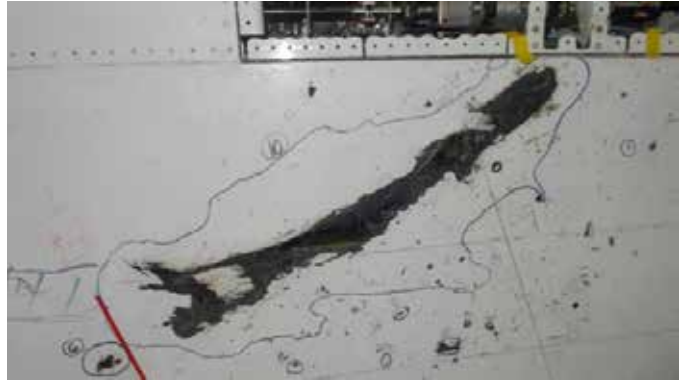
The left-wing structure sustained major debris impact damage when a segment of the first-stage LPT rotor disk 28 inches long penetrated the wing's centre fuel tank (Photo 3).

Photo 3. Left-wing lower surface damage
(Source: Bombardier Inc.)

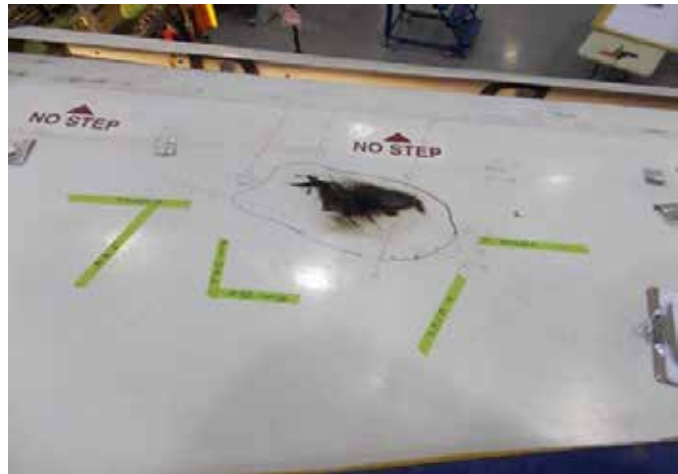
Photo 4. Left-wing upper surface damage showing burn marks
(Source: Bombardier Inc.)

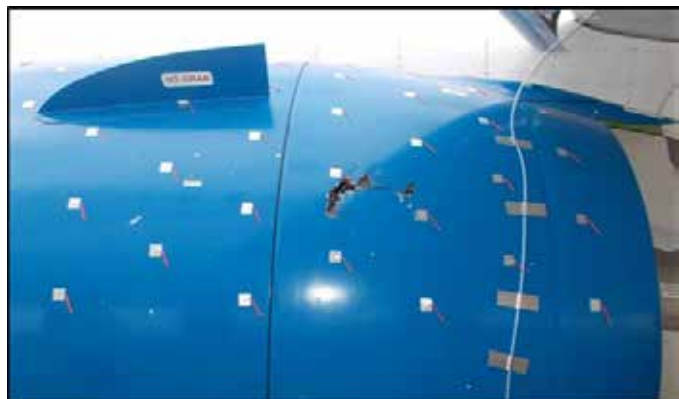
Photo 5. Damage to right-engine inboard thrust reverser cowl translating sleeve
(Source: Bombardier Inc.)

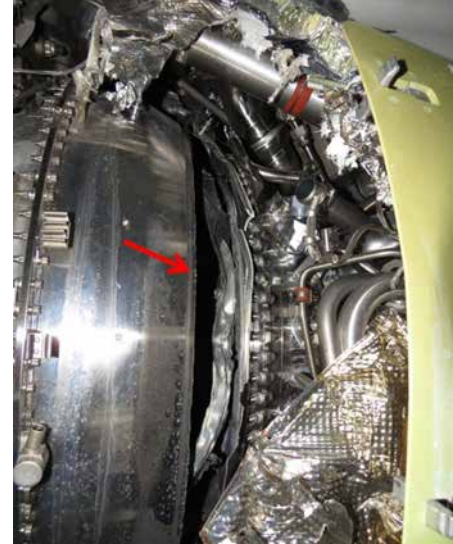
The main damage was found in the area of the first stage of the LPT. The initial visual examination of the engine while still on-wing revealed that the LPT case was breached around 95% of its circumference (Photo 6). The sole unbreached area was located at approximately the 8 o'clock position.

Photo 6. Example of a left-engine turbine case breach at the 3 o'clock position (Source: Bombardier Inc.)

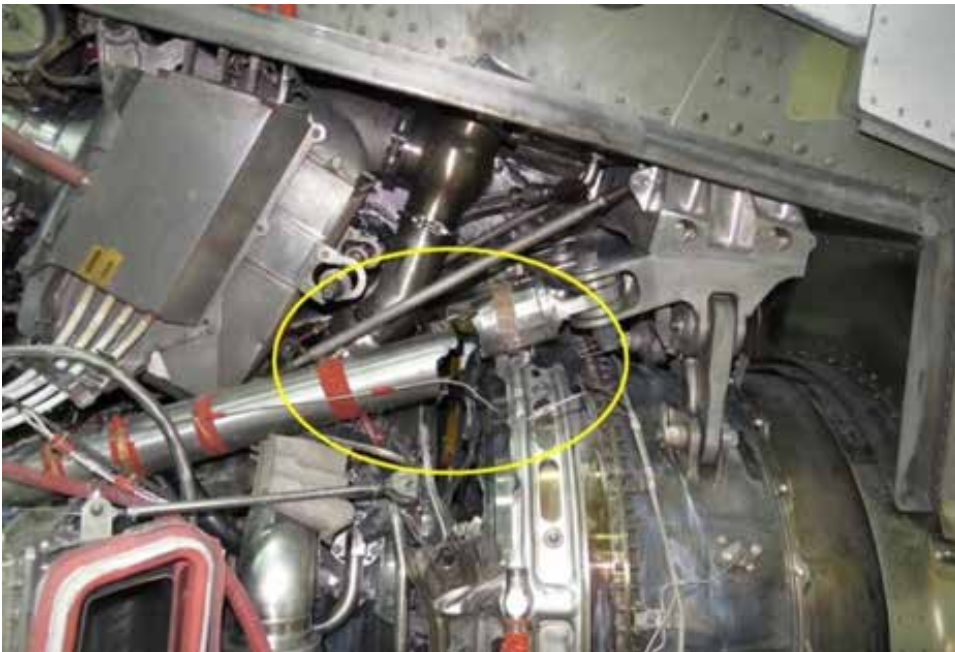
During the occurrence, the engine fire detector loops were severed by rotor disk debris, and there was no fire warning in the cockpit. However, the EICAS generated several warnings as the engine spooled down, one of which was an L ENG FIRE DET FAIL indication on the cockpit EICAS screen. When this type of indication appears, the procedure calls for monitoring the engine instruments.

Photo 7. Damage to left-engine outboard thrust link and fire detection loops (Source: Bombardier Inc.)

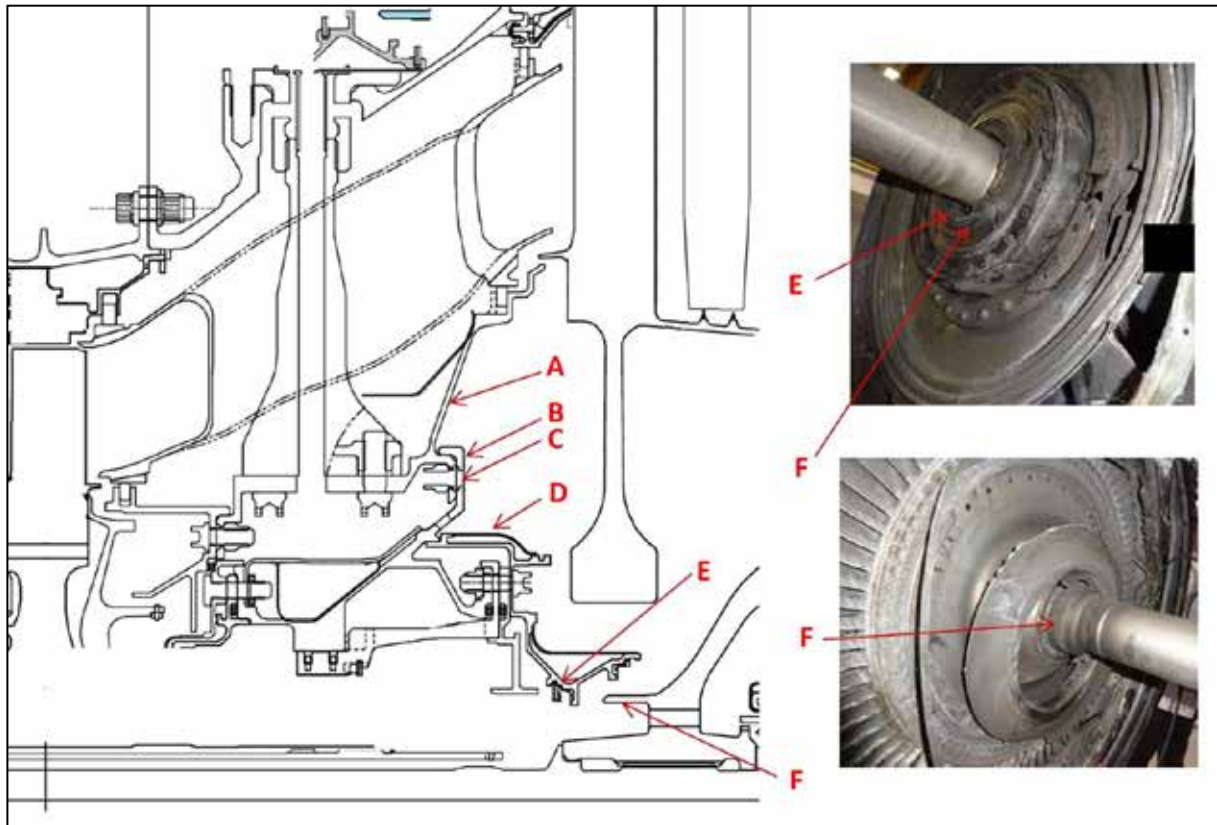
Figure 16. Cutaway view of thermal distress areas on the aft face of the turbine intermediate case (Source: Pratt & Whitney, with TSB annotations)

Step-by-step disassembly revealed further damage. Initial removal of the LPT from the TIC, which houses the No. 4 bearing compartment, revealed severe heat distress on the TIC's aft face, concentrated at the 4 o'clock position. Figure 16 illustrates the location of the following damage observed:

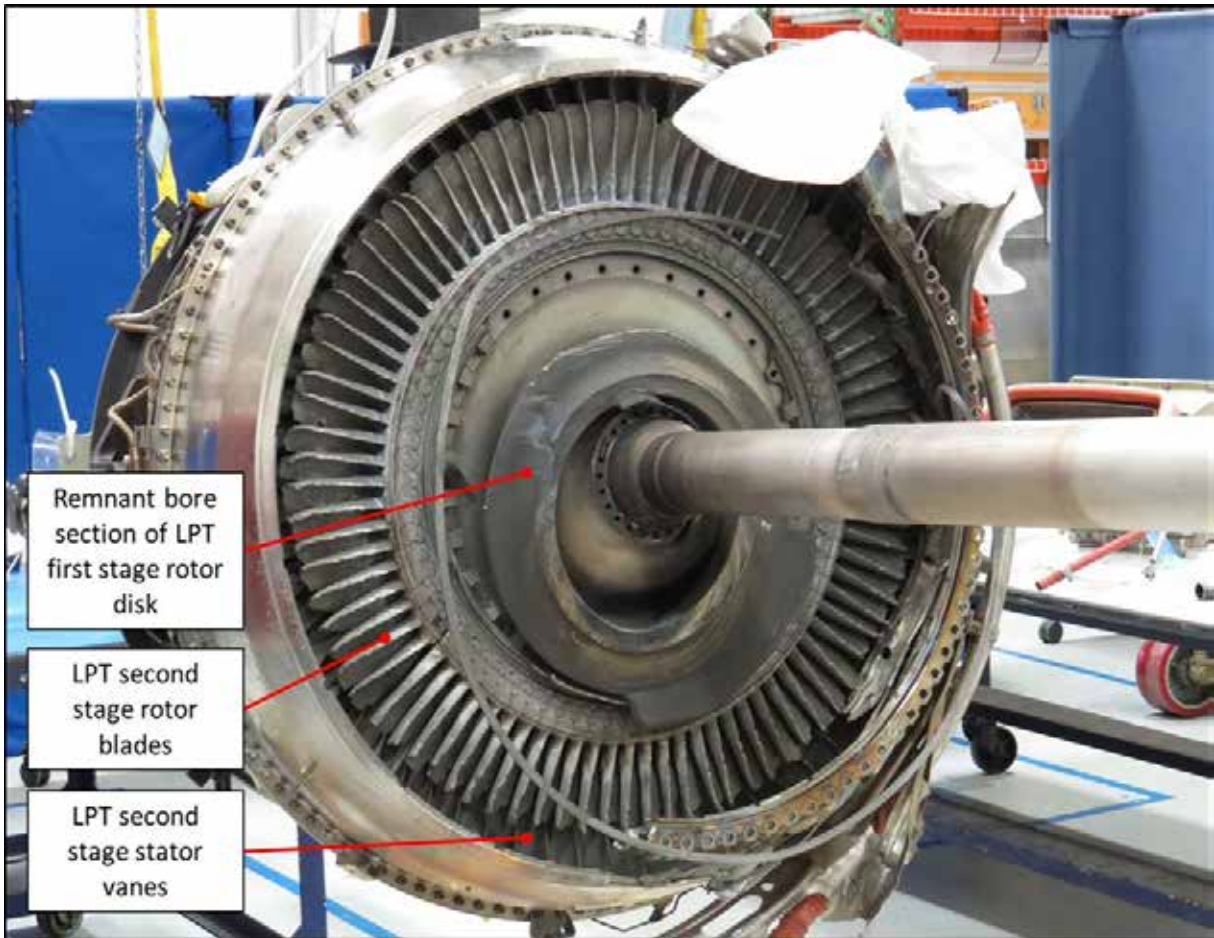
Photo 8. Front face of the low-pressure turbine (Source: Pratt & Whitney, with TSB annotations)

The bore section was the only remnant of the LPT first stage rotor found within the engine, hanging loosely on the LPT shaft. The first stage vanes, which are integral to the TIC, were in place and intact. The second stage stator vanes were absent altogether, and the second stage rotor blades were severely damaged (shortened and nicked) but were all accounted for and in their original location. The third stage stator vanes were also damaged, mainly exhibiting nicks (Photo 8).

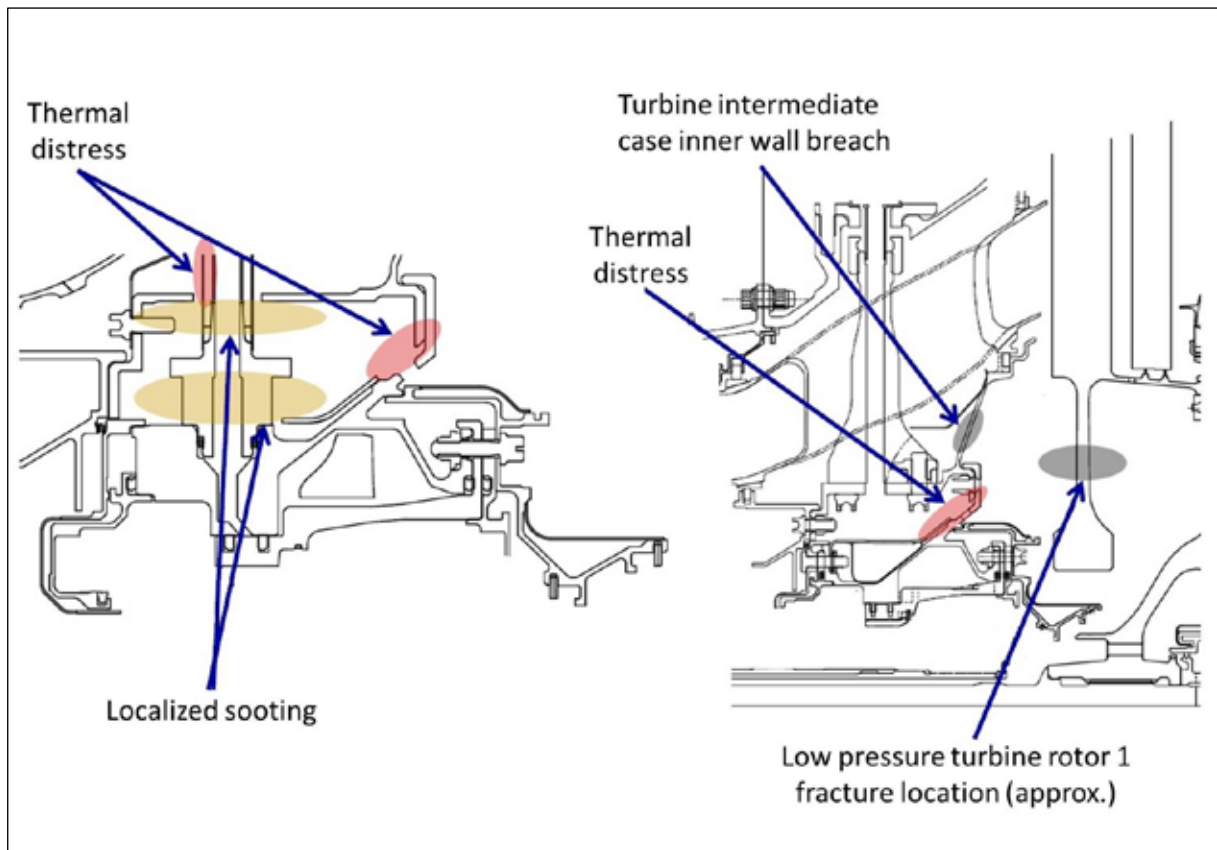
Figure 17. Cutaway views of thermal distress areas (Source: Pratt & Whitney, with TSB modifications)

Disassembly of the No. 4 bearing torque box area revealed soot concentrated around the mounting boss of the No. 4 bearing oil supply tube and a breach in the tube's heat shield (Figure 17).

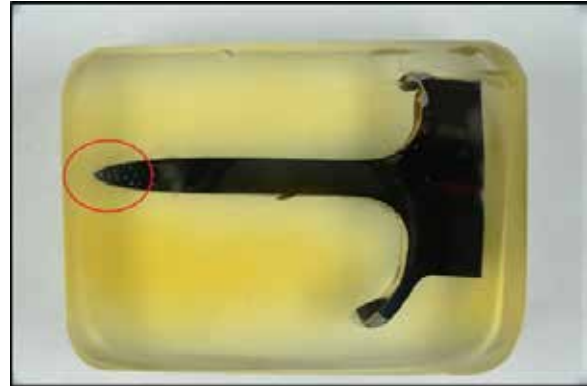
Photo 10. Rotor fragment section showing necking (Source: Pratt & Whitney)

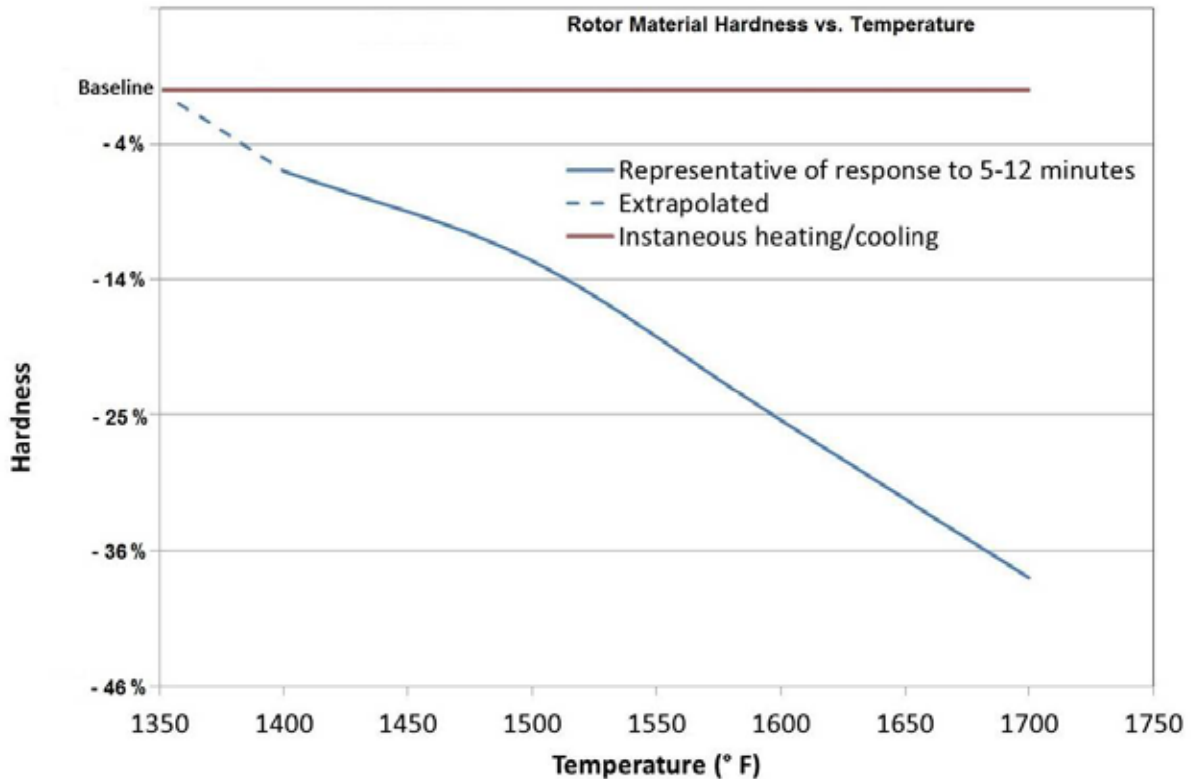
Figure 18. Rotor material hardness vs. temperature (Source: Pratt & Whitney)

The analysis revealed that the readings for occurrence rotor hardness were lower than those quoted in the manufacturing specifications. The sign of lower-than-expected hardness indicates that the rotor section released from the occurrence engine had experienced an elevated temperature exposure that softened the rotor material. Tests demonstrated that, as the material is exposed to elevated temperature, the hardness drops. It should also be noted that this process takes some time, as exposure of small laboratory specimens to the various temperatures for short periods of time showed no appreciable drop in hardness. Laboratory samples exposed to elevated temperatures for between 5 and 12 minutes did exhibit an appreciable drop in hardness. This is exemplified by the rapid heat/cool curve of fully heat-treated material (Figure 18).

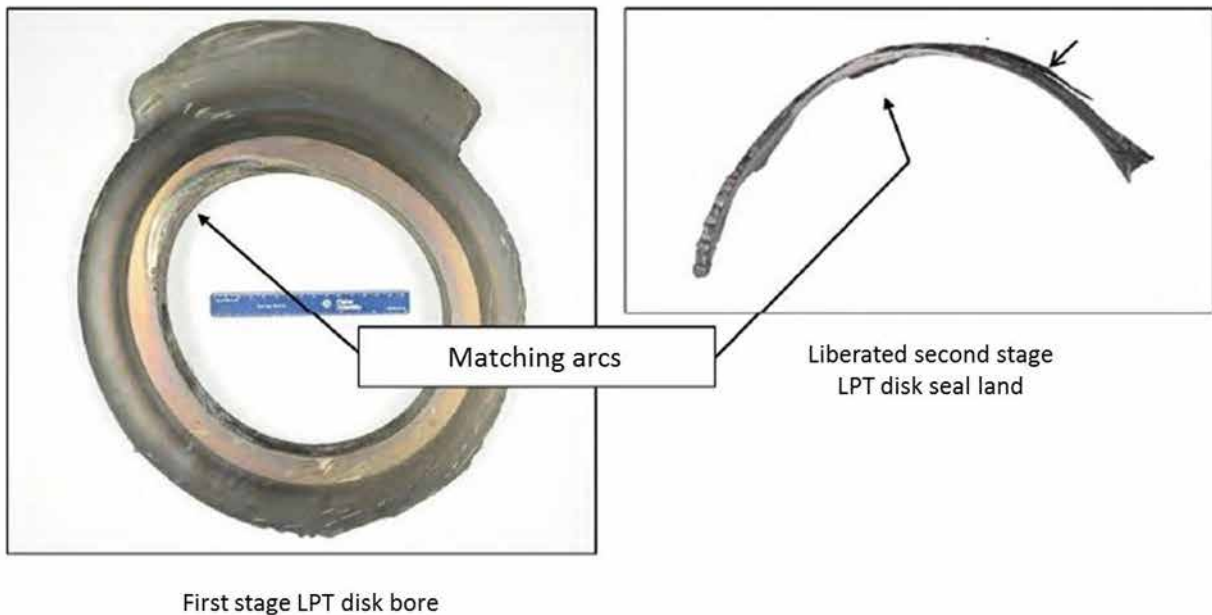
The bore section of the LPT1 rotor remained within the engine, hanging loosely around the rotor shaft, and was subsequently removed for analysis as part of the engine disassembly and investigation. It was photo-documented and subsequently sectioned for hardness evaluation. A cross-section of the LPT1 rotor section taken from the circumferential location that exhibited the greatest web necking indicated the point of rotor failure initiation and supported the conclusion that the rotor had been exposed to elevated temperatures.

Photo 11. Remnant of first stage LPT rotor bore and brush seal land (Source: Pratt & Whitney)
