AVIATION INVESTIGATION REPORT A15C0130

Collision with terrain

Apex Helicopters Inc.
Robinson R44, C-GZFX
Foleyet, Ontario, 17 nm S
08 September 2015

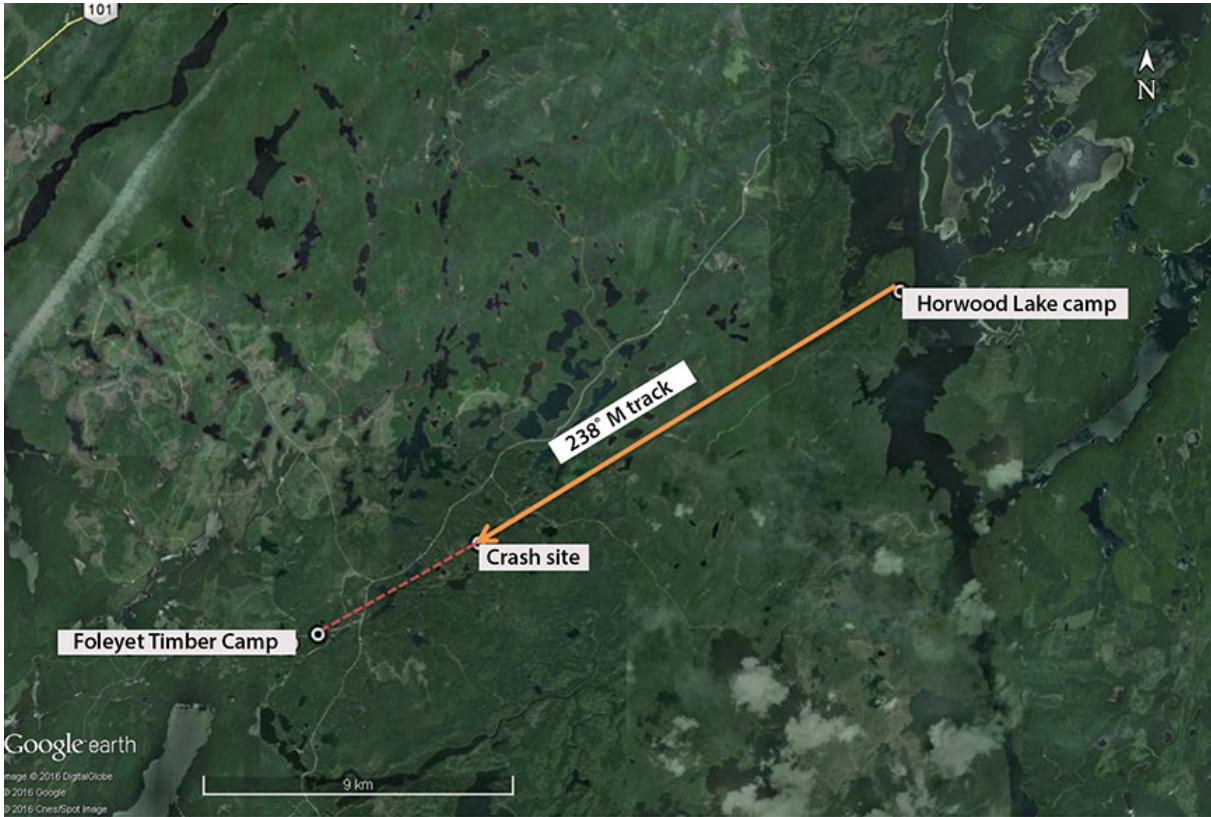
Figure 2. Map of the accident site along the direct route to the Foleyet Timber Camp. (Source Google Earth, with TSB annotations)

At approximately 2000, the supervisor drove the pilot of C-GZFX and the mix rig operator back to the helicopter and watched them lift off at approximately 2015. Sometime later, C-GZFX struck trees and the terrain at the top of a small hill approximately 8 nautical miles (nm) southwest of the Horwood Lake camp and along the direct route back to the FTC (Figure 2).

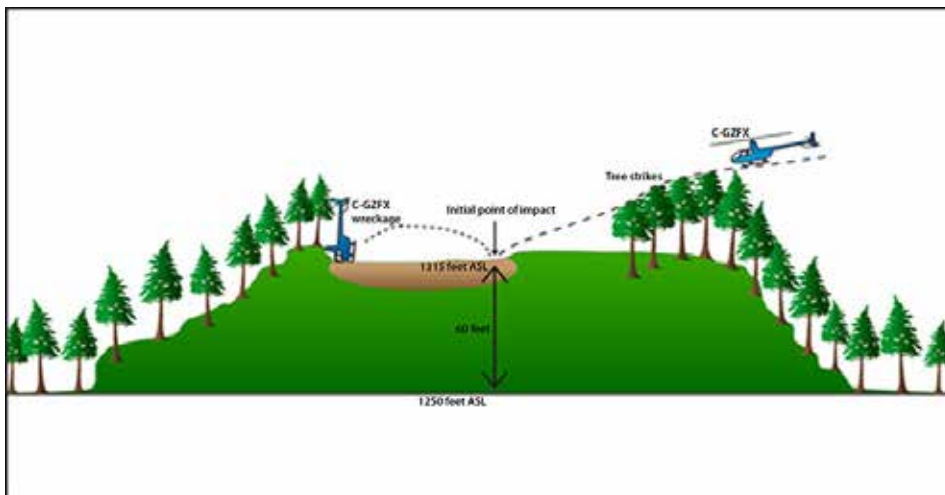
Figure 3. Diagram of wreckage site

The wreckage site (Figure 3) was located at the top of a small hill that was approximately 65 feet higher than the surrounding terrain. The initial direction of the tree strike trail was 200° magnetic (M). The helicopter struck the ground in a sparsely treed area. The subsequent wreckage trail was approximately 30 feet long and lay in a direction of approximately 305°M. Ground scars and damage to the main rotor blades were indicative of high rotor torque at the time of impact. An inspection of the wreckage, including the main rotor system, tail rotor system, engine, and flight controls, did not reveal any pre-impact anomalies. The level of damage to the cockpit indicated that the impact with the ground was not survivable. The carburetor heat control was set to the “ON” position; therefore it is likely that carburetor icing did not affect the engine’s performance.
