AVIATION INVESTIGATION REPORT A16A0084

Collision with wires

Bell 206B (Helicopter), C-GVJT
Flatlands, New Brunswick
04 September 2016

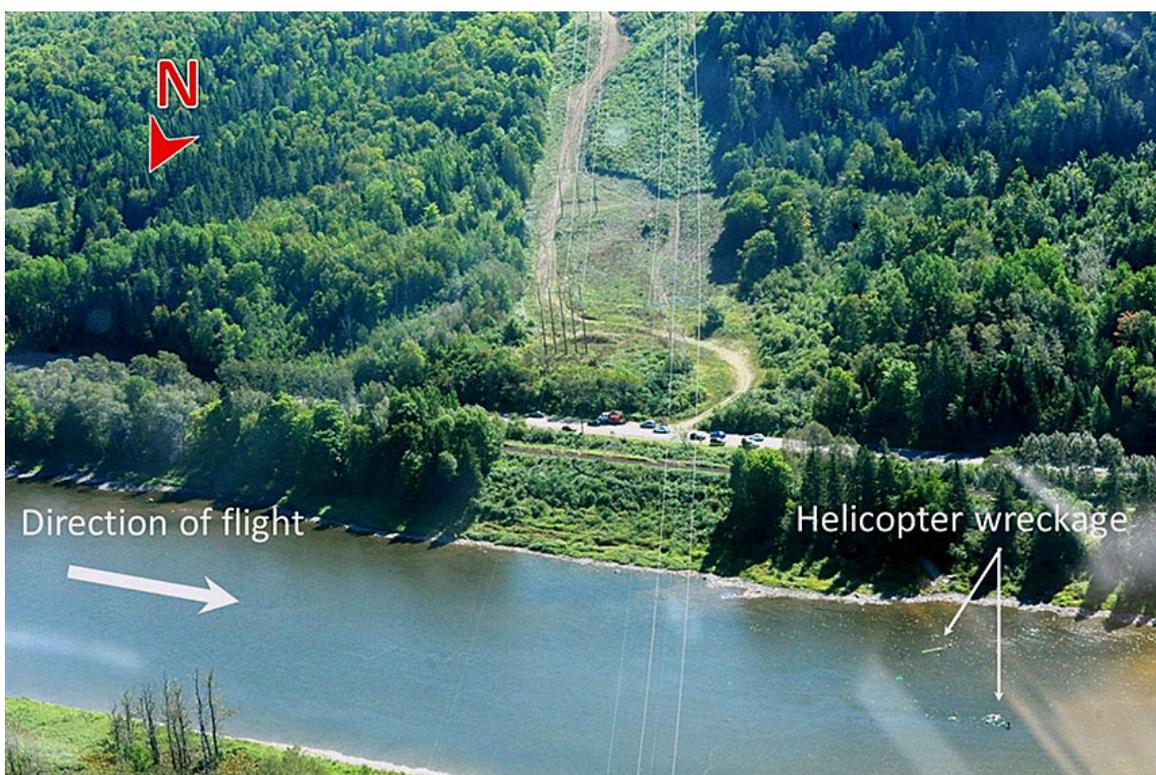
At 1547, the helicopter flew into and severed 4 conductor cables of the 230 kV power transmission lines at 58 feet above the Restigouche River on the south side of Long Island (Figure 1).

Figure 1. Aerial photo of occurrence site (Source: NB Power, with TSB annotations)

The helicopter broke apart after colliding with the conductor cables and continued on a ballistic trajectory³ for about 150 feet before falling into the water near the middle of the Restigouche River.

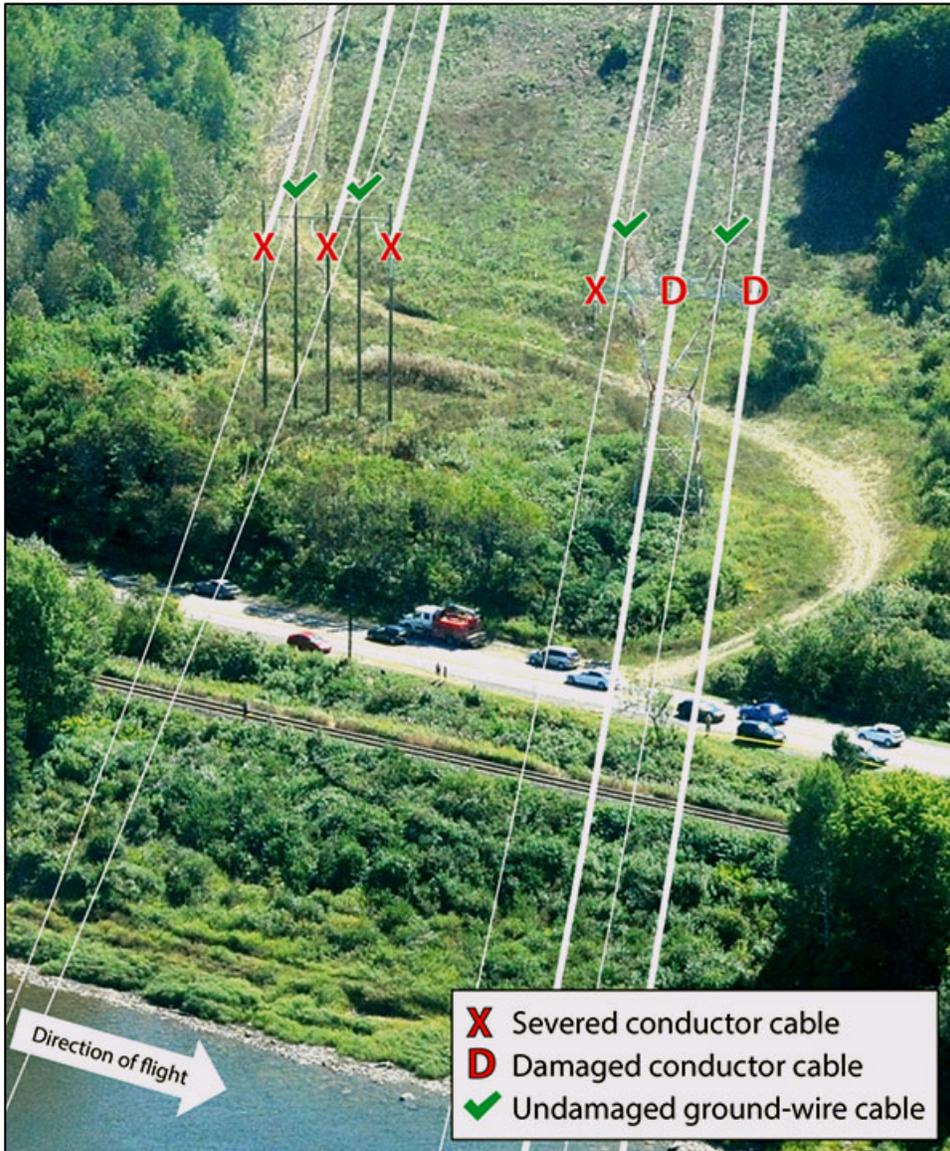
At the time of the occurrence, the conductor cables spanned the river at a height of 58 feet above the water.¹⁶ The overhead ground-wire cables were 96 feet above the water.

The helicopter severed 4 of the conductor cables and damaged the remaining 2 conductor cables. All of the overhead ground-wire cables remained undamaged (Figure 2).

Figure 2. The Flatlands–Long Island power transmission lines, indicating damaged wires. The conductor cables are represented by thick white lines, and the ground-wire cables by thin white lines. (Source: NB Power, with TSB annotations)

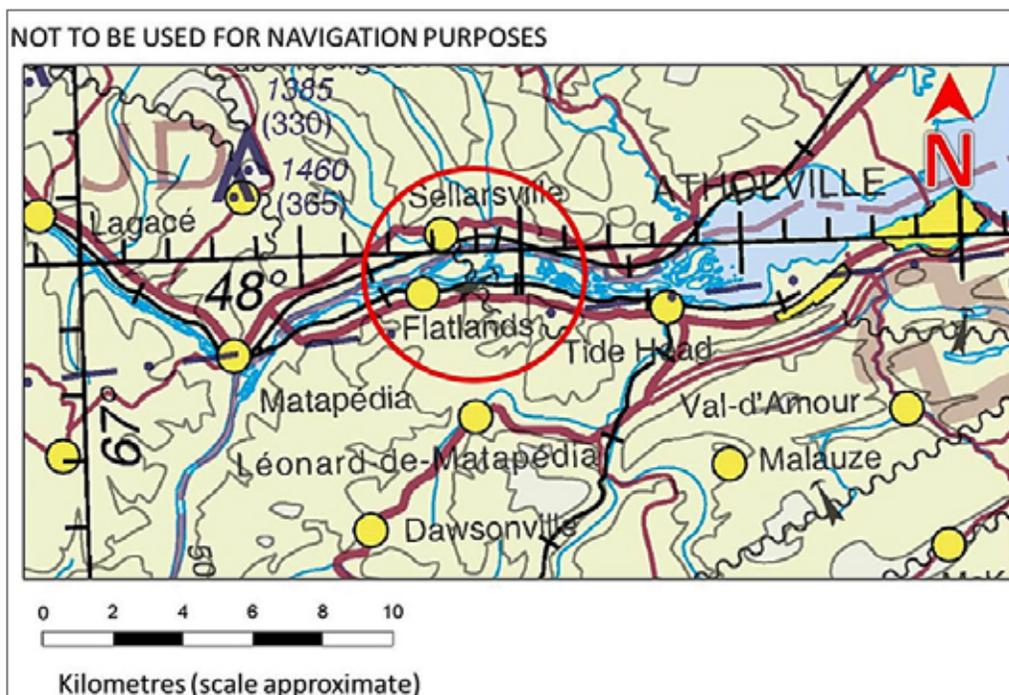
The Chicoutimi VNC did show segments of the power transmission line, but only the small portion over the Restigouche River at Flatlands–Long Island was marked due to the limited space on the VNC and the other prominent features included (Figure 3).

Figure 3. Magnified view of Chicoutimi VNC (AIR 5010) showing occurrence area (Source: NAV CANADA, with TSB annotations)

In regard to the area around Flatlands, NAV CANADA also stated that segments of power transmission lines were not depicted on the Chicoutimi VNC because they overlap with the surrounding roads and railways that follow the same path or direction as those power transmission lines. The positioning of obstruction and town labels in the area also resulted in segments of power lines not being depicted. The rationale behind depicting the small portion of power transmission line across the Restigouche River at Flatlands–Long Island is that it runs perpendicular to the roads and railways in the area (i.e., there is no overlapping of text and features). In addition, because it runs across the river between 2 communities, it has the potential to serve as a unique visual landmark. The pilot had a Chicoutimi VNC chart on board the occurrence flight; however, it was not consulted during the flight. The investigation could not determine whether the chart was reviewed prior to departure.
