AVIATION INVESTIGATION REPORT

A16W0170

Runway incursion

Calgary International Airport, Alberta

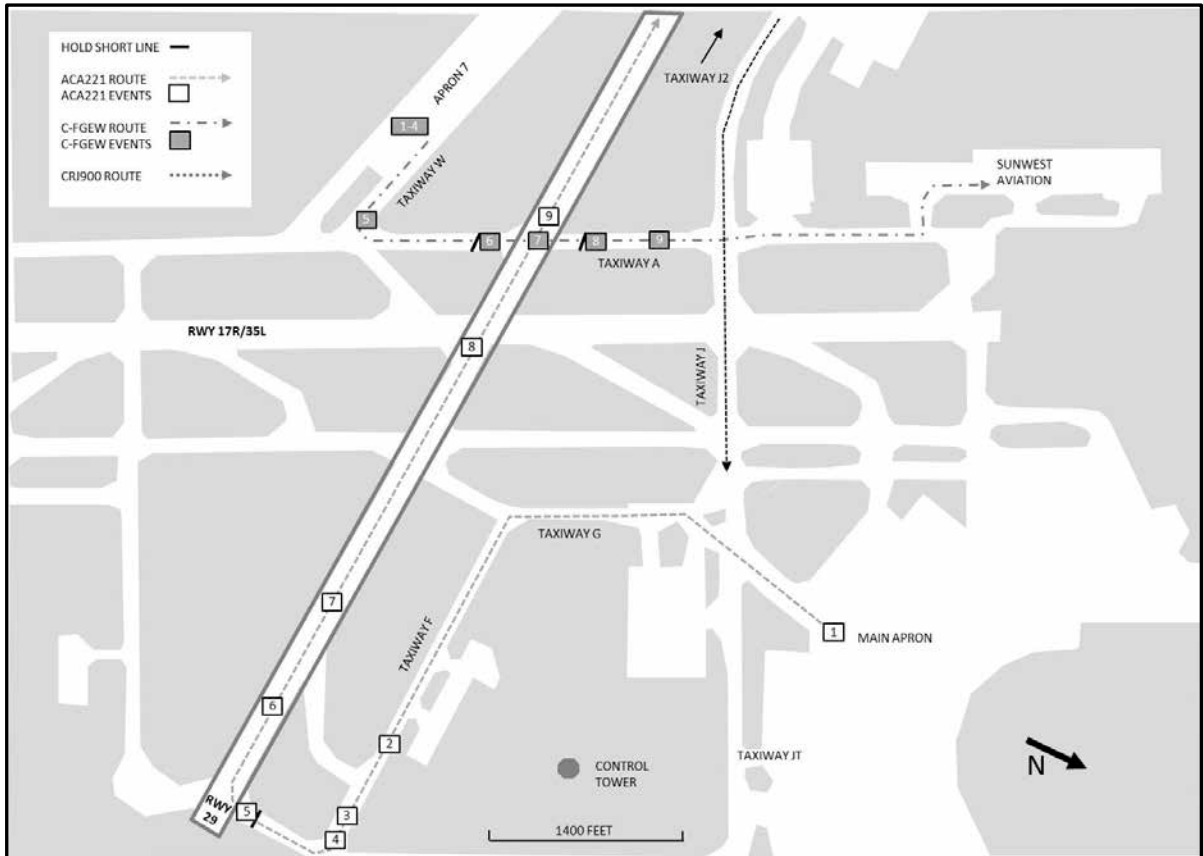
Figure 1. ACA221 and C-FGEW routes and event locations

Figure 1 and Table 1 depict the location, time, and description of events surrounding the runway incursion.

Location	Time	Event
1	1643:48	ACA221 left the gate and was cleared to taxi via taxiways G and F, and to hold short of Runway 29.
1	1647:45	A CRJ900 landed on Runway 29.
2	1648:02	C-FGEW, positioned at Apron 7, called the combined ground controller for taxi instructions to proceed to Sunwest Aviation on the northwest hangar line. It was instructed to taxi via taxiways W and A, and to hold short of Runway 29, which it proceeded to do.
3	1648:32	While taxiing on Taxiway F, ACA221 checked in with the combined tower controller.
4	1648:39	The combined tower controller asked whether ACA221 was ready for an immediate departure. ACA221 replied in the affirmative and was told to

continue taxiing for takeoff. ACA221 was then cleared for takeoff on Runway 29.
4	1648:49	The CRJ900 that had landed earlier cleared the runway on high-speed-exit ramp J2, then called the combined ground controller for taxi instructions. It was instructed to taxi on Taxiway J, cross Runway 35L, then take Taxiway JT to the main apron.
4	1649:02	The combined ground controller updated the flight data entry (FDE) for the CRJ900 in EXCDS to show its gate and taxi information.
5	1649:12	The combined ground controller updated the FDE in EXCDS for C-FGEW to reflect the clearance instruction to hold short of Runway 29. The combined ground controller then informed C-FGEW that it was cleared to cross Runway 29.
5	1649:19	The combined ground controller updated the FDE in EXCDS to reflect the clearance limit of the intersection of taxiways A and J for C-FGEW, and to ensure that it would not conflict with the CRJ900 that had just landed, was taxiing on Taxiway J, and would cross Taxiway A on its way to the gate.

6	1649:34	C-FGEW crossed the southern hold-short line for Runway 29 on Taxiway A.
7	1649:46	C-FGEW crossed the Runway 29 centreline.
8	1649:57	C-FGEW crossed the northern hold-short line for Runway 29 on Taxiway A.
9	1650:00	ACA221, departing on Runway 29, crossed Taxiway A airborne at approximately 136 knots ground speed.

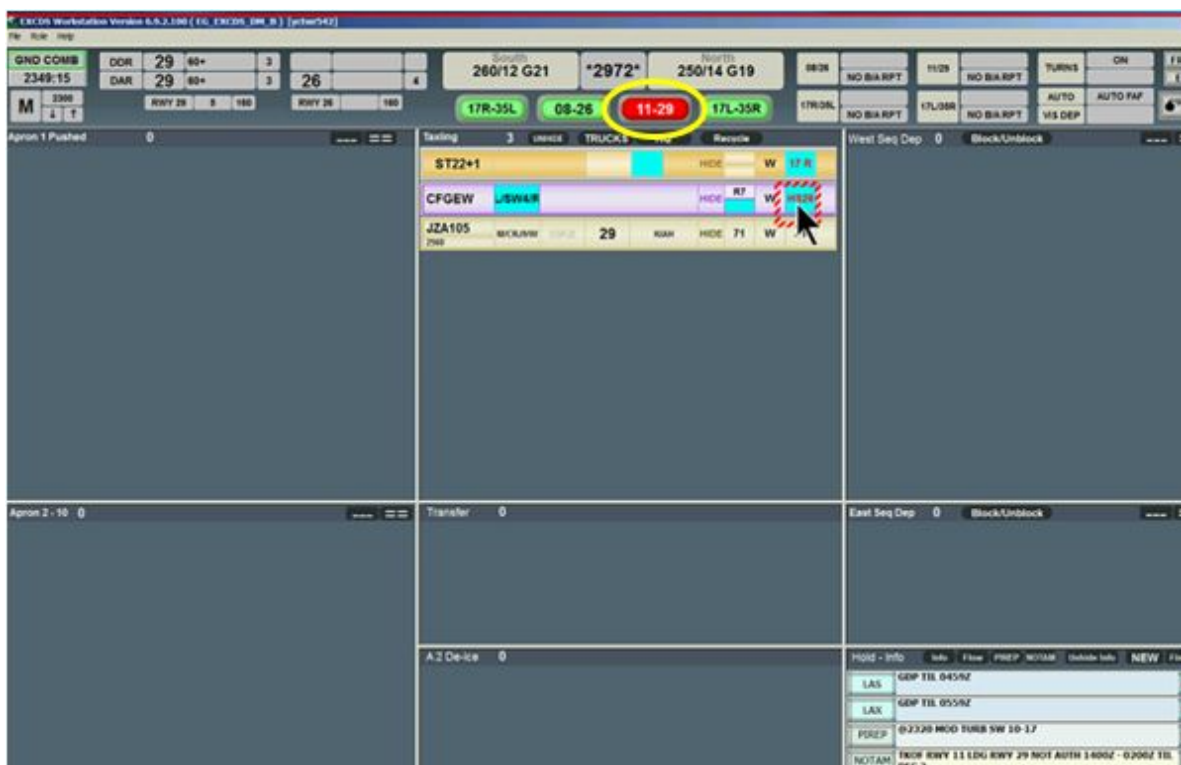
Figure 2. Image of the combined ground controller’s EXCDS display when C-FGEW was cleared to cross Runway 29. The runway jurisdiction system shows Runway 11/29 in red, indicating that it is under the jurisdiction of another controller (Source: NAV CANADA, with TSB annotations).

A memory aid was provided to allow controllers to verify runway ownership prior to clearance of aircraft onto a runway. The runway jurisdiction system (RJS) consisted of 4 indicators (one for each runway) that were located at the top of the extended computer display system (EXCDS) display. The indicators were green if a controller owned the runway and red if another controller owned the runway. Investigations into previous, similar runway incursions had found that the RJS did not provide an effective reminder of the need to carry out coordination, as it was always present and did not attract sufficient attention at the appropriate time. Similarly in this occurrence, the RJS did not provide a sufficiently compelling cue to ensure that the combined ground controller did not revert to the well-practised routine of clearing aircraft across Runway 29 without coordination.
