Air Transportation Safety Investigation Report A1800153

COLLISION WITH TERRAIN

Piper PA-28R-200, C-GDUM
Brantford Airport, Ontario
13 November 2018

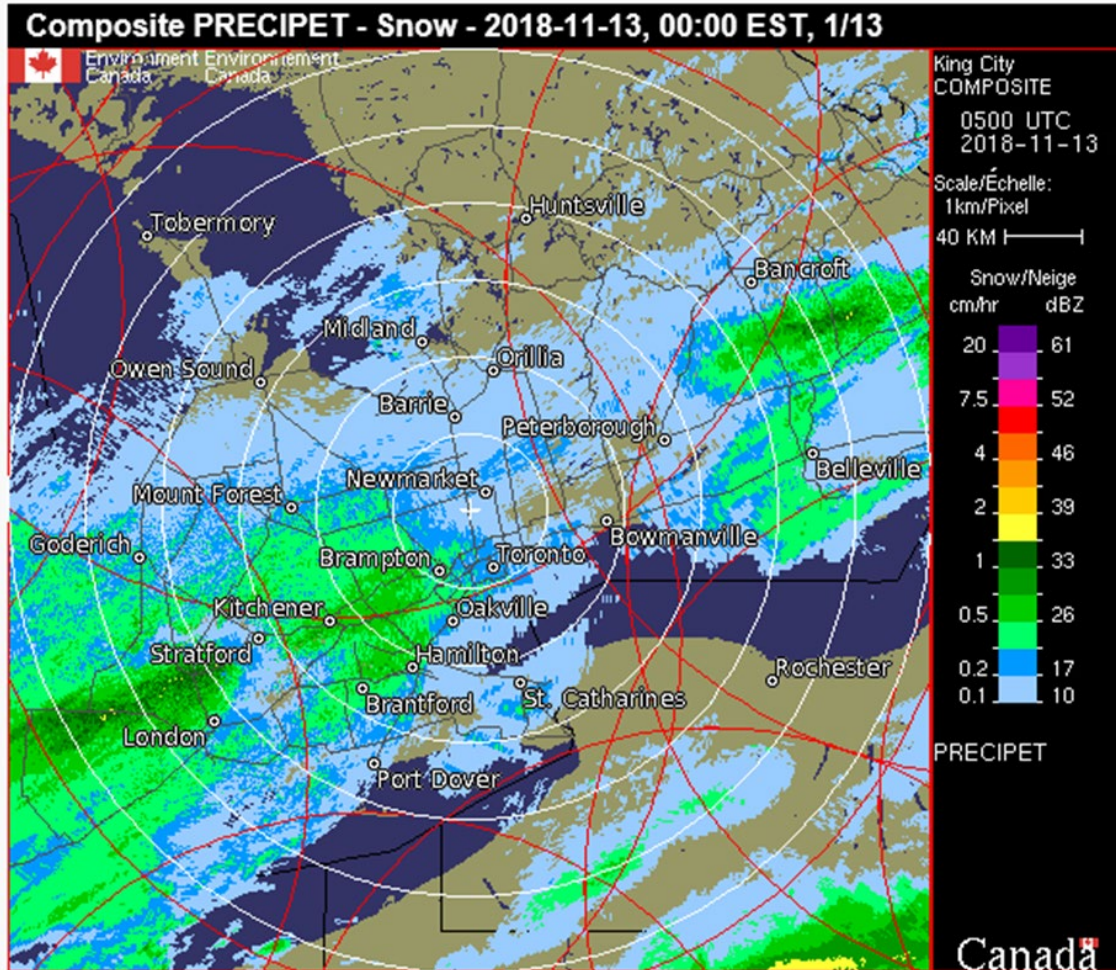
Based on historical weather radar data (Figure 1), there was precipitation in the form of rain or light snow at CZBA at the time of departure. The aerodrome routine meteorological reports from the 3 closest stations indicated visibilities as low as 1 statute mile in snow showers, and cloud ceilings at 1900 feet, with light winds and outside temperatures of around 0 °C at the surface.

Figure 1. Weather radar image showing system covering southeastern Ontario around the time of departure from CZBA (Source: Environment and Climate Change Canada)
