AIR TRANSPORTATION SAFETY INVESTIGATION REPORT A18W0129

CAPSIZE ON WATER LANDING

Simpson Air (1981) Limited
Cessna U206G, C-FNEQ
Little Doctor Lake, Northwest Territories
16 August 2018

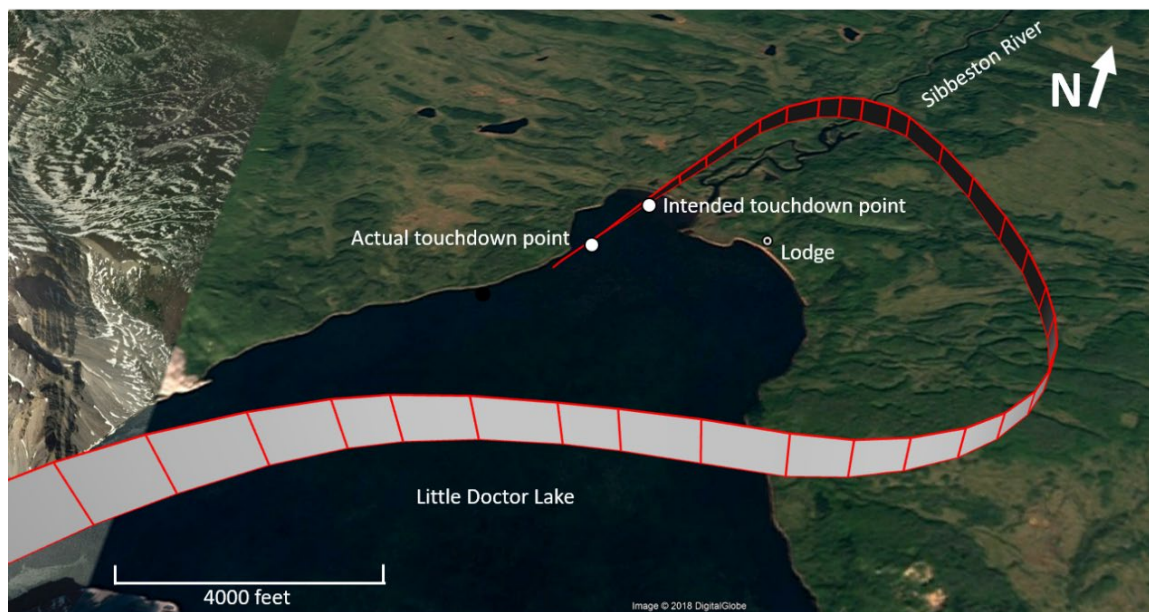
Figure 1. Global positioning system data showing the aircraft's final approach to Little Doctor Lake
(Source: Google Earth, map data DigitalGlobe, with TSB annotations)

The pilot set the flaps to 20° and flew the approach, planning to land in the bay.⁵ The approach was uneventful until approximately 300 feet above the surface of the water, when the rate of descent began to increase. The pilot increased power to compensate, resulting in the aircraft landing beyond the desired touchdown point.

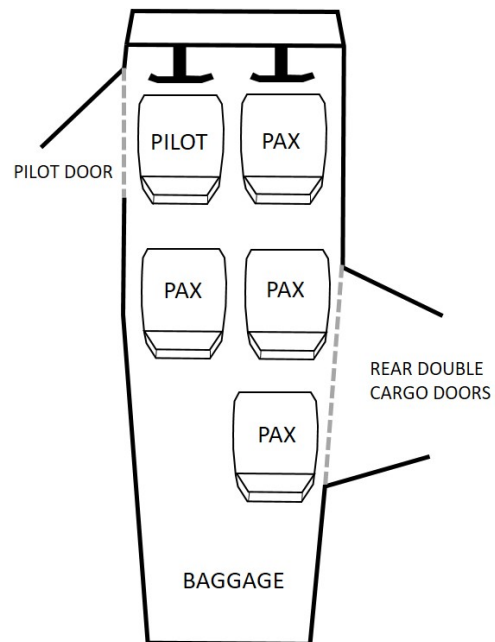
The aircraft was configured with 3 rows of seating; the first 2 rows had 2 seats, and the last row had a single seat on the right side of the cabin (Figure 2). The pilot, who had been seated in the front-left seat, received no injuries and was mobile and conscious during the entire event. The passenger who survived had been seated in the left seat of the middle row, behind the pilot. She also received no injuries and was mobile and conscious during the entire event.

The remaining passengers had been seated in the front-right seat, the right seat of the middle row, and the right seat of the last row. These passengers drowned; they had no other injuries.

Figure 2. Occurrence aircraft’s cabin configuration, with pilot and passenger (pax) seating arrangement and door locations (Source: TSB)

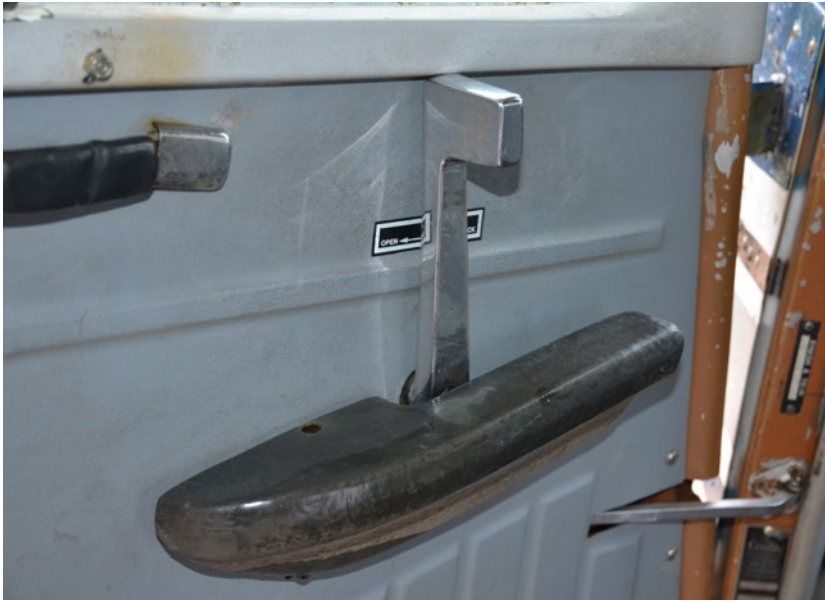
Figure 3. Pilot door handle in the closed position (Source: TSB)

As stated in TSB Aviation Investigation Report A0500147, by design, when the door is locked from the inside, it cannot be opened from the outside. In the context of that investigation, Cessna indicated the following:¹¹

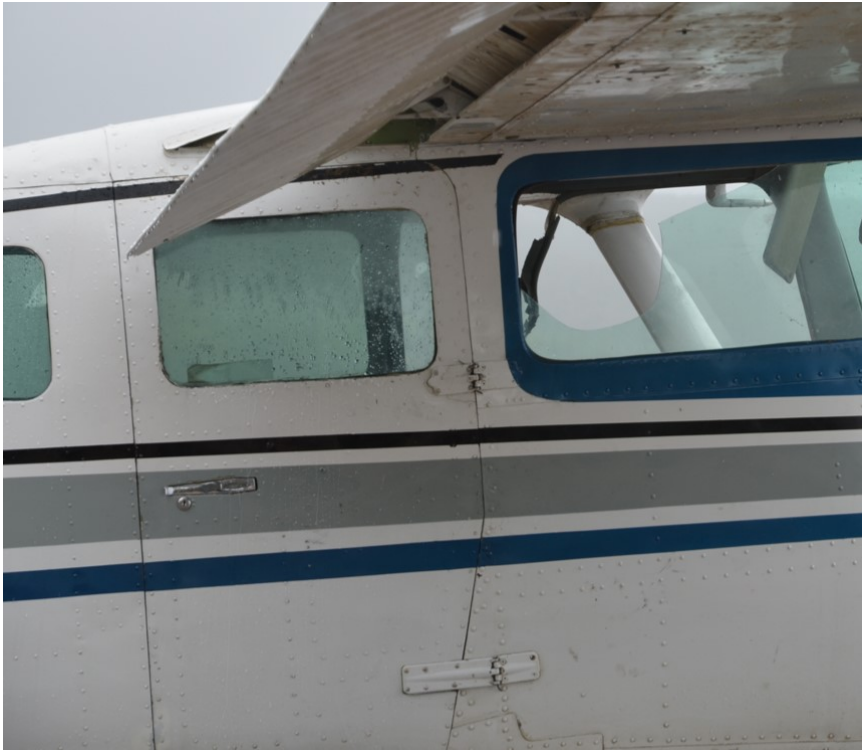
Figure 6. Image showing the position of the flaps at 20° down and how they obstruct the forward door of the rear double cargo doors (Source: TSB)

On 22 March 1991, Cessna issued Service Bulletin SEB91-4,¹⁴ providing a service kit and asking owners to incorporate a spring assembly that would automatically retract the handle on the aft door to allow the aft door to pass the forward door. The service kit also included luminescent placards to indicate the location of the door handle and to provide instructions on how to operate it. On 16 October 1997, Transport Canada (TC) issued Service Difficulty Alert AL-97-04,¹⁵ which strongly recommended that owners and operators incorporate Service Bulletin SEB91-4 if they had not already done so. Although incorporating the service bulletin simplifies the procedure to open the double cargo doors, it does not eliminate another problem: the jamming of the forward cargo door against the flaps.

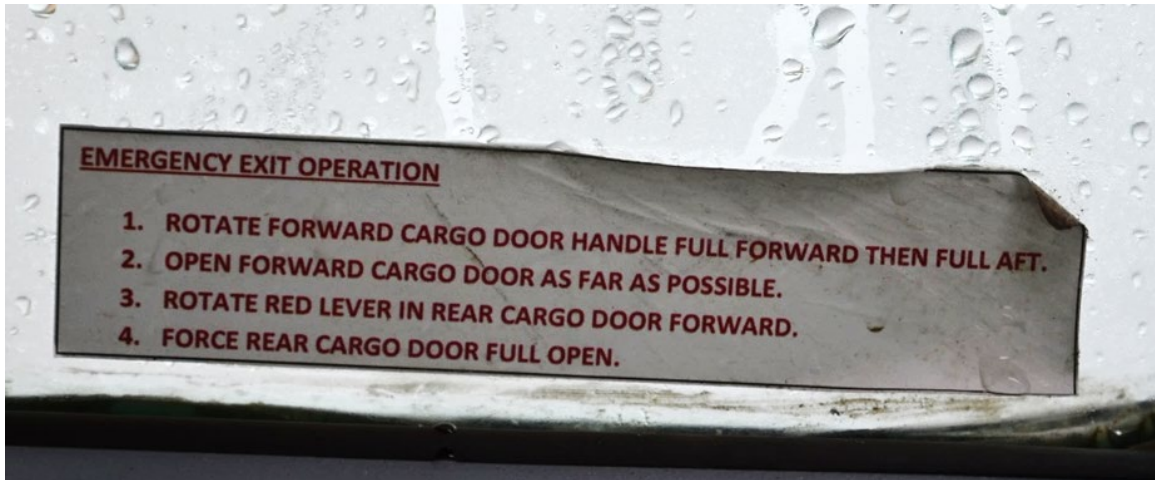
The procedure to open the door from the inside with the flaps down, which is listed on a placard above the handle on the forward cargo door (Figure 7), is the following:

1. Rotate forward cargo door handle full forward then full aft.
2. Open forward cargo door as far as possible.
3. Rotate red lever in rear cargo door forward.
4. Force rear cargo door full open.

Figure 7. Instructions for operating rear double cargo doors as an emergency exit on the occurrence aircraft (Source: TSB)

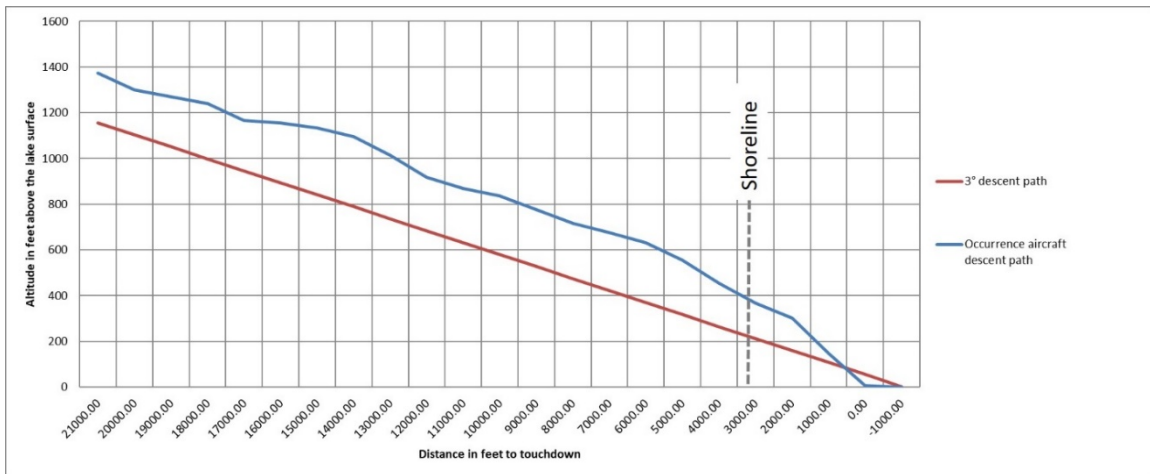
The data obtained were used to determine the approach route and profile of the accident flight (Figure 8). Once the occurrence aircraft crossed the shoreline, the descent angle increased from an average of 2.7° to 4.28° , to a peak descent angle of 6.17° .

Figure 8. The occurrence aircraft's descent profile versus a 3° descent path (Source: TSB)

In this occurrence, the rate of descent was high at the end of the approach, leading to a hard landing on the very rear of the floats in a near full-stall condition, with the stall warning horn sounding. The hard landing led to a bounce. No power was added to reduce the rate of descent for a subsequent touchdown. As the second attempt to land was made, the stall warning horn sounded again. As the aircraft settled, it touched down hard on the rear of the left float. There was enough energy to pitch the aircraft forward and to the right. The right wing contacted the surface of the lake, and the aircraft nosed over.
