AIR TRANSPORTATION SAFETY INVESTIGATION REPORT A19O0178

Loss of control and collision with terrain

Privately registered
Piper PA-32-260, N50DK
Kingston Airport, Ontario, 3.5 NM N
27 November 2019

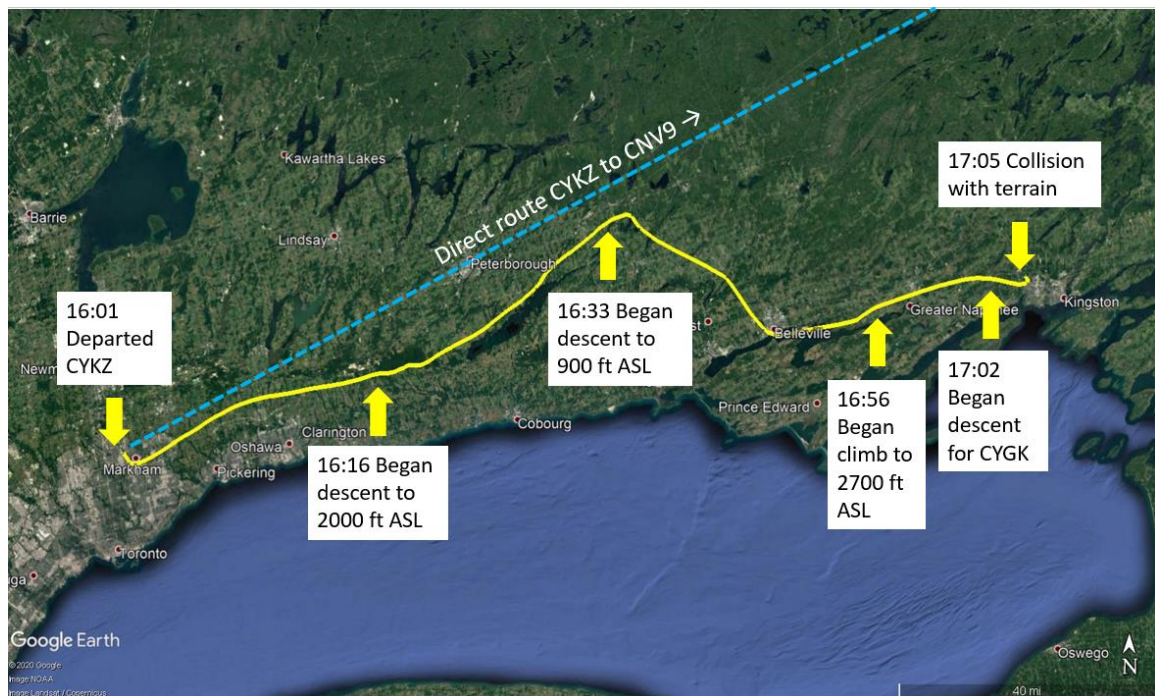
Figure 1. Occurrence aircraft’s route as compared to the planned direct route (Source: Google Earth, with TSB annotations, based on data retrieved from the pilot’s global positioning system)

The aircraft proceeded in the general direction of CNV9 for approximately 33 minutes (Figure 1). It climbed initially to the planned altitude of 3500 feet above sea level (ASL), where it flew for 15 minutes, before descending to 2000 feet ASL.

At 1633, the aircraft began a further descent and, at 1635, made a significant deviation toward the southeast, descending to as low as 900 feet ASL (200 feet above ground level [AGL]) near Havelock, Ontario. As the aircraft continued in a southeast direction

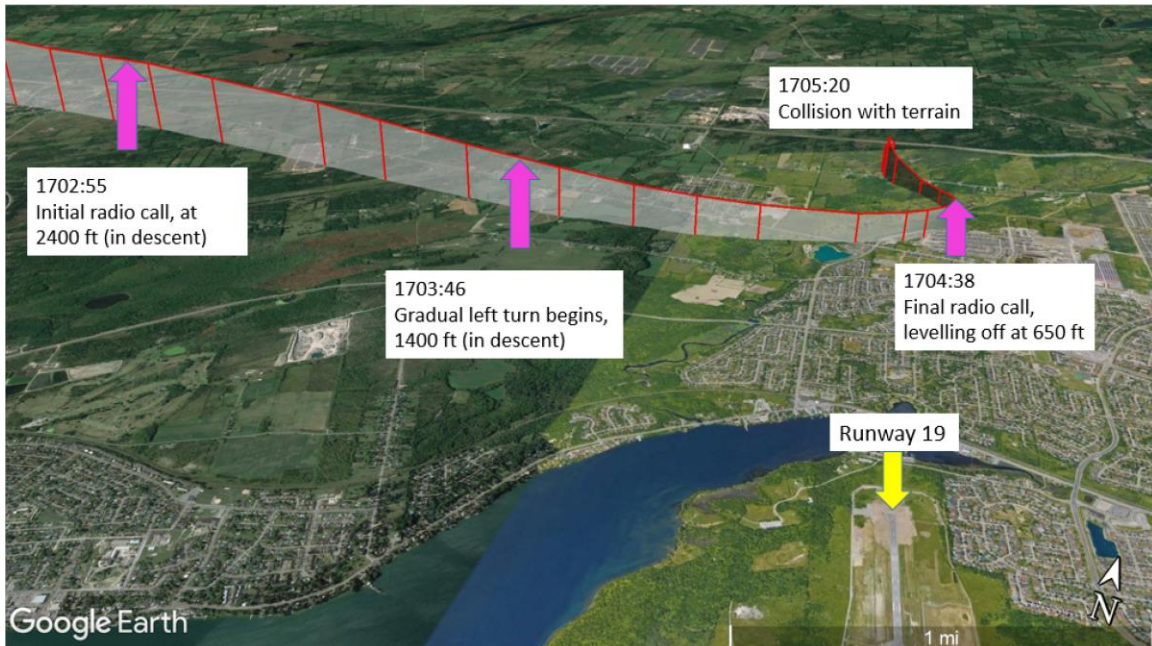
Figure 2. Occurrence aircraft's flight path during communications with the Kingston flight service station (Source: Google Earth, with TSB annotations, based on data retrieved from the pilot's global positioning system)

At 1702:55, the pilot made his 1st radio call to the CYGK flight service station (FSS) indicating that he was 4 NM north, inbound for a straight-in approach on Runway 19. At this time, the aircraft was actually 4.5 NM to the west, tracking 102° magnetic (M), in a steady descent through 2400 feet ASL at approximately 760 fpm (Figure 2).

At 1703:10, the CYGK FSS flight service specialist asked the pilot to confirm his position. The pilot replied that he was 4 NM to the north. The aircraft was actually 3.5 NM to the west, still tracking 102°M, in a steady descent through 2200 feet ASL. At the end of his transmission, the pilot began a sentence indicating that he would just overfly the field, but he hesitated and did not complete the sentence.

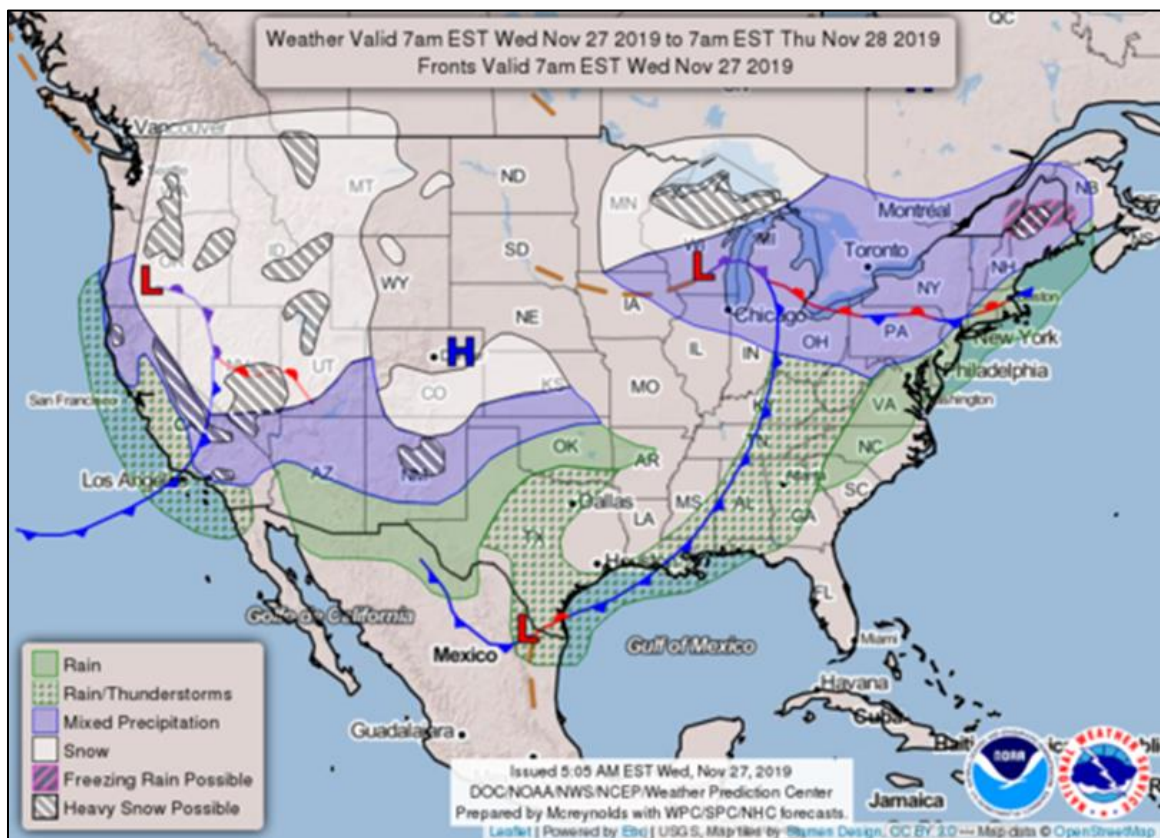
Figure 3. Forecast for 27 November 2019, accessed by the occurrence pilot through ForeFlight (Source: National Oceanic and Atmospheric Administration)

The low-pressure system depicted on the surface analysis was consistent with a chart the pilot viewed that morning entitled "Today's Forecast," produced by the U.S. National Oceanic and Atmospheric Administration (NOAA) and the U.S. National Weather Service (Figure 3). The NOAA chart clearly depicts a wide area of mixed precipitation (rain and snow) over the entire route of the planned flight.

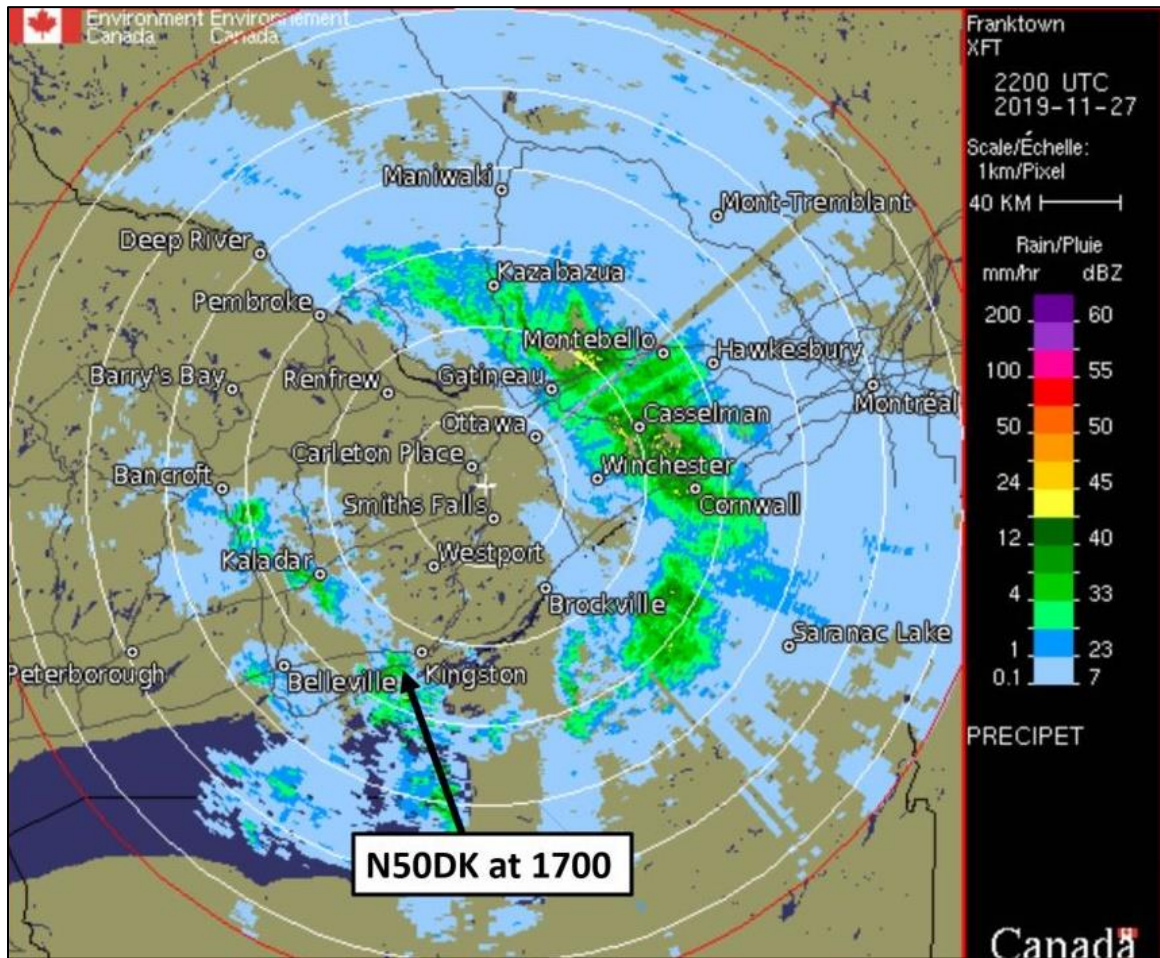
Figure 4. Franktown, Ontario, weather radar at 1700 Eastern Standard Time, showing moderate to heavy rain just west of Kingston, and the approximate position of the occurrence aircraft (N50DK) (Source: Environment and Climate Change Canada, with TSB annotations)

After flying for about 33 minutes, the aircraft descended to as low as 900 feet ASL and altered course from northeast to southeast. The weather radar at this time showed a band of weather from the northwest to the southeast, directly in the flight path of the aircraft before its diversion. The METAR for a nearby station (Peterborough) at 1626 reported a broken ceiling of 600 feet AGL and a visibility of 6 SM with light rain and mist.
