AIR TRANSPORTATION SAFETY INVESTIGATION REPORT A19P0112

CONTROLLED FLIGHT INTO TERRAIN

Seair Seaplanes
Cessna 208 Caravan, C-GURL
Addenbroke Island, British Columbia
26 July 2019

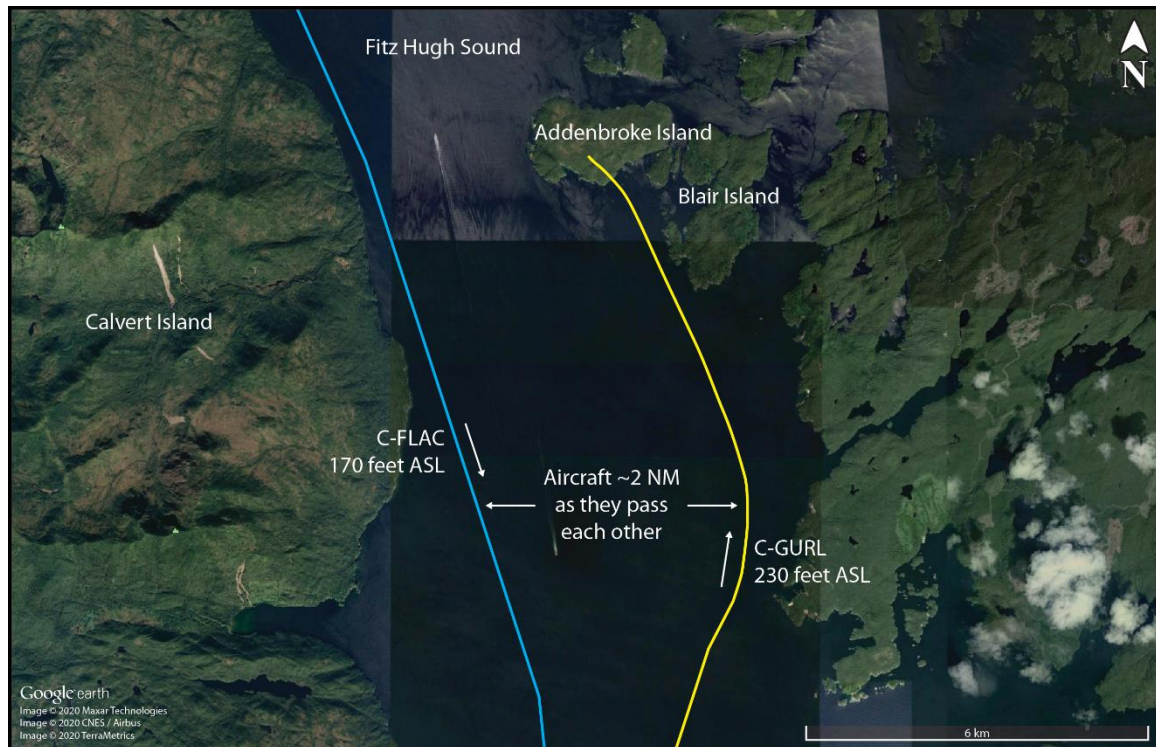
Figure 2. Aerial view showing the flight paths and altitudes of C-FLAC and C-GURL in Fitz Hugh Sound, as well as the distance between the 2 aircraft when they passed each other, just before the accident (Source: Google Earth, with TSB annotations)

At 1103, the 2 aircraft were separated by 2 NM and passed each other on reciprocal tracks, approximately 4 NM south of the accident site. The occurrence aircraft maintained a consistent track and altitude for the next 54 seconds, then slowly began a 25° change in track to the west (0.35 NM from the Addenbroke Island shoreline). Seven seconds after the turn started (0.12 NM from the island's shoreline), the aircraft entered a shallow climb averaging 665 fpm.

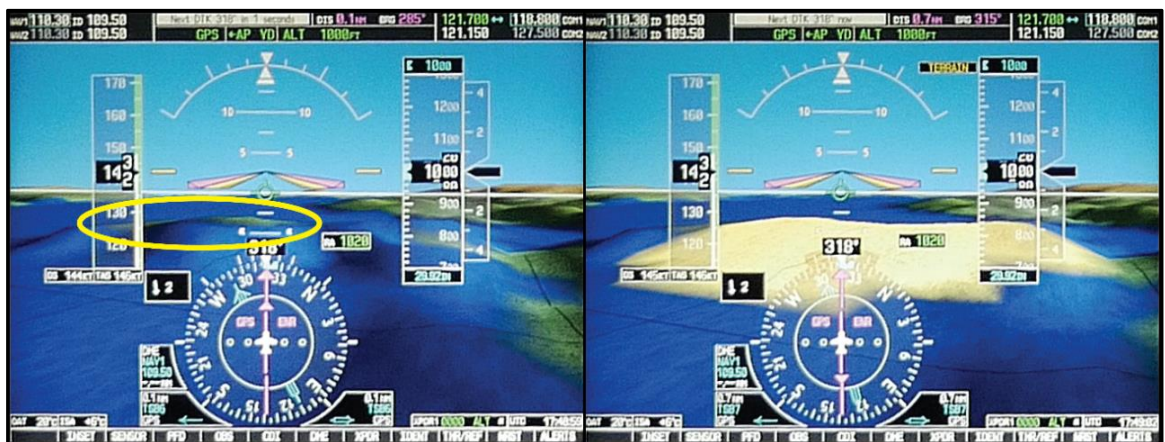
When the route was flown during the simulation with the FLTA enabled (un-inhibited), the system reacted reliably to the recognition of the Addenbroke Island land mass in the terrain database. When flown above the unit's RTC of 700 feet AGL, the FLTA provided an initial caution message when the aircraft was approximately 1.2 NM, or 30 seconds, from the Addenbroke Island shoreline (Figure 4). This caution message changed to a warning when the aircraft was 0.75 NM, or 19 seconds, from the shoreline.

Figure 4. Comparison of the geometry of the surface textures depicting Addenbroke Island as shown on the aircraft's primary flight display before activation of the terrain warning (left image) and immediately following activation of the terrain warning (right image) when flown at 1000 feet above ground level (Source: TSB)

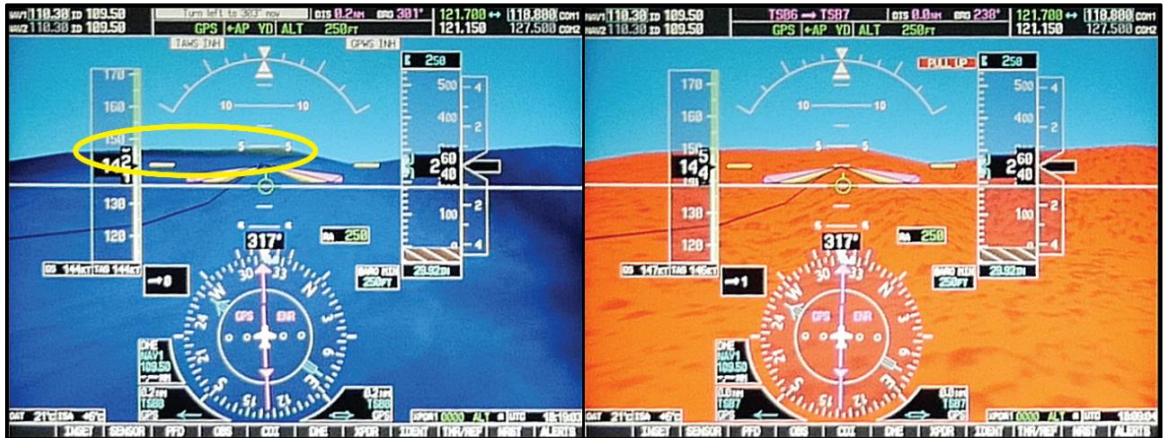
When flown at approximately the same altitude as the occurrence flight (which was below the RTC), the system produced continuous visual (Figure 5) and aural alerts.

Figure 5. Comparison of the geometry of the surface textures depicting Addenbroke Island as shown on the aircraft's primary flight display with the forward looking terrain awareness inhibited (left image), and with the forward looking terrain awareness enabled (right image) when flown at 250 feet above ground level (Source: TSB)

During testing, it was noted that the display of the synthetic vision technology depicts the Addenbroke Island landmass as a small portion of the actual landscape because the ocean blends partially into the island (green area circled in the left-hand images of Figure 4 and Figure 5). The investigation determined that approximately 6% of the island is represented as land on the PFD when comparing the geometry of the surface texture. The remainder of the island is depicted as ocean.

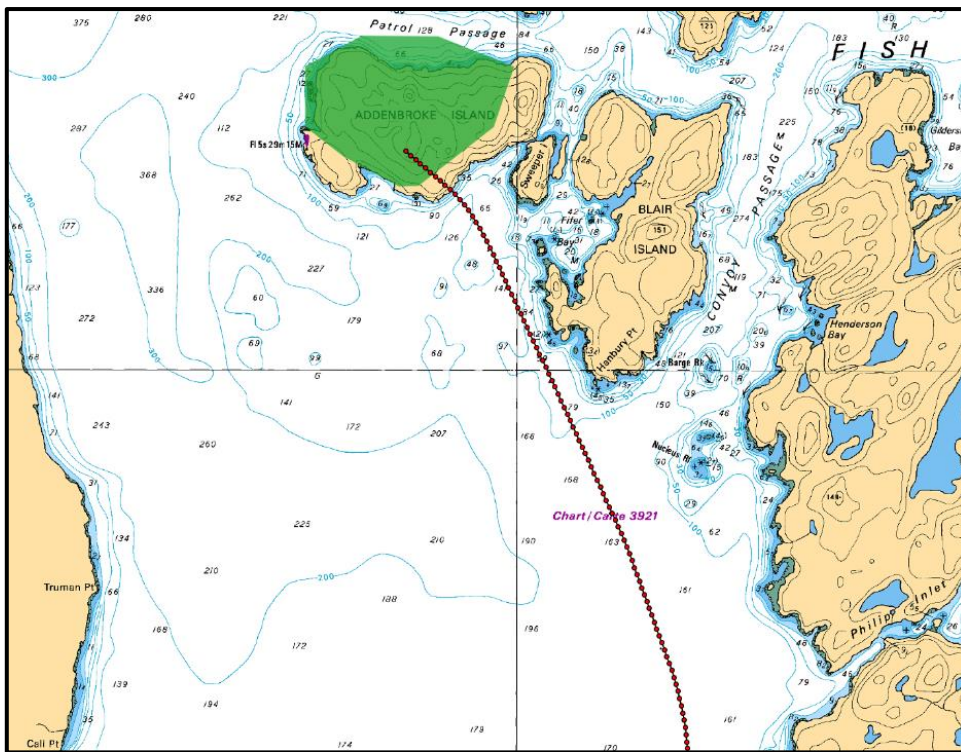
A similar comparison was performed for the MFD screen's pixel-based area of the landmass representation based on the database SD card onboard the occurrence aircraft. The investigation determined that the representation of Addenbroke Island that could be displayed on the MFD (as shown by the overlay in Figure 6) depicted approximately 86% of the actual landmass.

Figure 6. Screen pixel-based comparison of the installed Garmin G1000 basemap (shaded overlay) and the actual land mass for Addenbroke Island. The dotted line represents the actual track of the occurrence aircraft. (Source: Canadian Hydrographic Service Chart No. 3934, with TSB annotations)
