Air Transportation Safety Investigation Report A19P0187

COLLISION WITH TERRAIN

Cessna 172H, C-GECC
Tofino/Long Beach Airport, British Columbia, 31 NM NW
21 December 2019

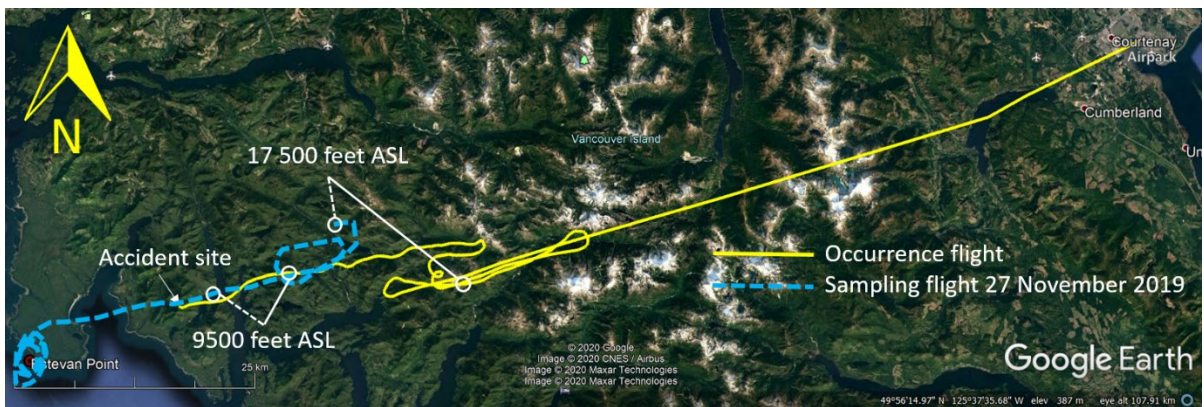
When the aircraft reached 9500 feet ASL at 1217, it did not level off to conduct a sampling as planned. Instead, it descended through 9500 feet ASL on a steady track heading southwest and continued its descent for 4 minutes at 80 to 100 knots groundspeed and an average rate of 1800 fpm, until it was no longer visible on radar. The last radar return was at 2800 feet ASL. There was no record of any radio communications from the aircraft.

The on-board NOAA sampling equipment's GPS (global positioning system) indicated that the aircraft came to rest at 1222 (Figure 1). It had struck trees and collided with the ground near Stewardson Inlet, BC. The pilot was fatally injured. The aircraft was destroyed. There was no post-impact fire.

Figure 1. Flight paths of the occurrence flight and the previous sampling flight, based on NAV CANADA radar and National Oceanic and Atmospheric Administration GPS data (Source: Google Earth, with TSB annotations)

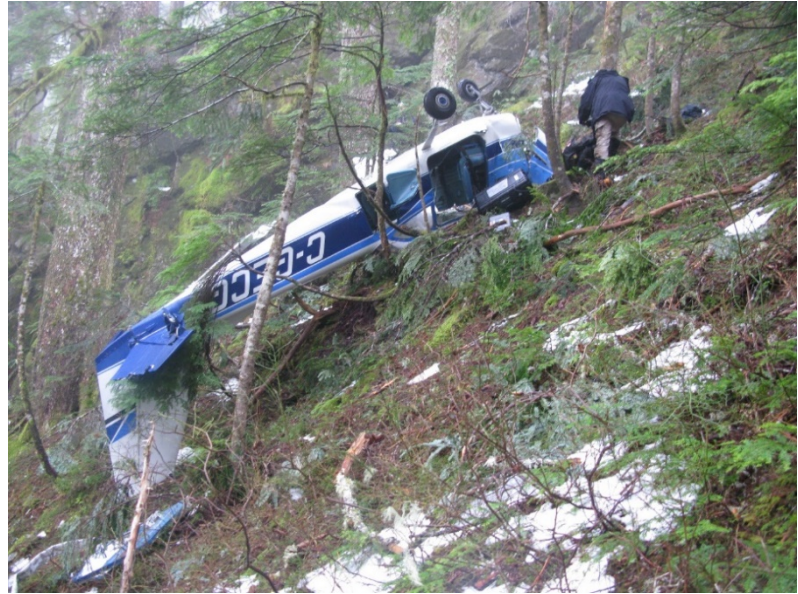
The wreckage was found at approximately 2600 feet ASL on a steep, densely wooded mountainside, 31 nautical miles (NM) northwest of Tofino/Long Beach Airport (CYAZ), BC. The damage was consistent with a low-energy impact (Figure 2).

Few tree tops and tree limbs were broken. The average height of the trees at the occurrence site was approximately 150 feet and those nearest the aircraft had bark scarring on the lower 60 feet, primarily on the sides facing east-southeast; the aircraft's flight path to the occurrence site from CAH3 was from the east-northeast. The scarring is consistent with the NOAA GPS track, which showed the aircraft made a right turn in the last 20 seconds of flight.

Figure 2. Occurrence site on 12 February 2020, looking west (Source: TSB)

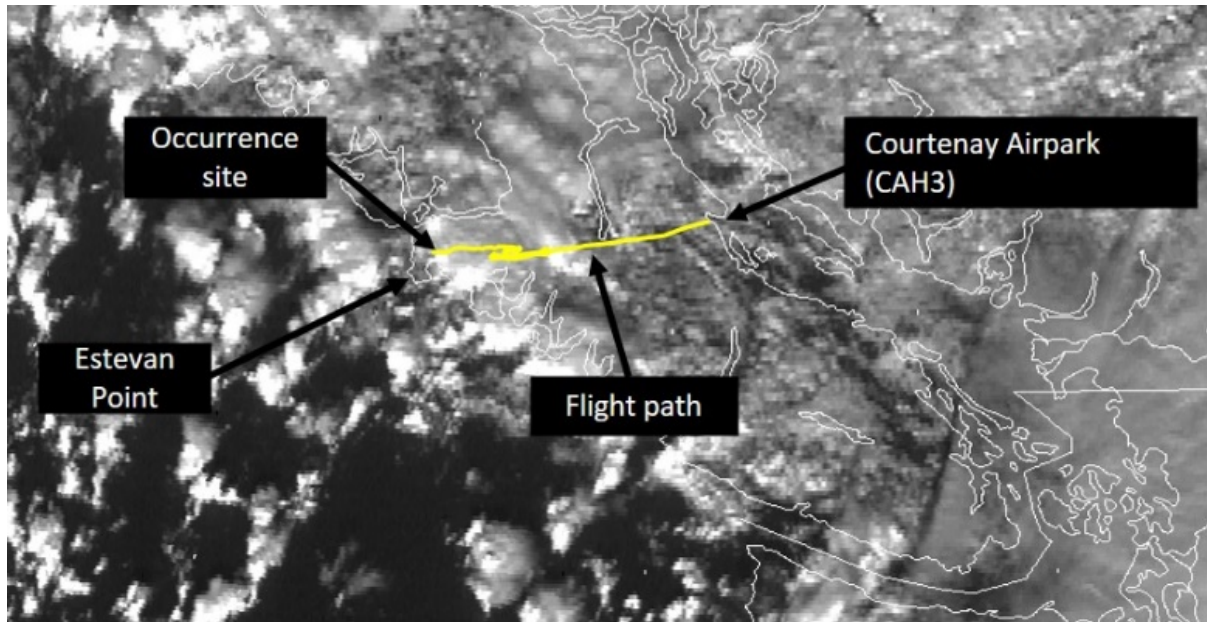
Lightning strikes were recorded near the occurrence site between 1000 and 1300⁶ and clouds of vertical development were observed on satellite weather imagery⁷ just south of the accident site (Figure 3).

Figure 3. GOES 15 visible satellite image of clouds taken approximately 15 minutes after the accident (Source: Environment Canada, with TSB annotations)
