AIR TRANSPORTATION SAFETY INVESTIGATION REPORT A19Q0010

RUNWAY EXCURSION DURING TAKE-OFF ROLL

Air Creebec Inc.
de Havilland DHC-8-102, C-GTCO
Rouyn-Noranda Airport, Quebec
23 January 2019

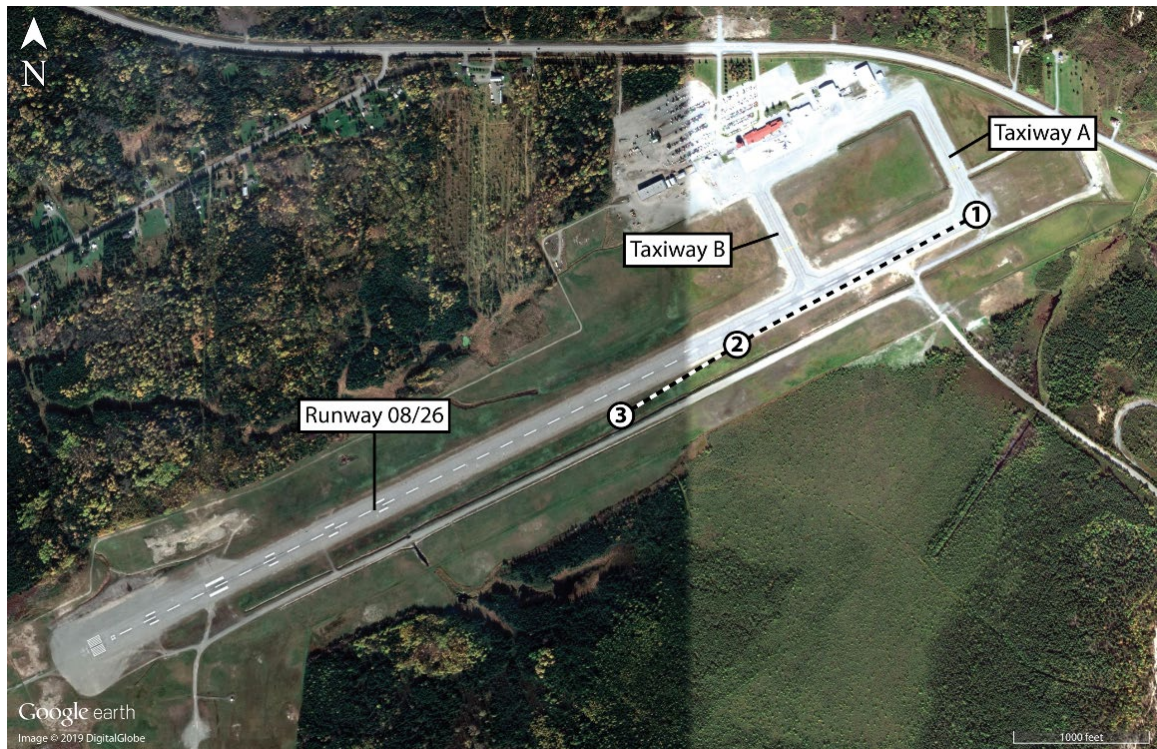
Figure 1. Estimated path of the occurrence aircraft on its take-off roll at the Rouyn-Noranda Airport (Source: Google Earth, with TSB annotations)

At 2137:04, the aircraft came to a stop 3000 feet from the threshold and 200 feet to the left of the Runway 26 centreline, on a heading of 147° (Figure 1, position 3 and Figure 2). The PF then carried out the engine shutdown procedure.

- 1: Beginning of take-off roll.
- 2: Left main landing gear rolled off the runway surface.
- 3: The aircraft came to rest.

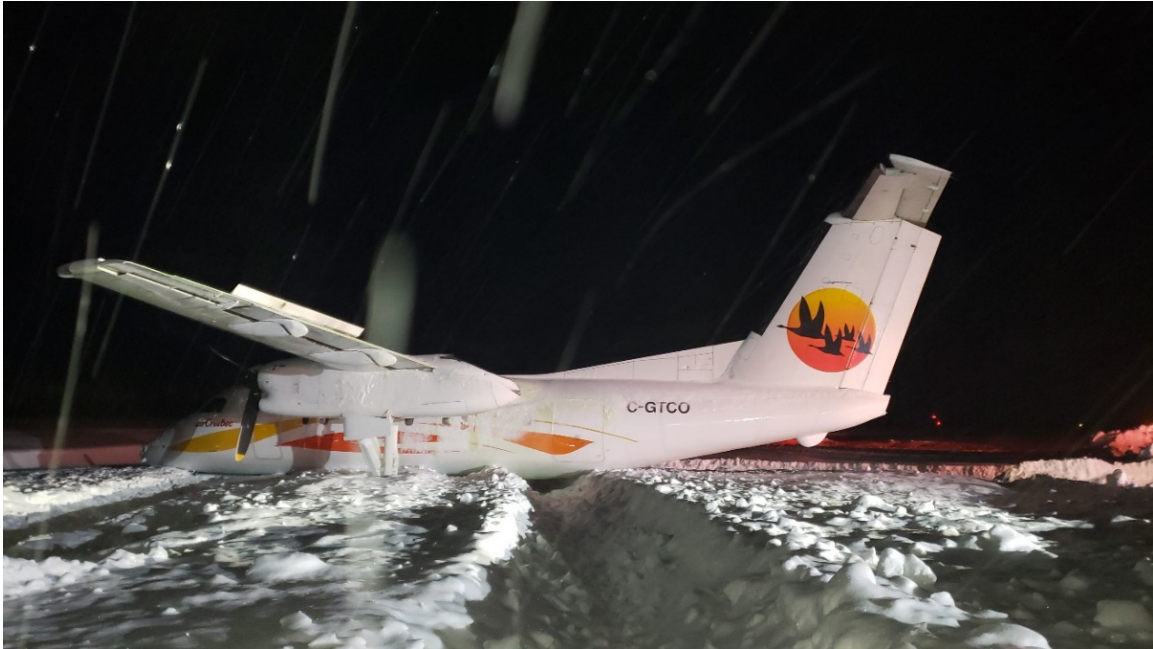
Figure 2. Aircraft after it came to rest (Source: Air Creebec Inc.)

One of the passengers received minor injuries. The aircraft sustained substantial damage to the fuselage, landing gear and propellers. The inspection of the aircraft after the accident revealed no faults before the impact that may have caused the aircraft to veer during the take-off roll.

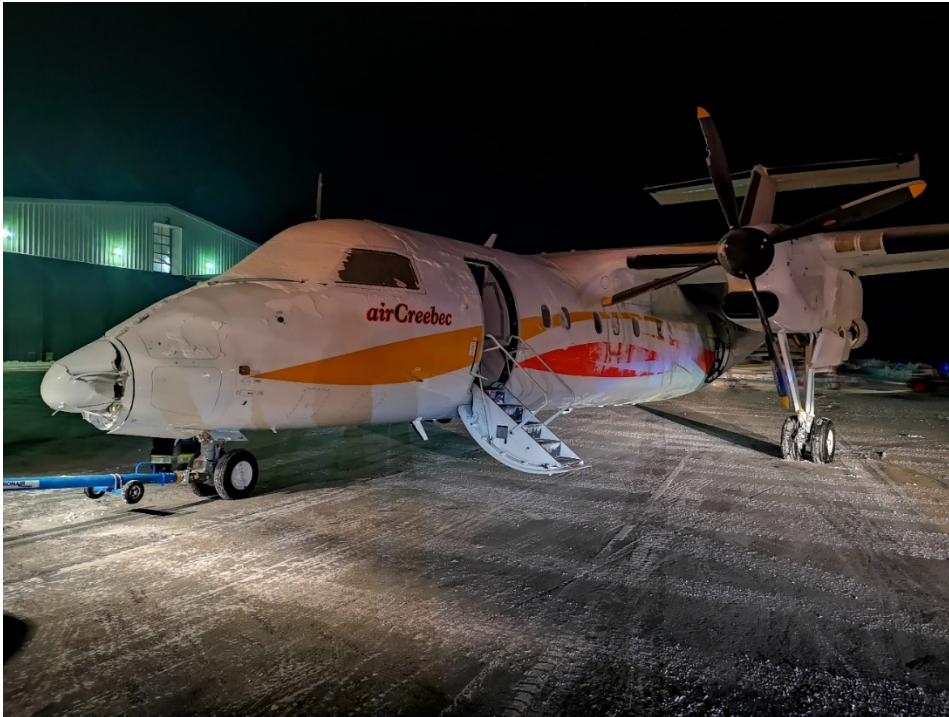
Figure 3. Aircraft after being towed; visible damage to the nose and propeller (Source: Air Creebec Inc.)

When the aircraft hit the 36-inch compacted snowbank, sections of both propellers broke off and damaged each side of the fuselage. Also, the aircraft's nose, belly and landing gear were damaged (Figure 3).

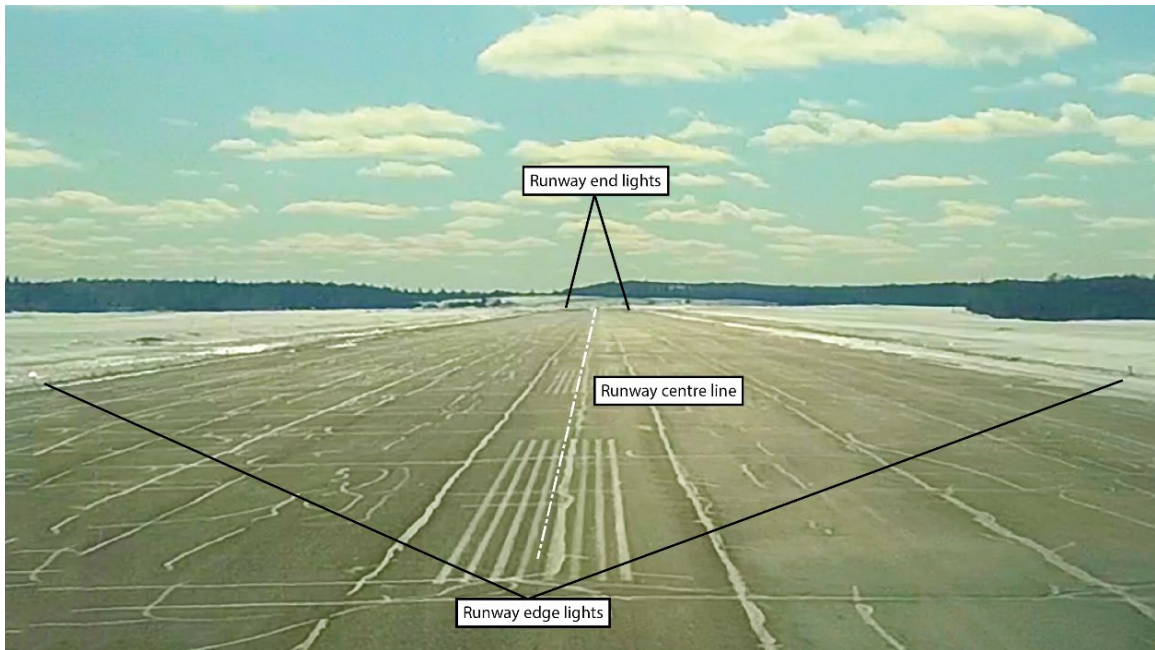
Figure 4. Markings on Runway 26 at the Rouyn-Noranda Airport, as seen during the day (Source: TSB)

Runway 26 also has runway centreline markings, which consist of 8 evenly spaced longitudinal lines. These lines begin 12 m (39 feet) from the runway designation marking and are spaced 50 to 75 m (164 to 246 feet) apart along the full length of the centreline (Figure 4). At the time of the accident, the runway markings were covered with snow and was not visible to pilots.

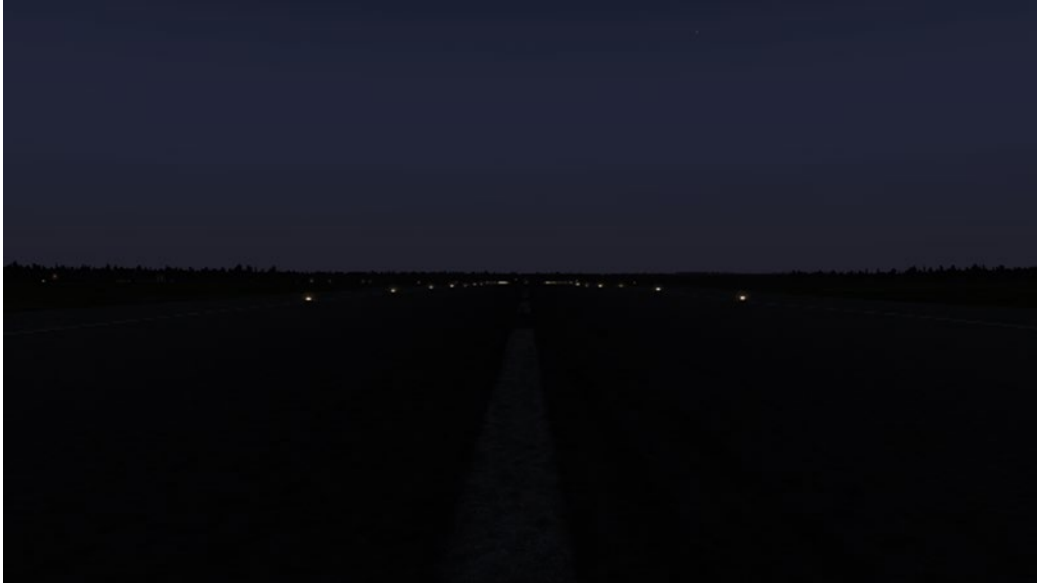
Figure 6. Runway edge lights seen by a pilot when the aircraft is on the runway centreline (Source: TSB, image created using the X-Plane Flight Simulator)

automobile drivers, pilots must look much further ahead before they can get an effective optical flow. When the optical flow of the left and right edge lights is symmetrical—in other words, the distance between the lights on the left is the same as the distance between the lights on the right—the aircraft remains exactly in the centre of the runway (Figure 6).

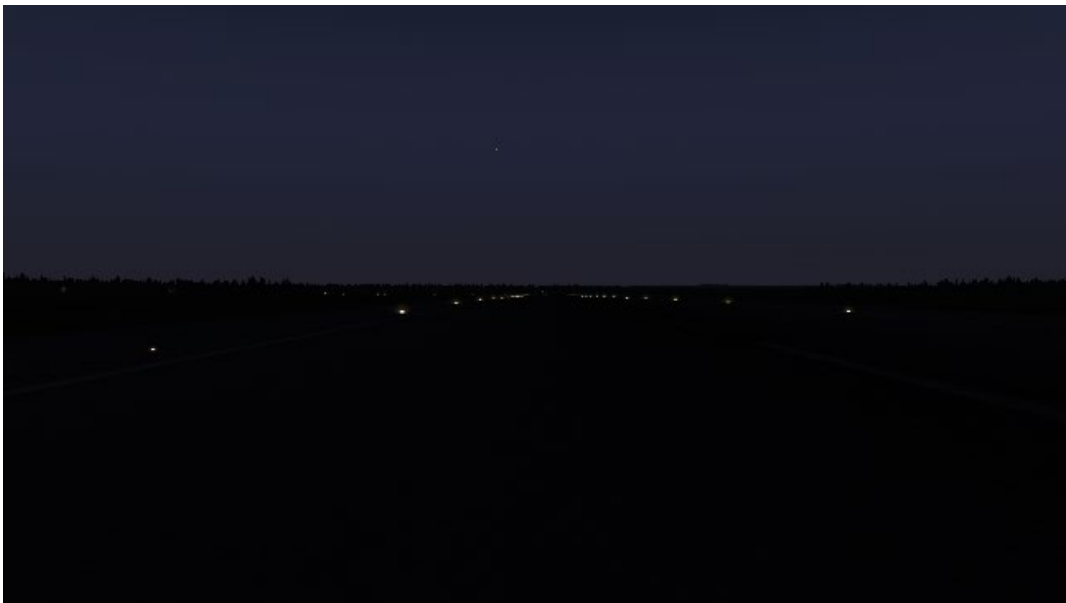
Figure 7. Runway edge lights seen by a pilot when the aircraft is 30 feet to the left of the runway centreline (Source: TSB, image created using the X-Plane Flight Simulator)

However, when the optical flow is no longer symmetrical and the distance between the runway edge lights appears to decrease on one side and increase on the other, it means that the aircraft is deviating toward the side where the distance is decreasing (figures 7 and 8).
