Air Transportation Safety Investigation Report A19Q0107

COLLISION WITH TREES

de Havilland DHC-2 Mk.1 (Beaver), C-GRHF (private)
Chibougamau, Quebec, 43 NM S
12 July 2019

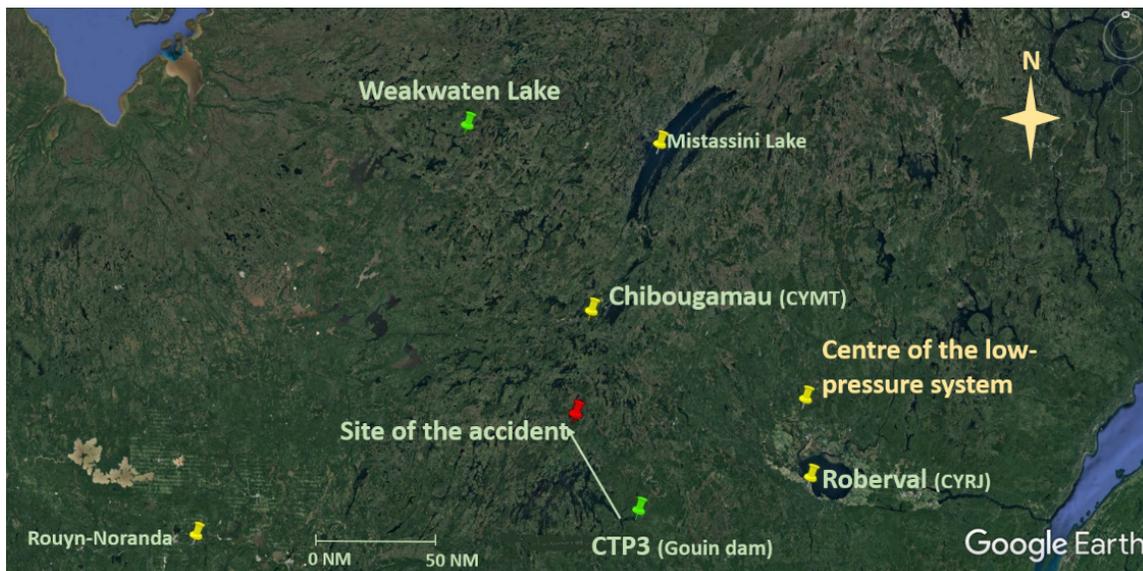
At 1300, the centre of a quasi-stationary low-pressure system was located approximately 37 statute miles (SM) north of the Roberval Airport (CYRJ), Quebec (Figure 1). Areas to the west and northwest of the low-pressure system were influenced by a cloudy return flow strengthened by high humidity, which was 87% at CTP3 and 100% near the site of the accident. Localized areas of mist, drizzle or intermittent rain were also possible in these areas, which could lead to a reduction in visibility and in the height of the cloud ceiling. Between 1300 and 1700, the Chibougamau/Chapais Airport (CYMT), Quebec, located approximately 43 nautical miles (NM) north of the scene of the accident, reported visibility varying between 2½ SM and 9 SM, with a ceiling at 400 feet above ground level (AGL) and intermittent low precipitation.³

Figure 1. Centre of the low-pressure system in relation to the points of interest in the occurrence (Source: Google Earth, with TSB annotations; map data: Image Landsat/Copernicus, Data SIO, NOAA, U.S. Navy, NGA, GEBCO)

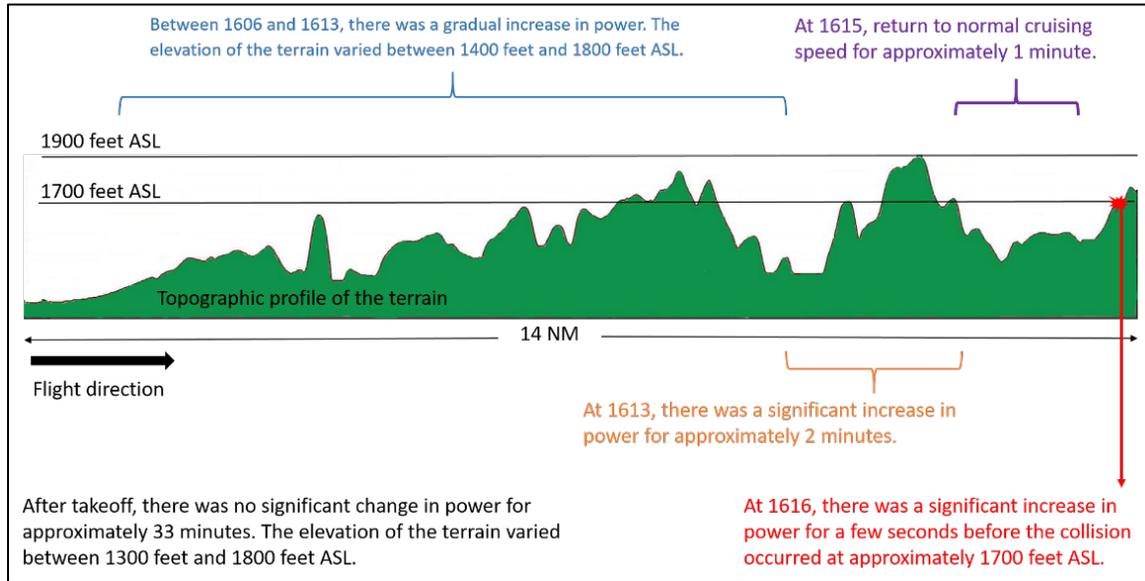
Using the aircraft's estimated straight path and comparing the data from the engine data recording and monitoring system, the estimated ground speeds and the topography, a correlation was found between the use of the power lever and the topography of the terrain (Figure 2). It was also found that the aircraft's altitude in relation to the terrain lessened as the flight progressed.

Figure 2. Correlation between the topographic profile of the terrain and power parameters (Source: TSB)

In this occurrence, the fact that there was a sudden increase in power a few seconds before the collision with the trees, while the aircraft was possibly descending toward a rising terrain, suggests that the pilot saw the trees too late. The reduced speed, excess weight and proximity of the trees prevented the aircraft from regaining sufficient altitude to avoid the impact.

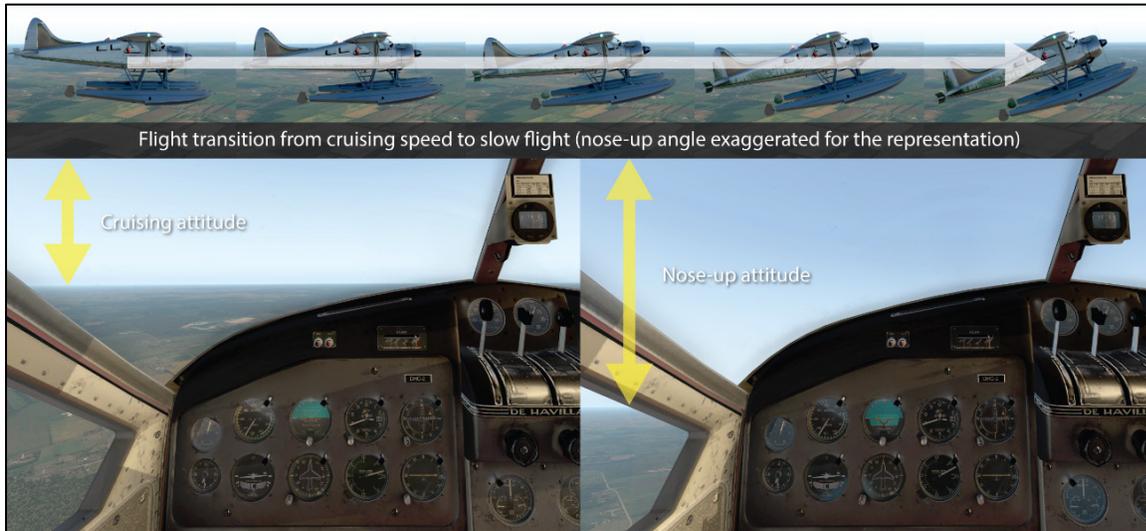
In slow flight, the aircraft is more nose-up than it is at cruising speed. The nose-up position changes the position of the horizon visible from the cockpit as well as the earth's surface that is visible (Figure 3). The horizon and the earth's surface are therefore the main visual cues used by a pilot to determine the aircraft's attitude. If a pilot sees the horizon move to the lower part of the windshield and the earth's surface that is visible diminish above the instrument panel, the pilot can recognize the aircraft's nose-up position.

Figure 3. Visual references of the attitude from the cockpit (Source: TSB)

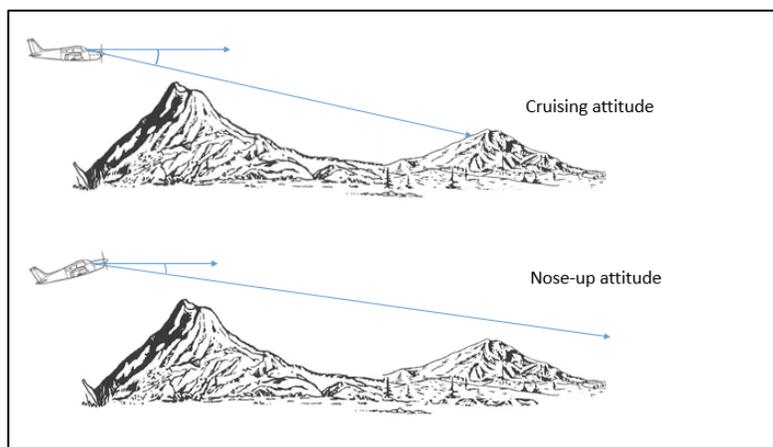
In slow flight, the pilot's front viewing angle is reduced (Figure 4). Also, when the aircraft has a high instrument panel, as is the case in the DHC-2, the reference line for the actual horizon and the terrain may be completely hidden by the instrument panel. Hence, the visual cues needed to detect obstacles straight ahead are greatly reduced, which hinders the pilot's ability to maintain a safe altitude when flying at low altitude, and even more so when visibility is reduced.

Figure 4. Pilot's viewing angle depending on the flight attitude (Source: TSB, using figures in Transport Canada's Air Command Weather Manual [TP 9352E] and Flight Training Manual [TP 1102E])
