## **AIR TRANSPORTATION SAFETY INVESTIGATION REPORT A19Q0153**

### **LOSS OF CONTROL AND COLLISION WITH TERRAIN AT NIGHT**

Cargair Ltd.  
Cessna 172M, C-GSEN  
Racine, Quebec  
04 September 2019

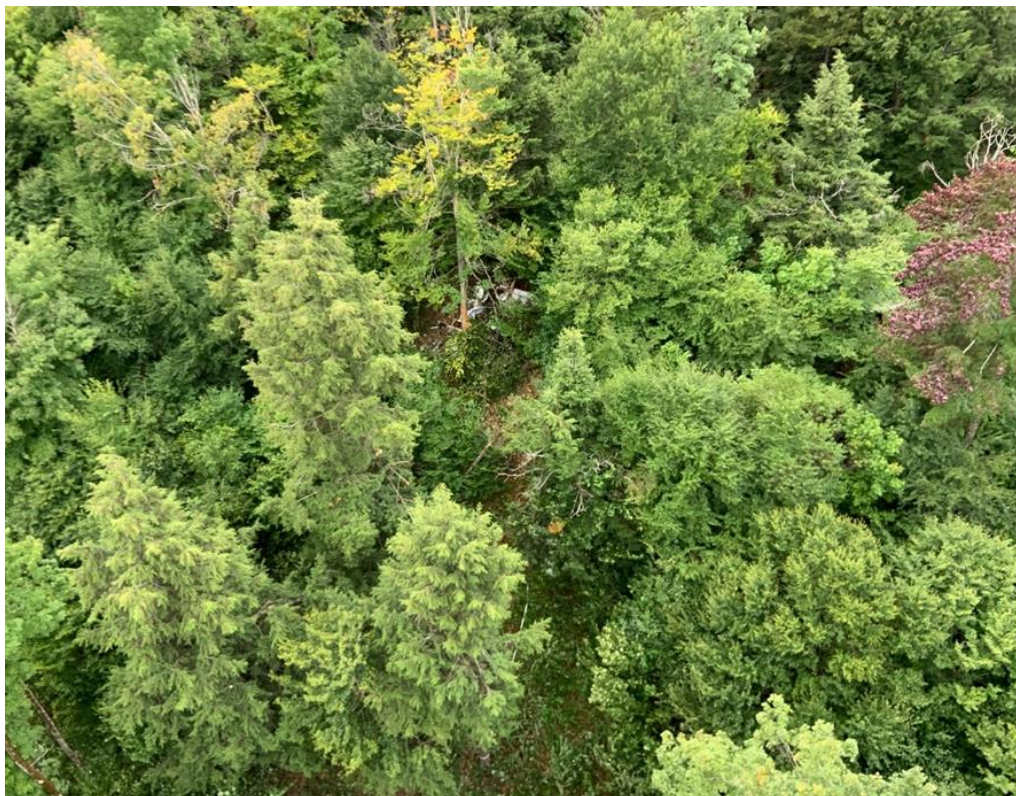
The wreckage of the occurrence aircraft was located 3 days later, on 07 September 2019, in a heavily wooded area near Racine, Quebec (Figure 1), at an elevation of 887 feet ASL. The aircraft had struck trees and had been destroyed by impact forces. The pilot received fatal injuries on impact. There was no post-impact fire. No signal was detected from the emergency locator transmitter (ELT).

Figure 1. Aerial view of the wreckage site (Source: Sûreté du Québec)

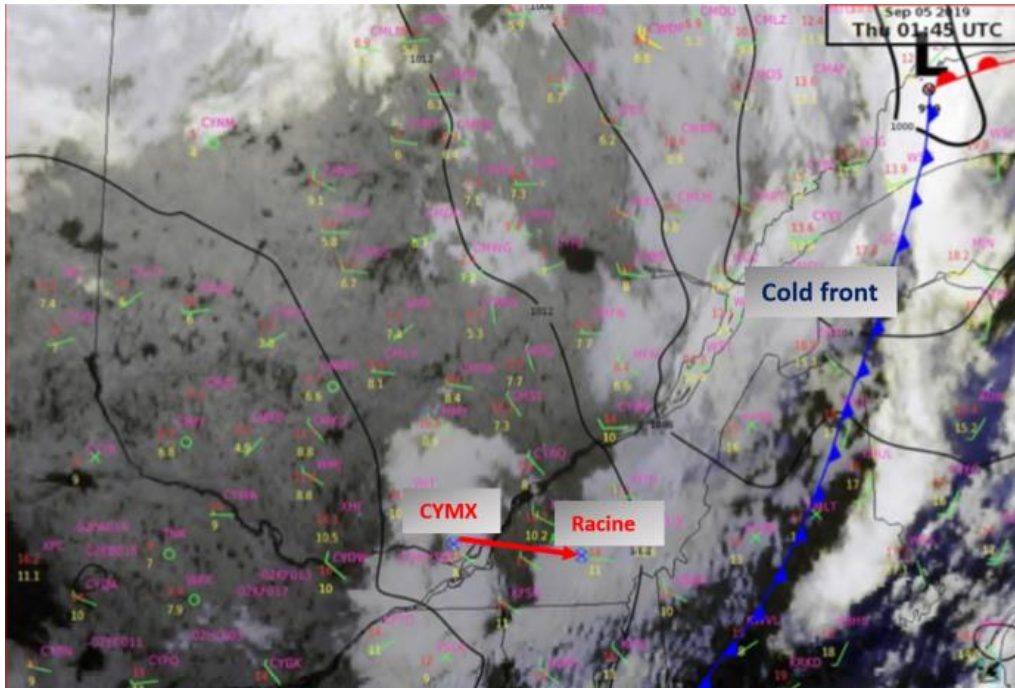
At approximately the time of and near the area of the occurrence, precipitation-rain radar images showed convective cloud embedded within the stratocumulus cloud, as well as possible light showers. Images also showed the presence of shallow towering cumulus (TCU) cloud embedded within the stratocumulus layer (Figure 2).

Figure 2. Multi-spectral satellite imagery valid at 2145 on 04 September 2019 depicting cold front (Source: Environment and Climate Change Canada, with TSB annotations)

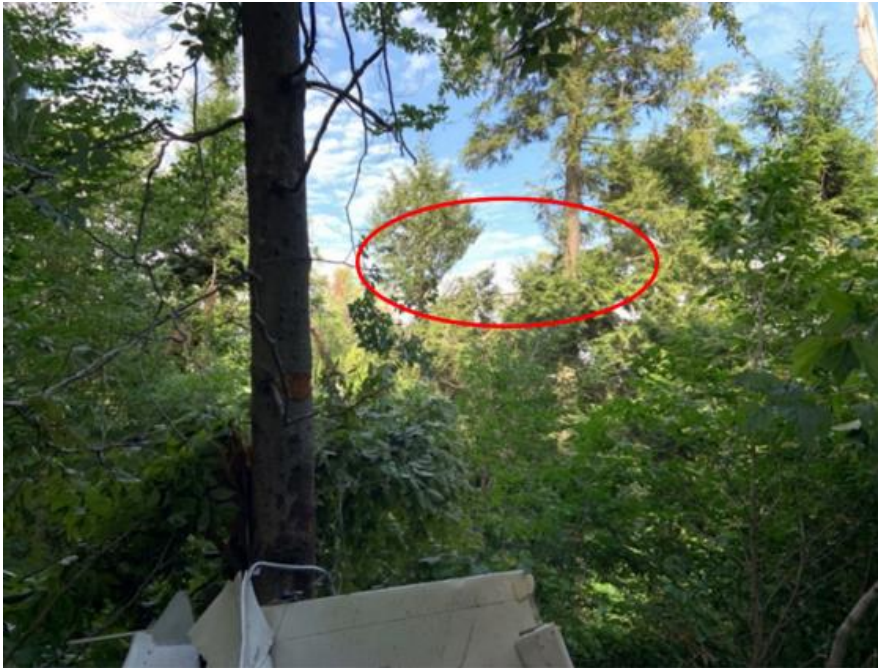
The accident site was in a heavily wooded area near Racine, Quebec. The aircraft's wings first struck 2 tall evergreen trees. Damage to the trees indicate that the aircraft was travelling at high velocity in a nose-down, banked attitude before it struck them (Figure 3).

Figure 3. Damage to trees caused by the occurrence aircraft looking back towards the direction of flight (Source: Sûreté du Québec, with TSB annotation)

After the first strike, the aircraft collided head on with a hardwood tree. The aircraft's fuselage wrapped around the tree's trunk before striking the ground, inverted, on the opposite side. All flight control surfaces were accounted for and came to rest scattered within a restricted perimeter from the point of impact, indicating that the aircraft broke up on impact and not in flight. There were no signs of pre-impact failures of material or component malfunctions.

Damage to the propeller as well as the number and proximity of the propeller marks on the tree's trunk were consistent with power being produced at the time of impact. The throttle was found to be in the full-power position.

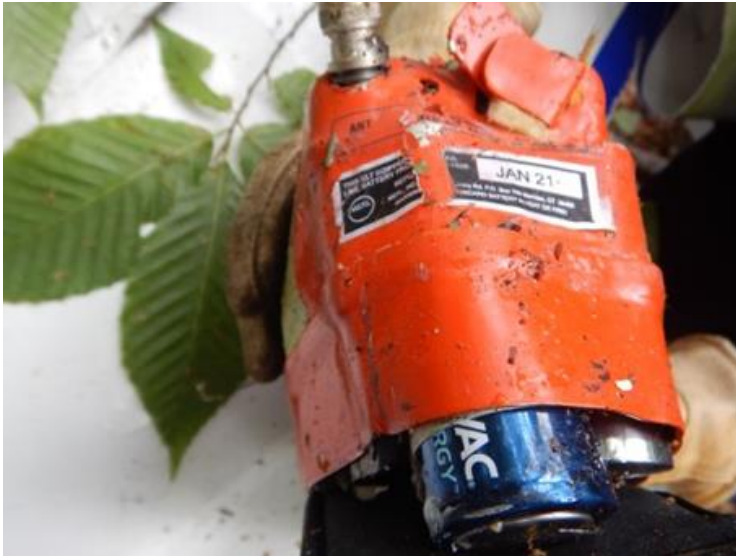
The ELT was sent to the TSB Engineering Laboratory for analysis. It was determined that the ELT was likely serviceable in the moments leading up to the impact. However, damage to the battery pack, mode selector switch, and antenna coaxial cable, individually or combined, would have immediately interrupted transmission capabilities, making detection of an ELT distress signal impossible (Figure 4).

Figure 4. Occurrence aircraft's emergency locator transmitter  
(Source: TSB)

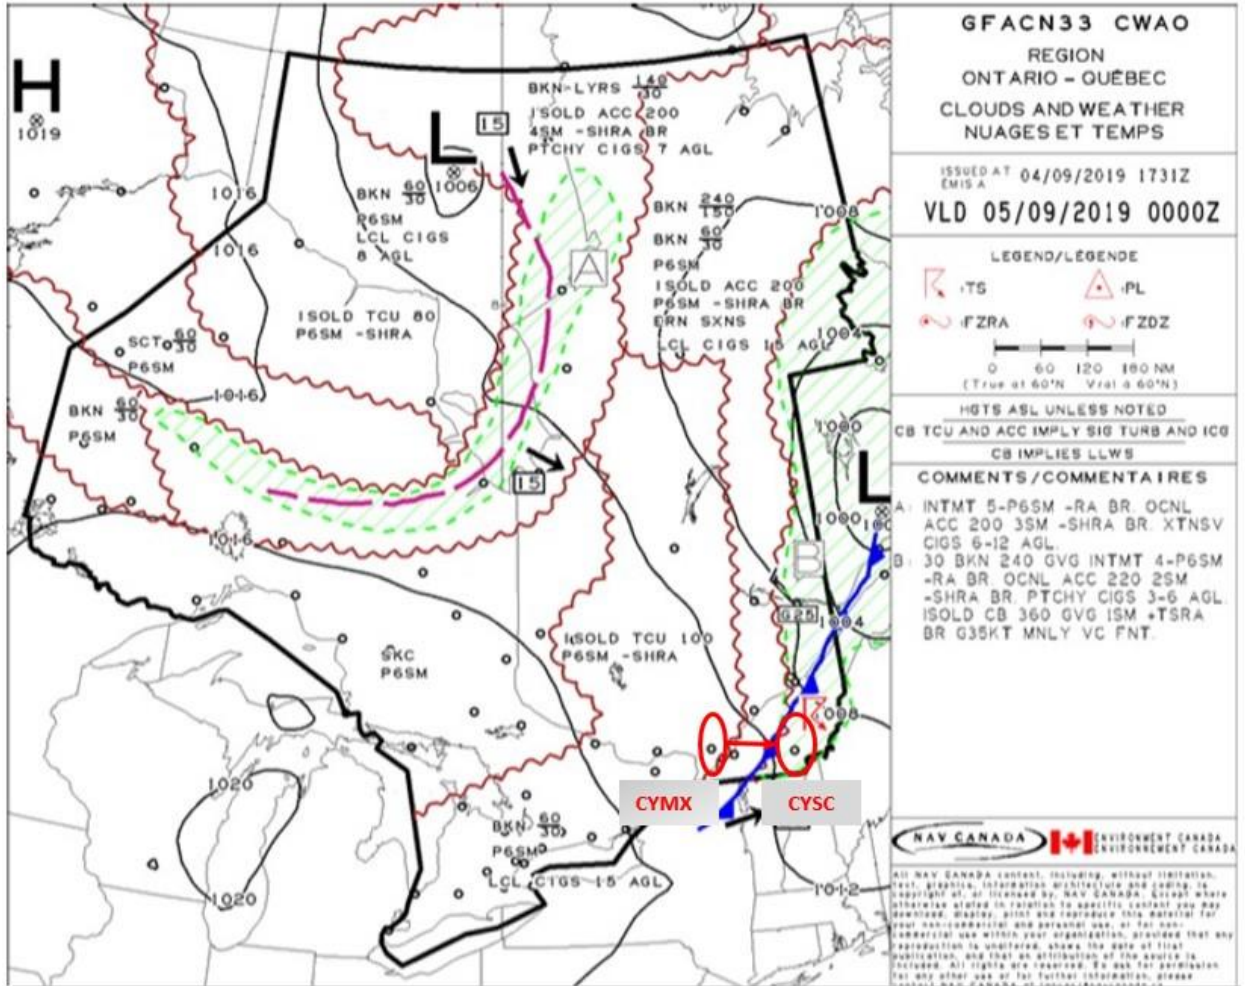
**Appendix A – Graphic Area Forecast (GFA) Clouds and Weather Chart – GFACN33 issued at 1331 Eastern Daylight Time**

Graphic area forecasts (GFAs) show the general upcoming weather conditions for a given geographic area.<sup>9</sup> On the day of the occurrence, a clouds and weather chart issued at 1331 and valid at 2000, showed a low-pressure system located near Baie-Comeau, in eastern Quebec, with a cold front extending south into the U.S., moving eastward at 20 knots. The cold front was forecast to be west of CYSC at 2000 (Appendix A).

In the vicinity of the cold front, the following conditions were expected:

- broken ceilings at 3000 feet ASL, with tops at 24 000 feet ASL;
- visibility variable between 4 and more than 6 statute miles (SM);
- light rain and mist;
- occasional altocumulus castellanus with tops at 22 000 feet, giving visibilities of 2 SM in light rain showers;
- patchy ceilings between 300 and 600 feet above ground level (AGL);
- isolated cumulonimbus clouds with tops at 36 000 feet ASL, giving visibility of 1 SM in heavy thundershowers and mist; and
- winds gusting to 35 knots.

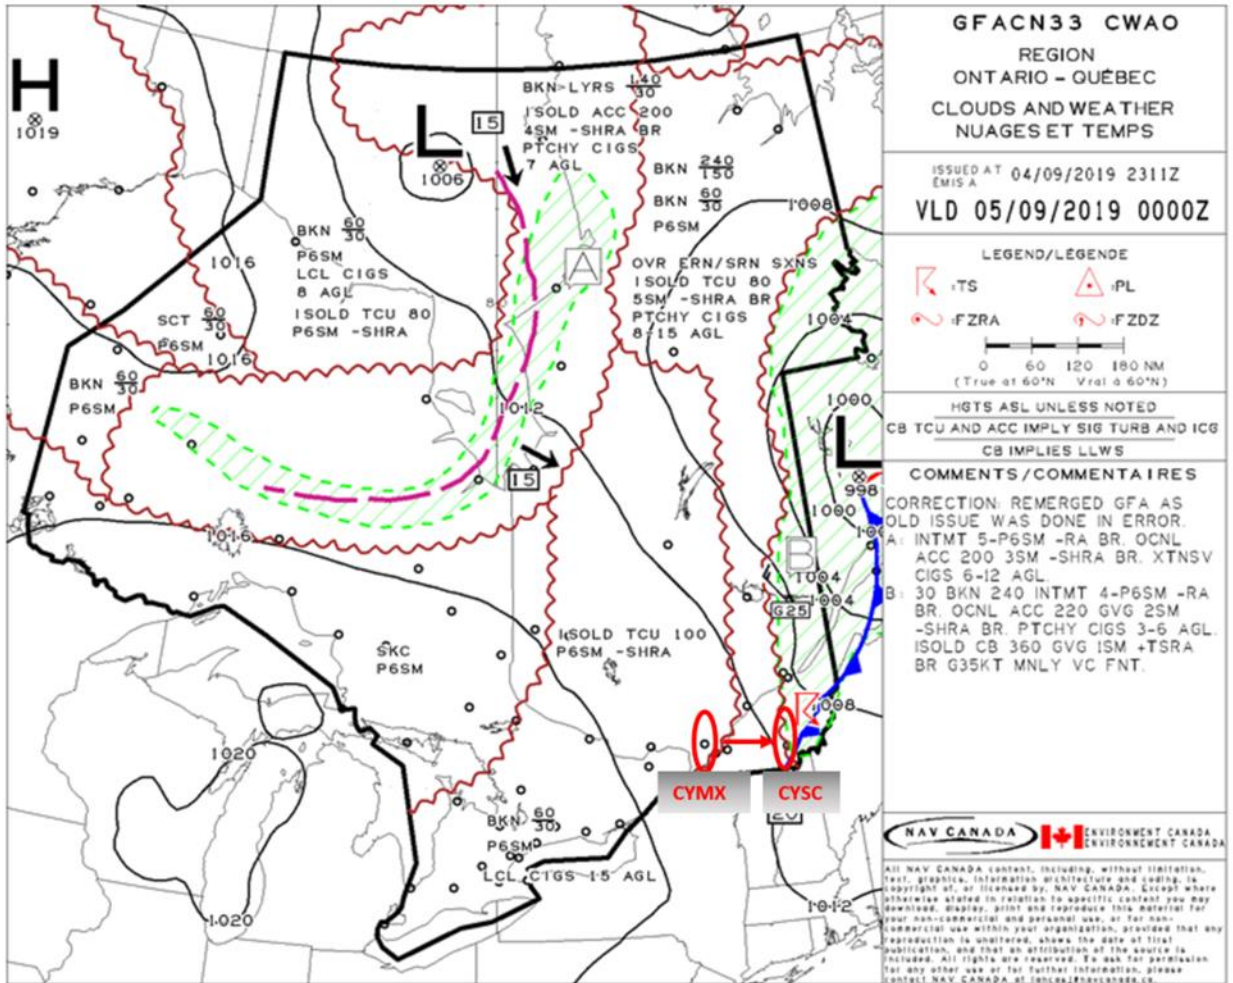
### Appendix B – Graphic Area Forecast (GFA) Clouds and Weather Chart – GFACN33 issued at 1911 Eastern Daylight Time

At 1911, a revised GFA (Appendix B) was issued with similar conditions to those depicted in the GFA issued at 1331, with the following exceptions:
