# Air Transportation Safety Investigation Report A19W0063

## LOSS OF CONTROL AND COLLISION WITH TERRAIN AFTER TAKEOFF

Privately owned  
Cessna 170B, N4512C  
Whitehorse/Erik Nielsen International Airport, Yukon  
27 May 2019

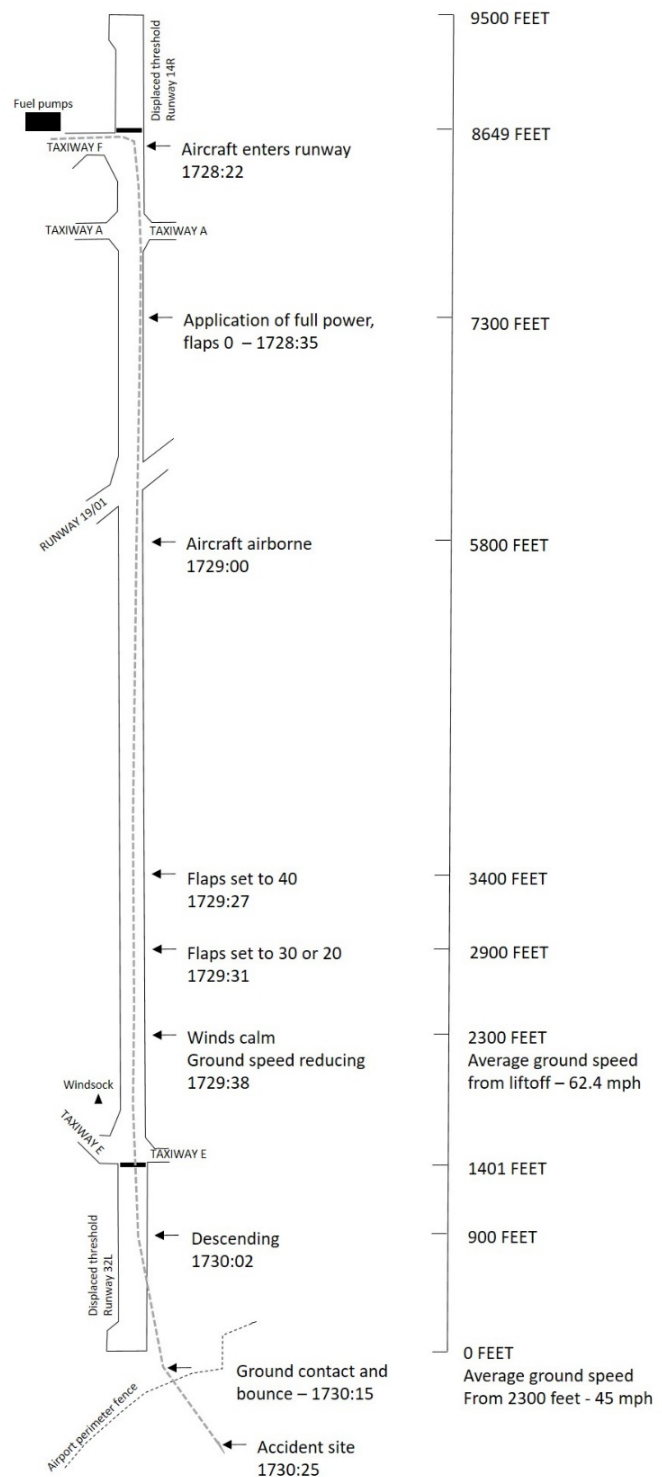
Figure 1. Diagram depicting the occurrence flight (Source: TSB)

At approximately 1720,<sup>2</sup> after the aircraft was refuelled and the flight plan was filed, the second pilot, who was the pilot flying and was seated in the left seat, taxied along Taxiway F to Runway 14R (Figure 1).

After entering Runway 14R from Taxiway F, the pilot flying taxied down the runway<sup>3</sup> and positioned the aircraft for takeoff on the very left side of the runway, approximately 2200 feet down the runway. He then steered the aircraft diagonally to the right to allow for a more into-wind take-off run.

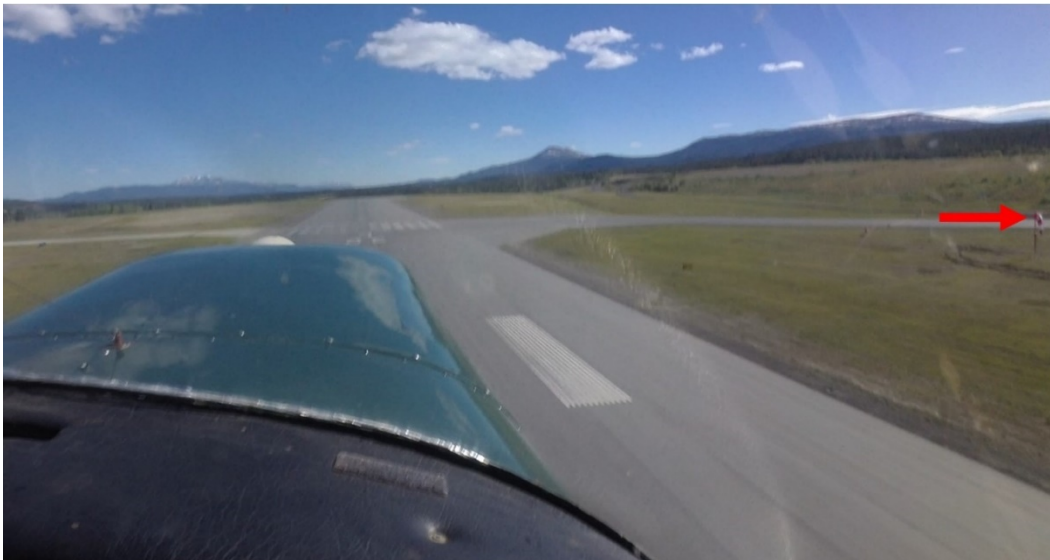
With 3400 feet of runway remaining, the pilot flying lowered the flaps from 0° to 40°. With 2900 feet of runway remaining, the pilot reduced the flap setting to either 30° or 20° where they remained; the exact setting could not be determined. With 2300 feet of runway remaining, the aircraft entered the area of calm wind as indicated by the limp windsock (Figure 2).

**Figure 2. Image capture of the takeoff (at 1729:38). The red arrow points to the windsock at the far end of Runway 14R, indicating calm winds. (Source: Video recorder installed on the aircraft involved in the occurrence, with TSB annotation)**
