AIR TRANSPORTATION SAFETY INVESTIGATION REPORT A20C0016

RUNWAY EXCURSION

Perimeter Aviation LP
Fairchild SA227-DC Metro 23, C-GJVB
Dryden Regional Airport (CYHD), Ontario
24 February 2020

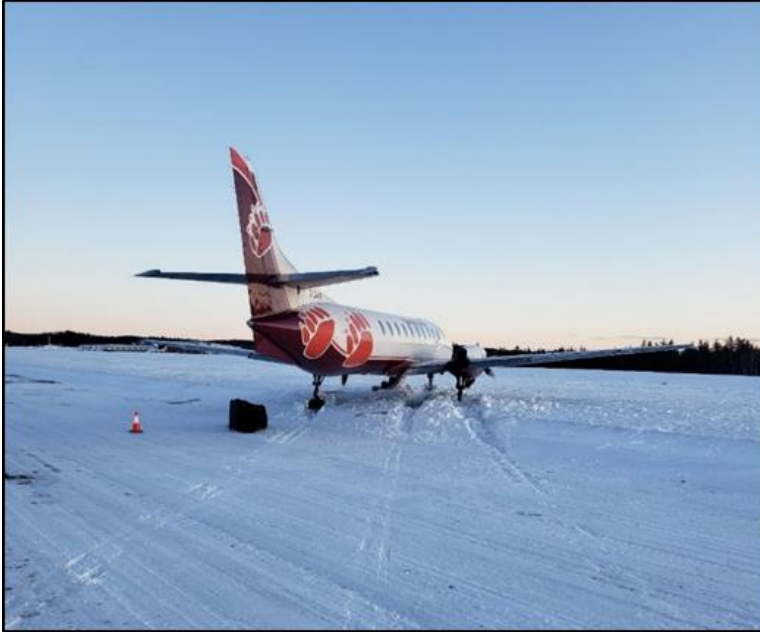
Figure 1. Occurrence aircraft after coming to a stop (Source: Ontario Provincial Police)

The aircraft was substantially damaged. One passenger sustained serious injuries to his hand from splintered wooden propeller blade pieces that penetrated the fuselage. All flight crew and passengers egressed the aircraft through the main cabin door and were met by emergency response. The emergency locator transmitter did not activate due to insufficient impact forces on the aircraft.

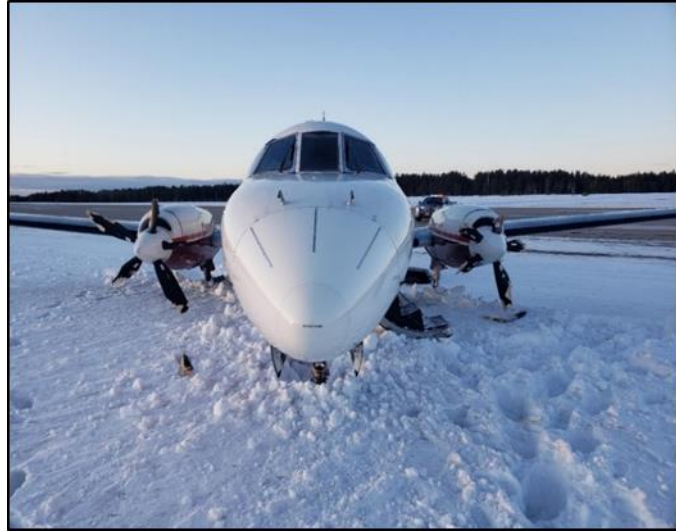
The occurrence aircraft came to a rest facing a southerly direction and was subsequently towed to a nearby hangar for further inspection by TSB investigators. The blades of both propellers were shattered, and the remaining blade roots were found at a low blade angle (Figure 2). Both engine mounts were found fractured and bent and both nacelles sustained substantial distortion. Both inboard upper wing and forward fuselage skins exhibited slight wrinkling.

Figure 2. Shattered propellers (Source: Ontario Provincial Police)

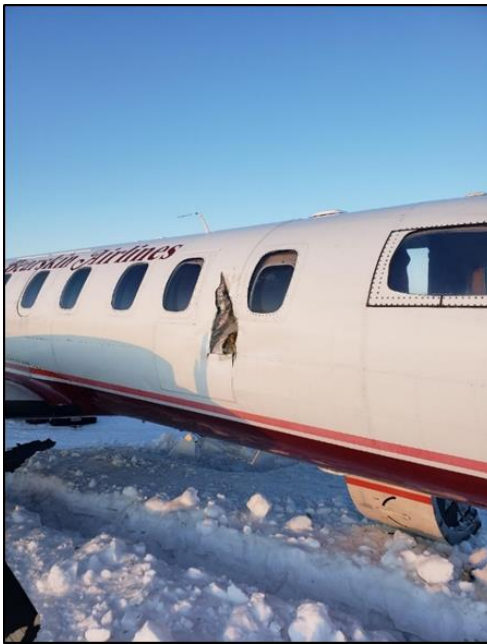
The forward fuselage area revealed complete penetration of both reinforcement panels⁶ and skins adjacent to the edge of each propeller disc (Figure 3 and Figure 4). The fuselage also sustained smaller punctures to the belly skin.

Figure 3. Right-side fuselage penetration (Source: Ontario Provincial Police)

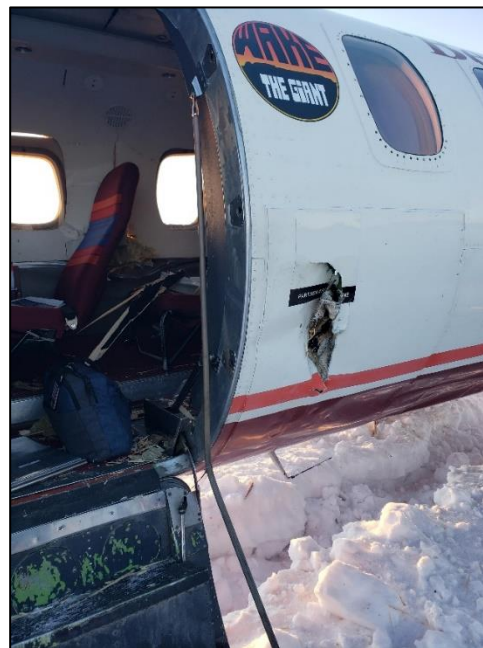
Figure 4. Left-side fuselage penetration (Source: Ontario Provincial Police)

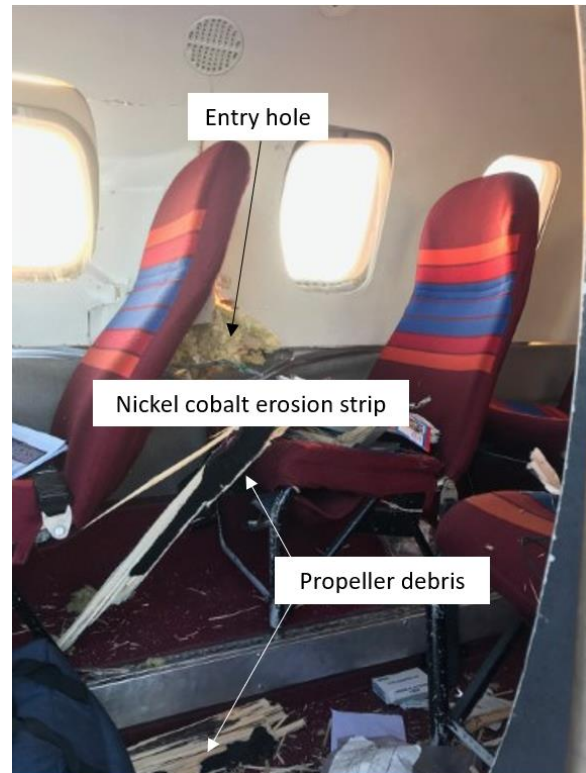
An inspection of the aircraft cabin area revealed large entry holes by the first seat in the left aisle and the second seat in the right aisle and also revealed large amounts of propeller debris and splinters (Figure 5).

Figure 5. Propeller debris in cabin (Source: Ontario Provincial Police, with TSB annotations)
