AIR TRANSPORTATION SAFETY INVESTIGATION REPORT A20C0107

RUNWAY EXCURSION

Calm Air International LP
Avions de Transport Régional ATR 42-300, C-FAFS
Naujaat Airport, Nunavut
26 November 2020

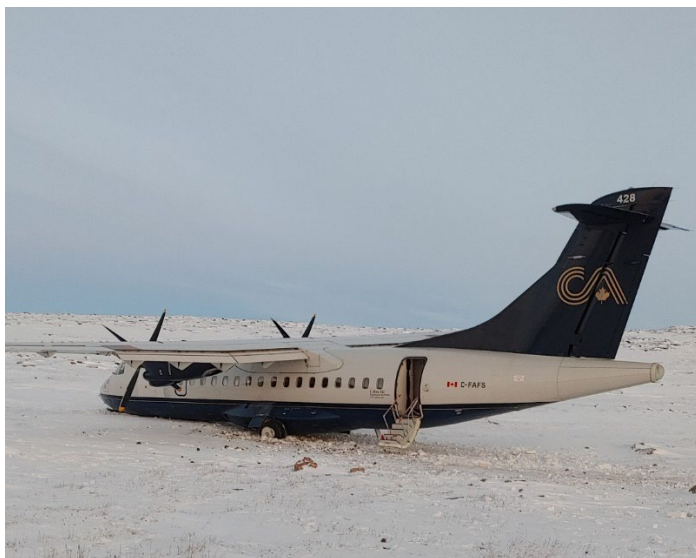
Figure 1. Wreckage site (Source: Naujaat Airport)

The captain received serious injuries and the 2 other crew members received minor injuries. The aircraft was substantially damaged (Figure 1). The emergency locator transmitter did not activate.

After the aircraft had departed the maintained surface of the runway, it travelled through a windrow of compacted snow, then crossed through a shallow ditch and continued over rough terrain. During the runway excursion, the aircraft sustained damage to the forward fuselage belly area. Additionally, the nose gear collapsed, both main landing gear assemblies were damaged, and the left main landing gear was almost completely severed from its attachment points.

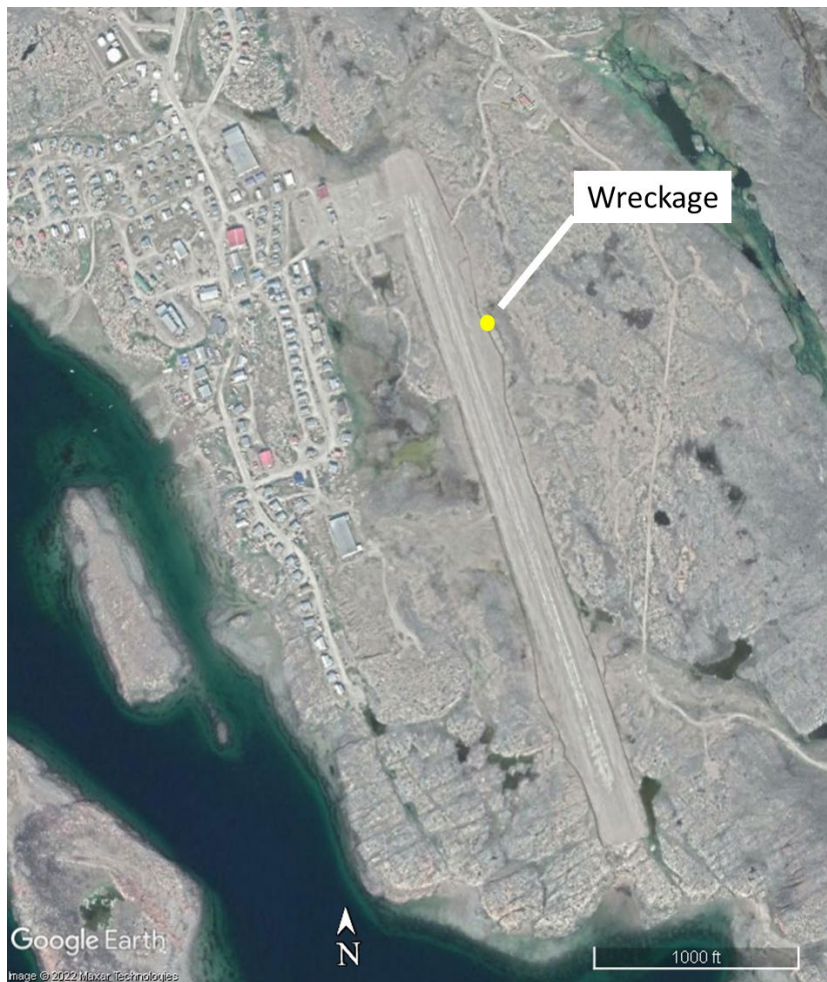
The aircraft came to rest approximately 2500 feet from the threshold of Runway 34 on the unprepared adjacent area to the east (Figure 5). Its location was approximately 108 feet east of the runway edge.

Figure 5. Location of wreckage (Source: Google Earth, with TSB annotations)

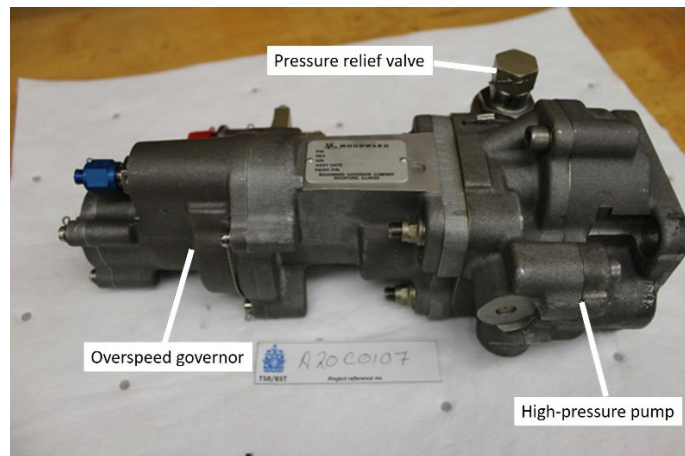
A tear-down inspection of the left PCU revealed that it did not meet certification criteria and was slow to function at normal operating temperatures. More detailed component testing of the propeller's high-pressure oil pump (Figure 6) revealed that the pump's pressure relief valve had failed and was not allowing adequate oil pressure to build up in the system.

Figure 6. Overspeed governor and high-pressure pump assembly (Source: TSB)

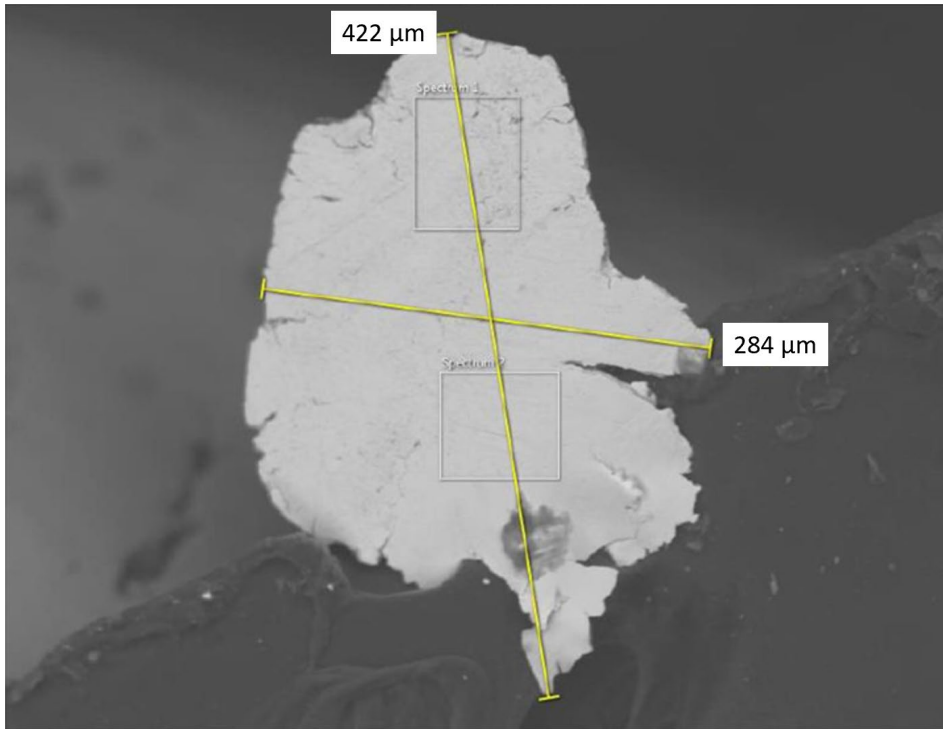
A metal fragment composed of a low-grade iron substance (Figure 7) was discovered stuck to the sealing surface of the pump's pressure relief valve (Figure 8), which prevented the pressure relief valve from sealing. The origin of the metal fragment could not be determined; however, the composition of the metal contaminant was not consistent with any parts tested. Given the size of the metal fragment, it should have been trapped by the engine oil filter.

Figure 7. The metal fragment, retrieved from the sealing surface, was composed of a low-grade iron substance not common to the parts tested (Source: AeroControlex Group, Inc, with TSB annotations)

Metal contamination from an undetermined source was found in the high-pressure pump's pressure relief valve and was preventing the valve from sealing. The impeded seal decreased the pressure output from the high-pressure pump, and decreased the ability of the PCU to control the propeller pitch.

A contaminant inside the left propeller's high-pressure pump caused its pressure relief valve to fail. As a result, the propeller entered a pitch-lock condition and remained in that condition until the aircraft landed.

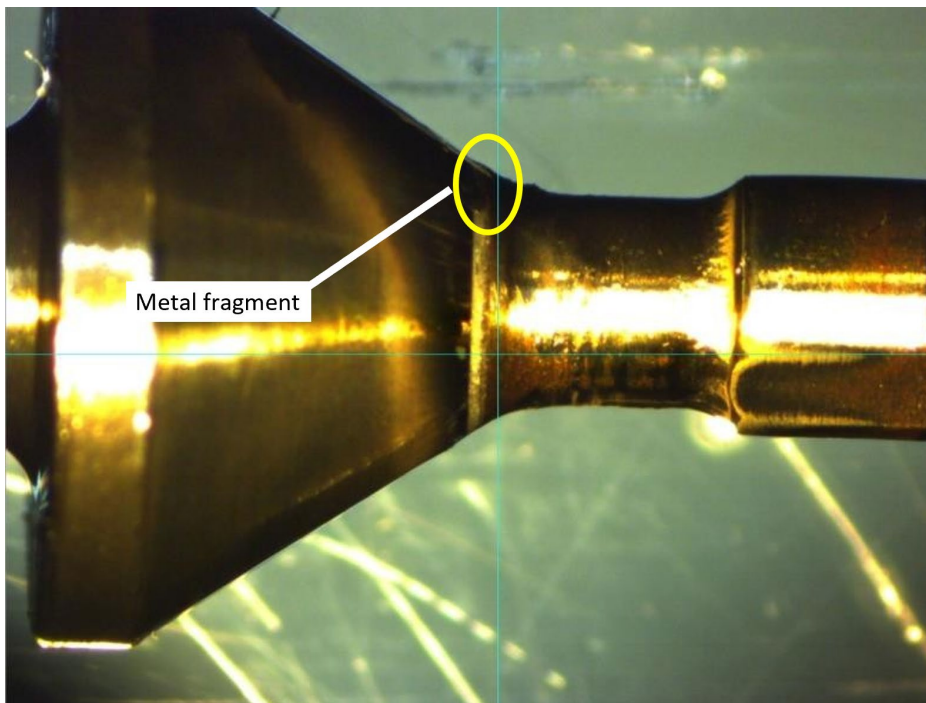
Figure 8. Location of the metal fragment on the sealing surface on the high-pressure valve (Source: AeroControlex Group, Inc, with TSB annotations)
