AIR TRANSPORTATION SAFETY INVESTIGATION REPORT A21Q0138

RIGHT MAIN LANDING GEAR FAILURE ON LANDING

Air Canada

Airbus A330-343, C-GFAF

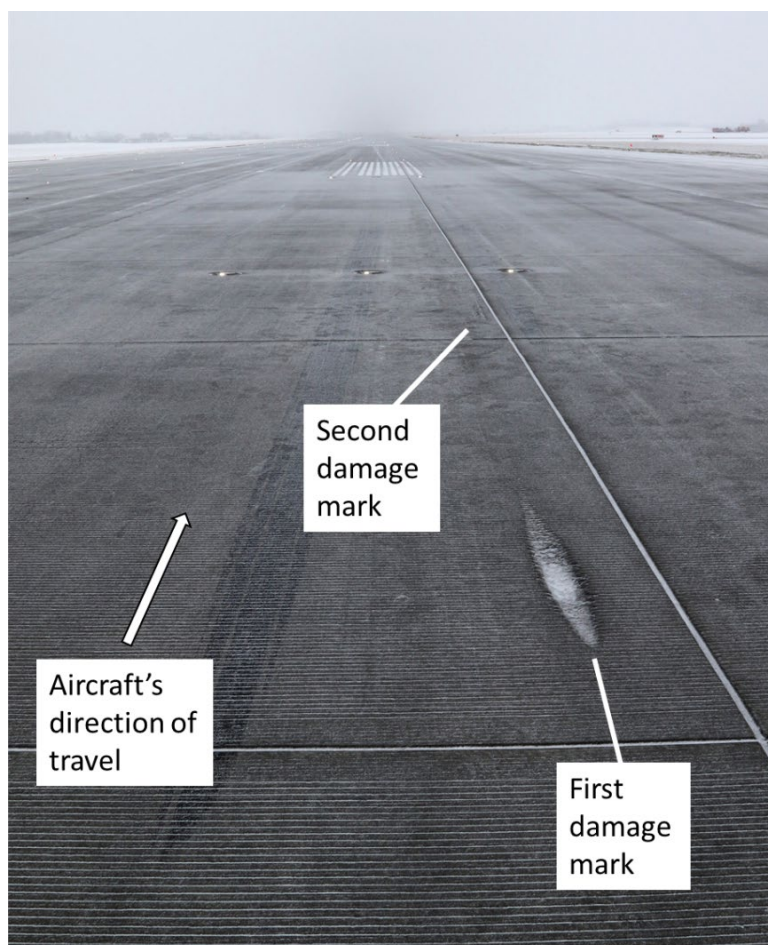
The concrete surface of Runway 06L was slightly damaged. When the bogie beam failed, the landing gear shock strut collapsed onto the surface of the runway. The shock strut's initial point of contact with the runway damaged the concrete surface over a length of 1.7 m and a maximum depth of 5 cm. The second damage mark, which was 1.8 m long, was superficial (Figure 1).

Figure 1. Damage marks on the runway (Source: TSB)

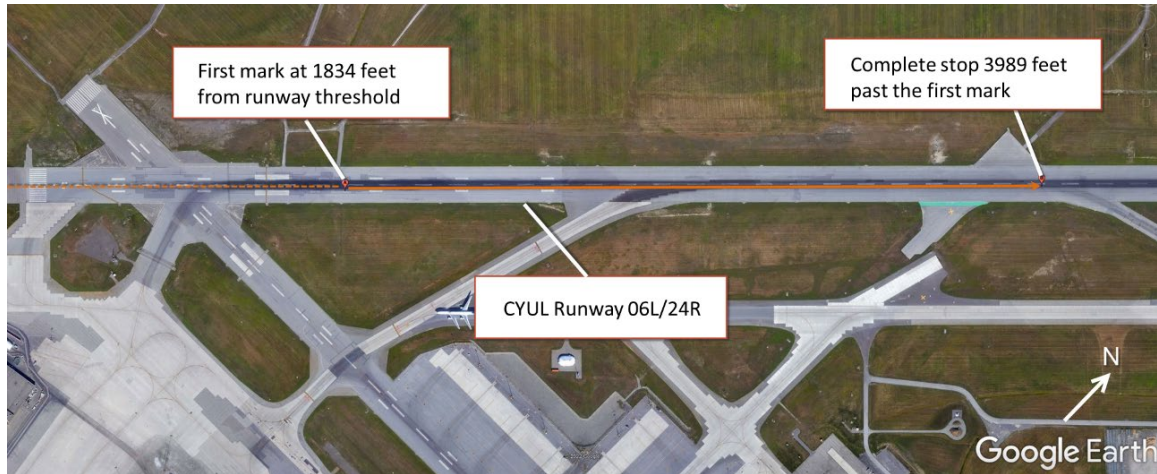
According to the damage observed on the runway by TSB laboratory personnel who examined the runway, the landing gear failure occurred 1834 feet beyond the runway threshold. Various parts of the right main landing gear broke off and were found between the failure location where the first damage mark was left on the runway and the location where the aircraft came to rest, which was 3989 feet further (Figure 5).

Figure 5. Aerial view of the relevant portion of Runway 06L indicating the distance travelled by the aircraft between the first damage mark and the stopping point (Source: Google Earth, with TSB annotations)

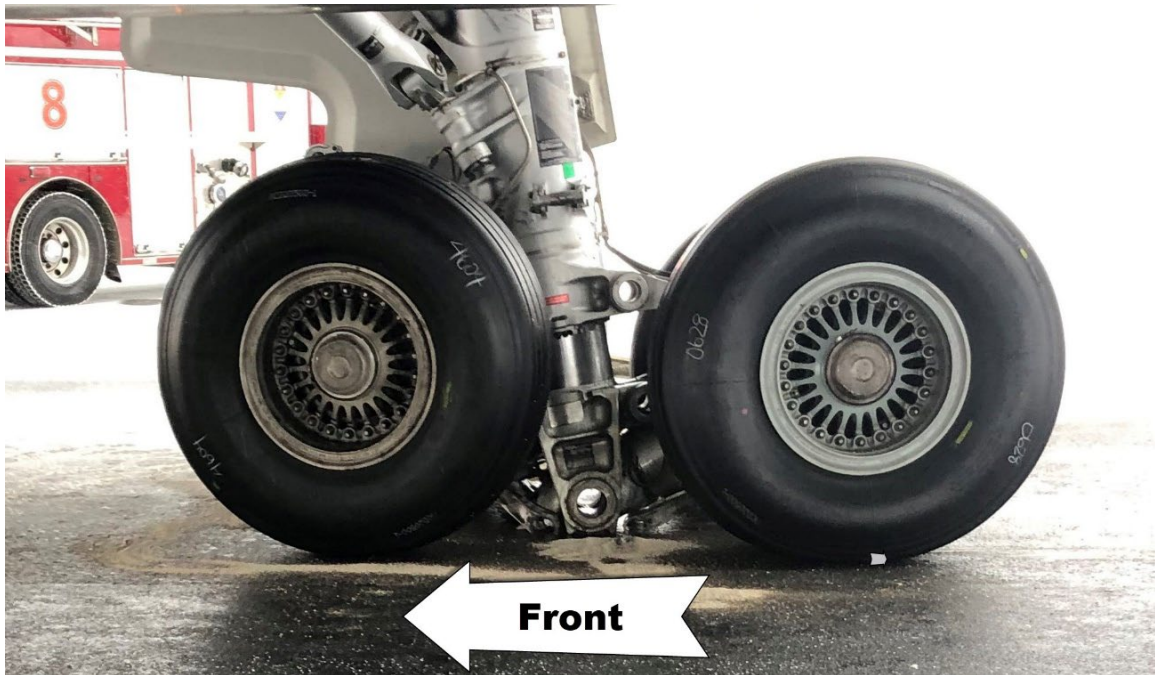
The bogie beam was broken in front of the shock strut hinge. The forward part, including the axle for the No. 3 and No. 4 wheels, was separated completely, and was only held in place by various hydraulic lines, electrical harnesses, and the pitch trimmer system arm. The tire on the No. 8 wheel had been perforated by debris produced by the fracturing of the beam. The lower part of the landing gear strut was abraded up to the hinge. The attachment points of the brake anti-rotation rods were abraded completely, and the rods were no longer being held to the strut (figures 6 and 7).

Figure 6. View of the damaged right main landing gear, looking outboard (Source: ADM aircraft rescue and firefighting services, with TSB annotations)

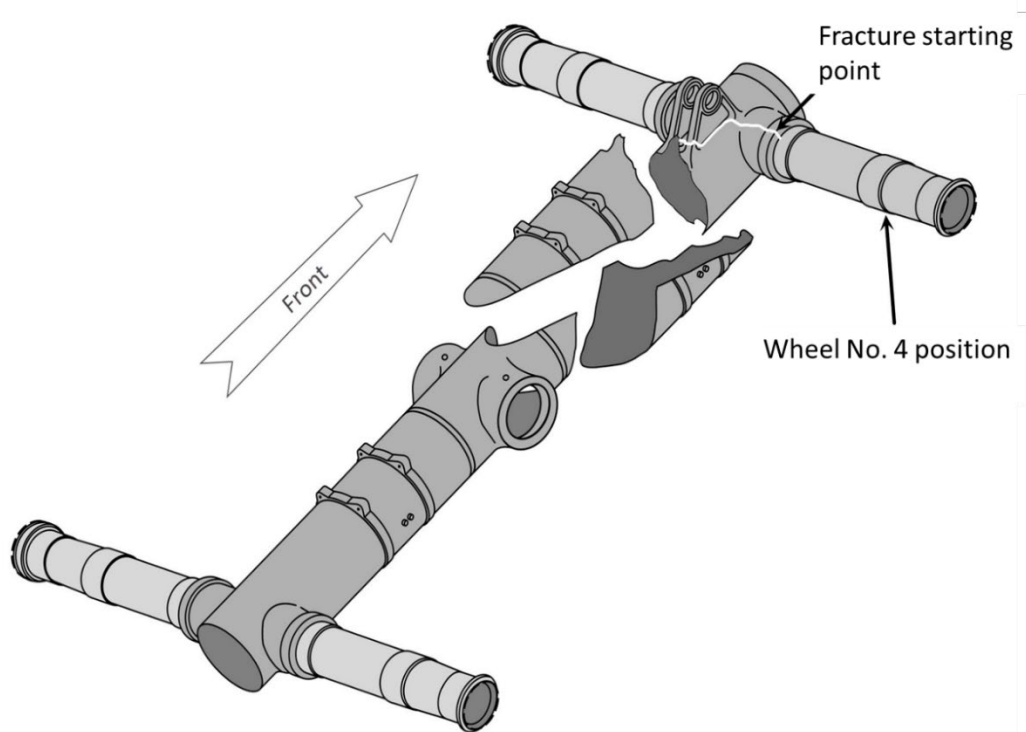
The preliminary examination of the fracture surfaces drew the investigators' attention to the area of the front right bore, where the aluminum-bronze bushing was installed near the No. 4 wheel. The fracture surface at this location (Figure 8) had a different texture than the other fractures over approximately 1 cm².

Figure 8. Diagram of the main fragments from the bogie beam (Source: TSB)

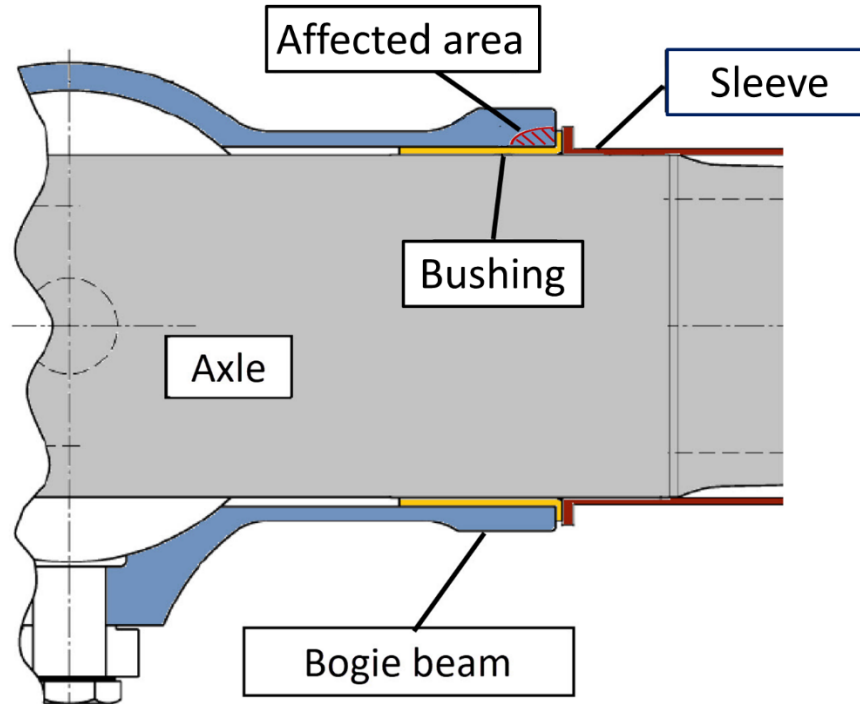
A closer examination was carried out with a binocular microscope, using approximately 10X magnification. An incipient secondary crack was discovered near the main fracture, as well

as discoloration and cadmium clusters on the chamfer, indicating that the cadmium had reached its melting point¹⁹ after an overheating, and had then resolidified (Figure 9).

Figure 9. Cross-sectional view of the assembly showing the area affected by heat
(Source: Safran, with TSB annotations)

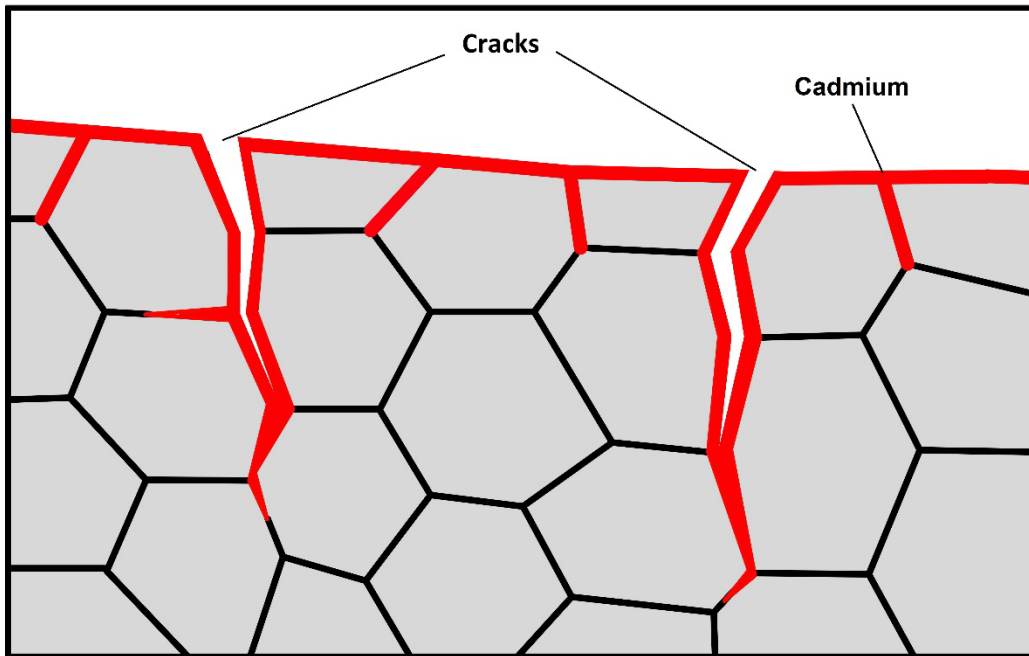
On the occurrence bogie beam, the presence of cadmium within the base metal granular structure was identified using a scanning electron microscope. The temperature reached by the beam's base metal allowed the cadmium protective layer to liquify (melt) and spread between the grains of 300M steel by capillary action, making the steel fragile and resulting in the formation of 2 cracks (Figure 10).

Figure 10. Diagram illustrating the spread of molten cadmium (bold line) between the grains of steel and the formation of cracks (Source: TSB)

One of these cracks was the cause of the complete fracturing of the bogie beam. Cadmium was also discovered in the cracks, indicating that the cracks formed when the cadmium was still in a liquid state.

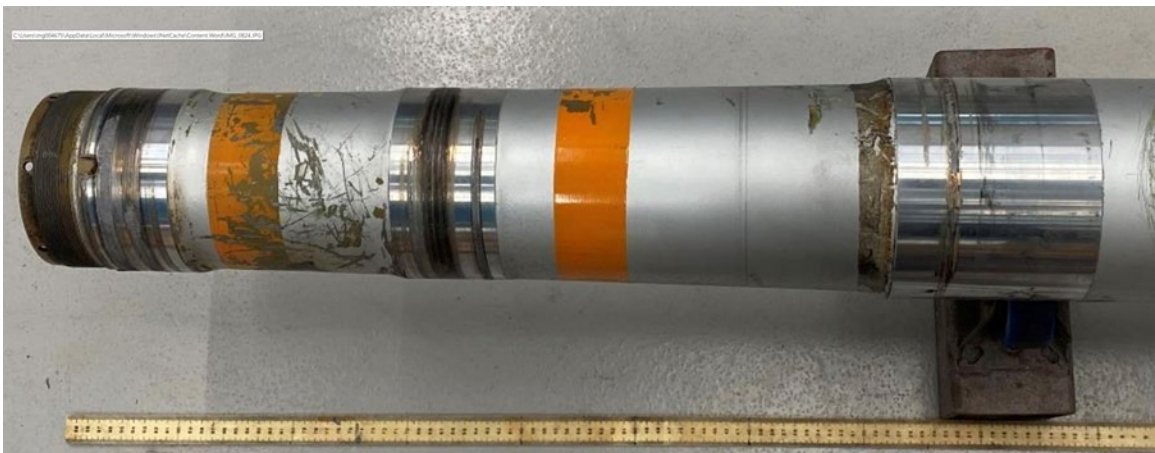
The axle that was removed and replaced following the incident on 17 December was examined. Signs of overheating were observed in several spots on the No. 4 wheel side, not only in the form of discoloration of protective layers, but also in the form of molten metal transferred from the protective sleeve (figures 11 and 12).

Figure 11. The No. 4 wheel axle damaged during the incident on 17 December (Source: Safran)

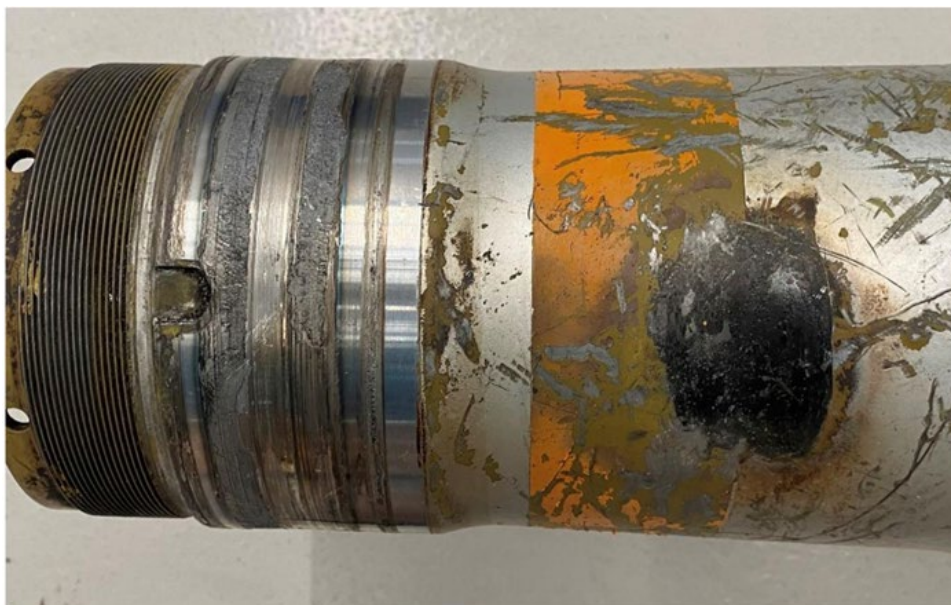
Figure 12. Friction marks on the No. 4 wheel axle damaged during the incident on 17 December (Source: Safran)
