# AIR TRANSPORTATION SAFETY INVESTIGATION REPORT A21W0090

## **LOSS OF CONTROL DURING LANDING**

Privately registered  
Daher TBM700 N (TBM 910), C-FFYM  
Westlock Aerodrome, Alberta  
10 October 2021

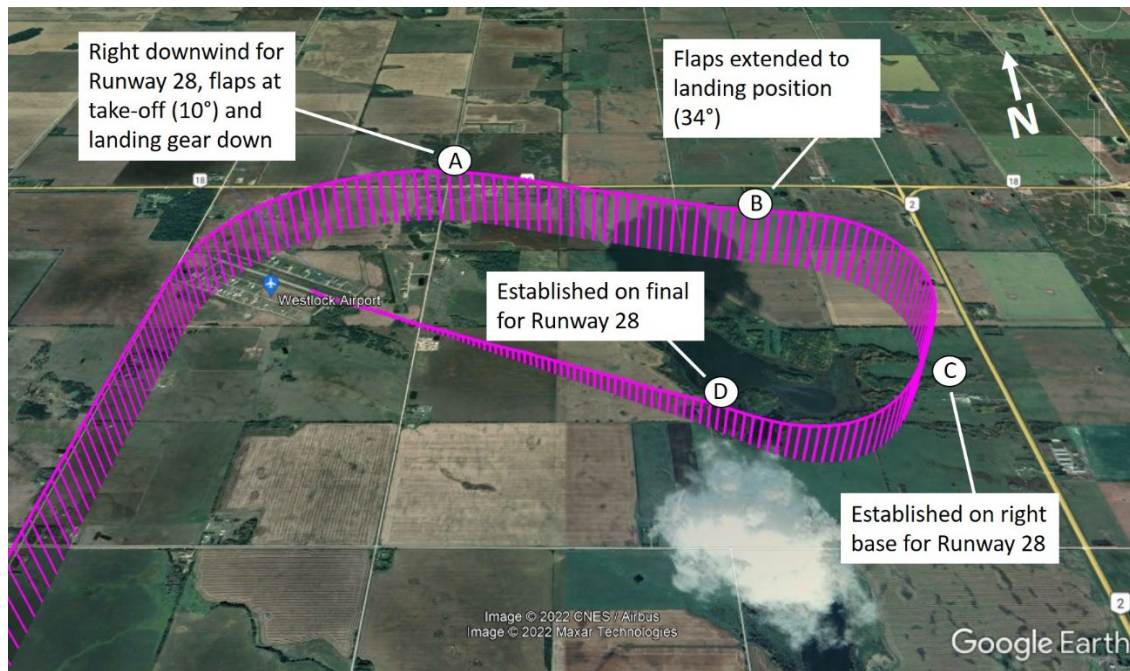
The aircraft approached CES4 from the south (Figure 1), and at 1059:40, it crossed over the aerodrome mid-field at approximately 1250 feet above ground level (AGL)<sup>3</sup> and 126 knots indicated airspeed (KIAS), configured with the landing gear extended and the flaps set to the take-off position (10°).<sup>4</sup> The aircraft then banked right to join the mid-right downwind leg.

Figure 1. Image showing the occurrence approach to Westlock Aerodrome; the circled letters correspond to those in Figure 2 (Source: Google Earth, with TSB annotations)

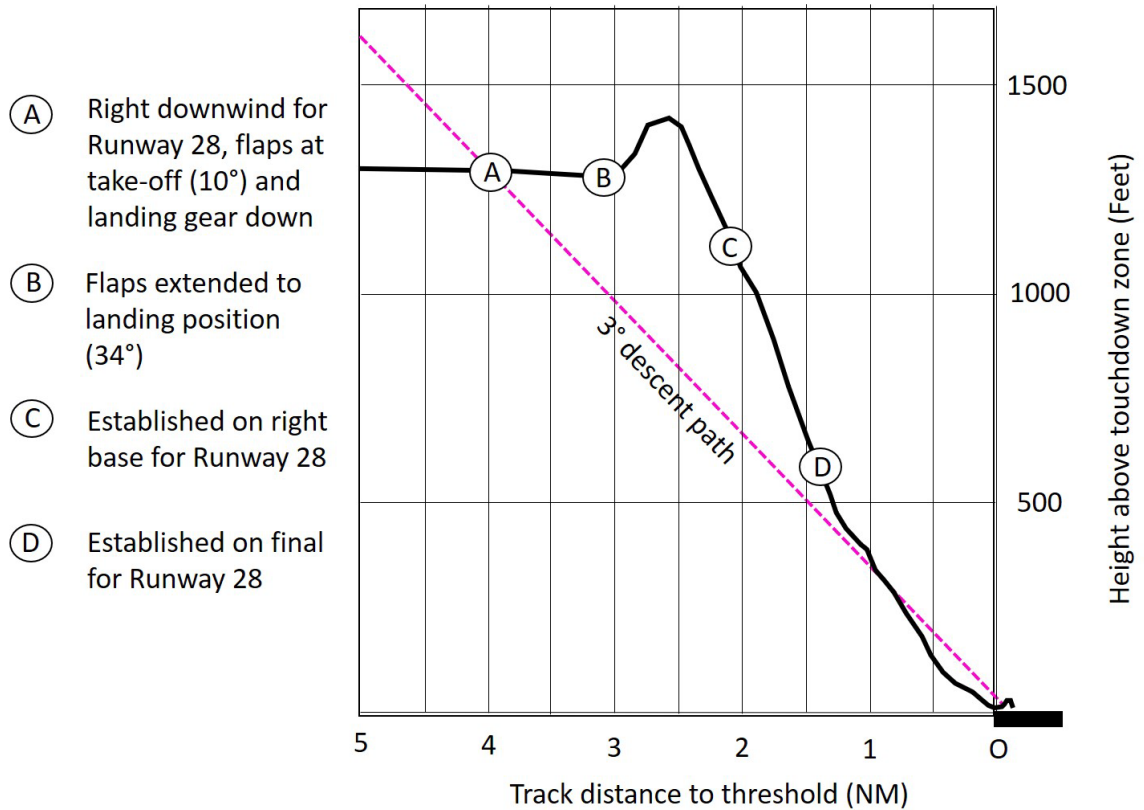
As the aircraft turned right to join the base leg, the flaps were lowered to the landing position (34°,<sup>5</sup> the full-flap setting), and the aircraft climbed to 1400 feet AGL (Figure 2). On the base leg, the aircraft was travelling at 104 KIAS, with a torque setting of 36%, and a rate of descent of 1200 fpm.

Figure 2. Graph showing the aircraft's descent path, from data obtained from the flight data recorder (Source: TSB)

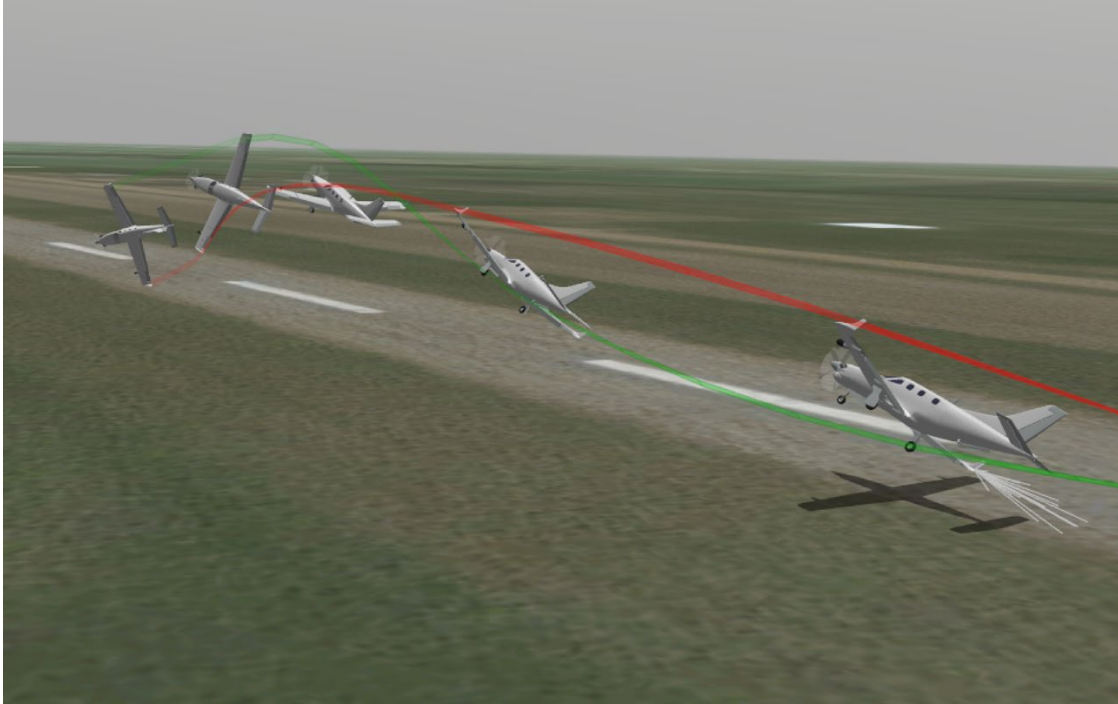
After the right wing tip had contacted the runway, the roll reversed and was increasing through 5° left bank as the aircraft approached the centreline and began to pitch up to 24°. The aircraft climbed 28 feet, and the stall warning system activated again with repetitive stall warnings. The aircraft continued to roll left and began to descend, whereupon the left wing contacted the runway surface and fractured. The aircraft continued to roll, and, at 1102:34, it struck the ground inverted, slid off the south side of Runway 28, and came to rest in the grass approximately 50 feet from the runway's south edge.

Figure 3. Still frames from an animated reconstruction of the occurrence based on flight path data (Source: TSB)

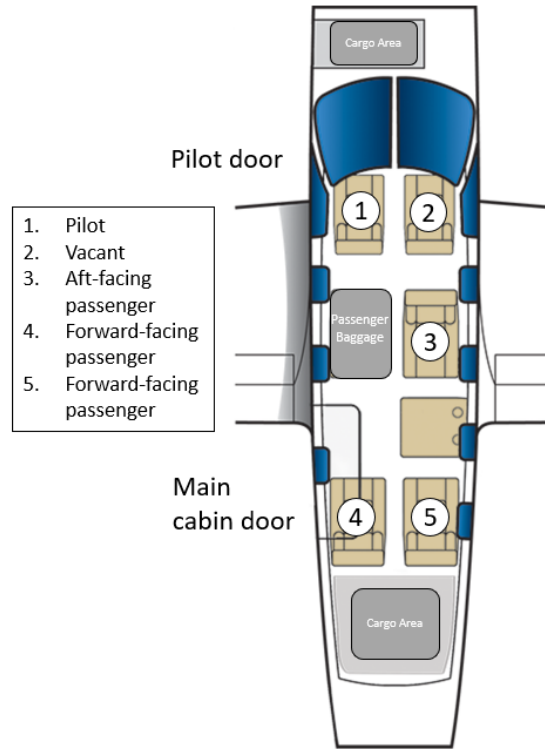
The occurrence aircraft passenger cabin was configured with 3 seats.<sup>10</sup> This seating configuration consisted of 2 individual, forward-facing seats at the rear of the cabin and a mid-cabin rear-facing passenger seat located behind the right cockpit seat. The 4<sup>th</sup> seat, a rear-facing seat located behind the left cockpit seat, had been removed to accommodate a pet travel kennel and passenger baggage. All cabin seats are mounted on the same rails as the cockpit seats.

Figure 4. Cabin configuration and seat occupancy of occurrence aircraft (Source: TBM\_6\_seats by Larre-anthony, [https://commons.wikimedia.org/wiki/File:TBM\\_6\\_seats.png](https://commons.wikimedia.org/wiki/File:TBM_6_seats.png), licensed under CC BY 3.0, with TSB annotations)

During the impact sequence, loose items in the cabin tumbled about the cabin and accelerated forward as the aircraft rolled inverted, struck the ground, and slid off the runway. The rear-facing forward seated passenger was injured by the loose items, which were not properly secured. The passenger also received injuries when she struck the cabin bulkhead because she was not restrained by her shoulder harness.

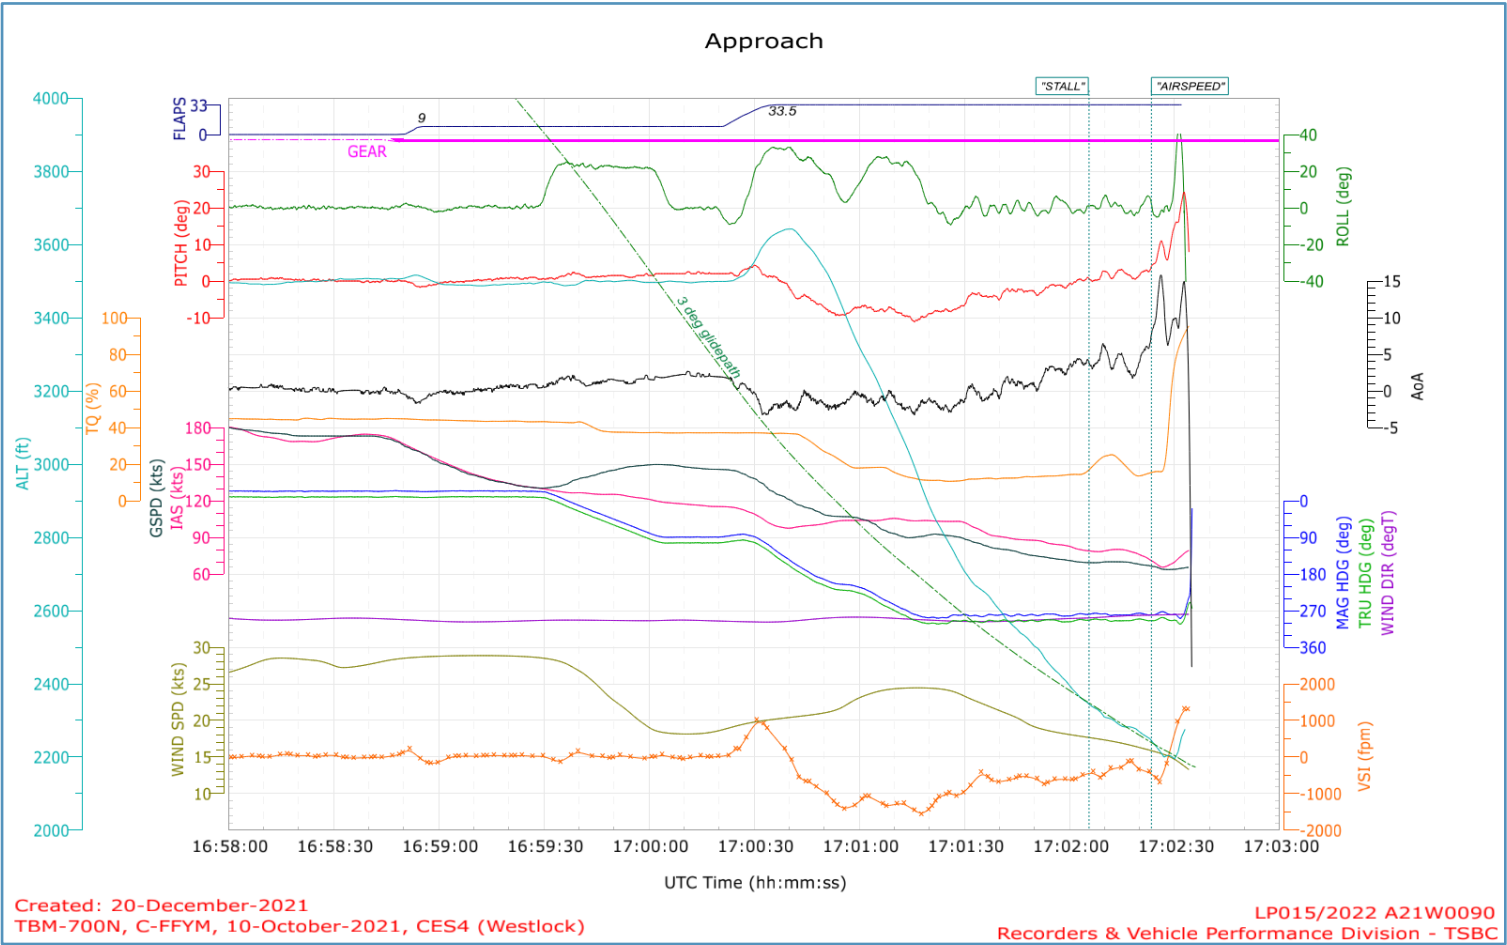
## Appendix A – Approach flight data plot

At 1101:20, the pilot rolled out of the right turn and entered the final approach on the extended centreline of Runway 28. The aircraft was 1.4 nautical miles (NM) from the threshold of Runway 28, at a height of 631 feet above the landing elevation. At this point, a descent path of 3.9° would have been required to cross the threshold at 50 feet AGL; this was significantly steeper than an optimal or typical descent path of 3°.<sup>6</sup> The aircraft's indicated airspeed was 104 knots, and the pitch attitude was 9° nose down. The descent rate was 1500 fpm, and the engine power was set to 11% torque (Appendix A).
