AIR TRANSPORTATION SAFETY INVESTIGATION REPORT A23P0039

COLLISION WITH VEHICLE AND TERRAIN

Privately registered
Cessna 182P, C-GIDY
Langley Regional Airport, British Columbia
02 May 2023

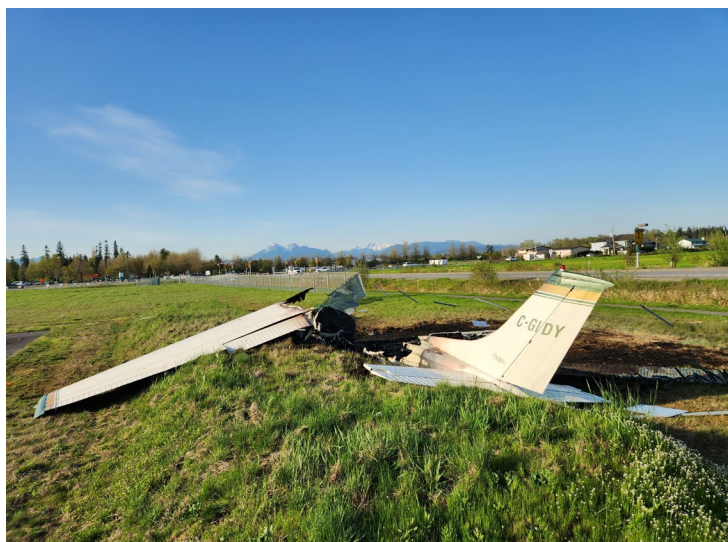
Based on video and photographic evidence of the accident, as well as examination of the site, the aircraft was aligned with the runway centreline before it struck the pickup truck. After the impact with the truck and the airport perimeter fence, the aircraft pivoted 90° to the right and impacted the berm. It was destroyed in the post-impact fire (Figure 2). All major components of the aircraft were accounted for at the accident site.

Figure 2. Occurrence aircraft wreckage after the post-impact fire (Source: TSB)

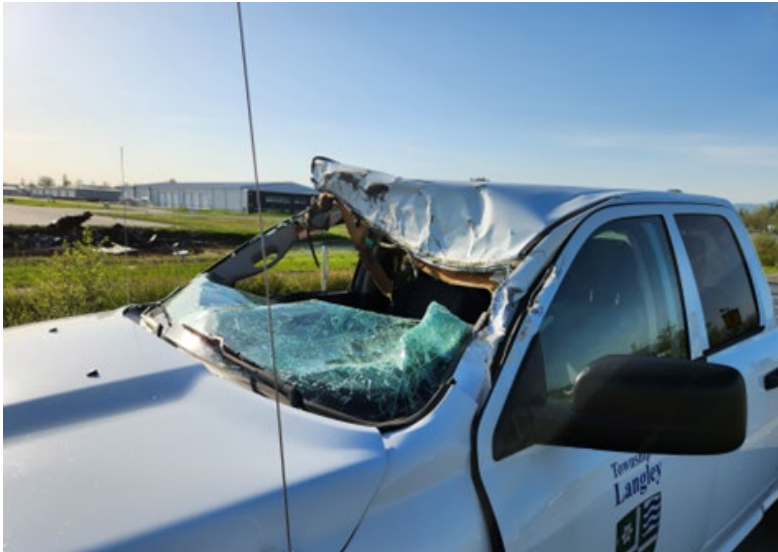
There was significant damage to the pickup truck (Figure 3), the airport fence, and the surrounding grassy area, adjacent to the runway.

Figure 3. Pickup truck damaged by the occurrence aircraft (Source: TSB)
