AVIATION OCCURRENCE REPORT

CONTROLLED FLIGHT INTO TERRAIN

**PREFERRED FLIGHTS INC.
PIPER PA31-350 NAVAJO CHIEFTAIN C-GNPG
BATHURST, NEW BRUNSWICK
04 JANUARY 1994**

REPORT NUMBER A94A0003

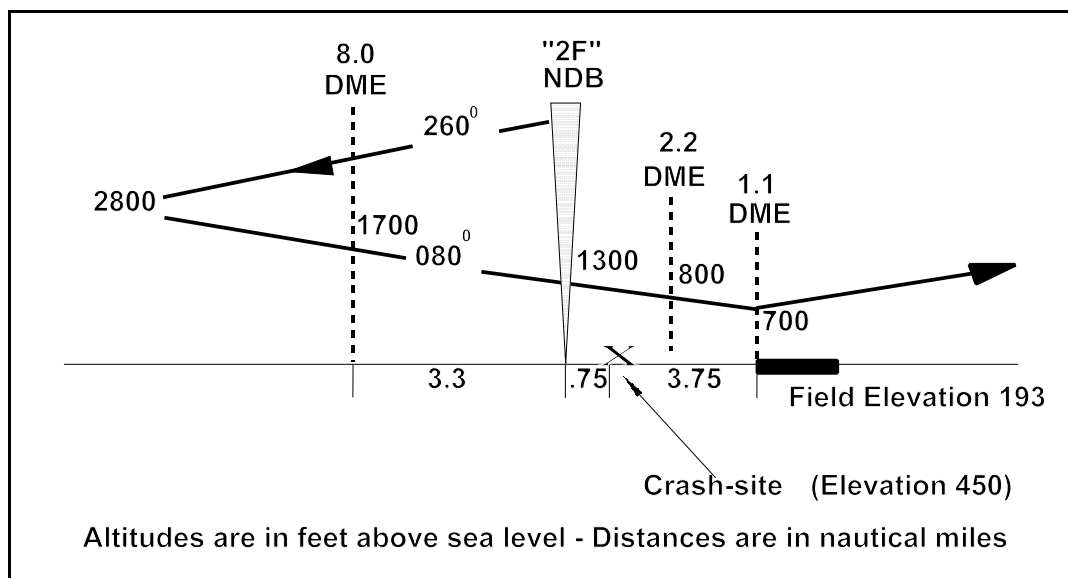
Figure 1 - Approach Profile

During the non-precision instrument approach to runway 10, the aircraft struck trees .75 nautical miles (nm)³ inside the Bathurst beacon and 3.75 nm from the airport.

conducting the NDB/DME runway 10 approach would cross the Bathurst beacon 4.5 nm from the airport, at an altitude of 1,300 feet asl and on a heading of 080 degrees magnetic, and begin a final descent to the minimum descent altitude (MDA) of 700 feet asl. Figure 1 shows the appropriate altitudes, the normal approach profile, and location of the accident site.
