### LOSS OF ALTITUDE CONTROL DURING CIRCLING APPROACH

MILLAR WESTERN INDUSTRIES LIMITED  
IAI 1124A, WESTWIND II C-FMWW  
MEADOW LAKE, SASKATCHEWAN  
27 JANUARY 1994

REPORT NUMBER A94C0014

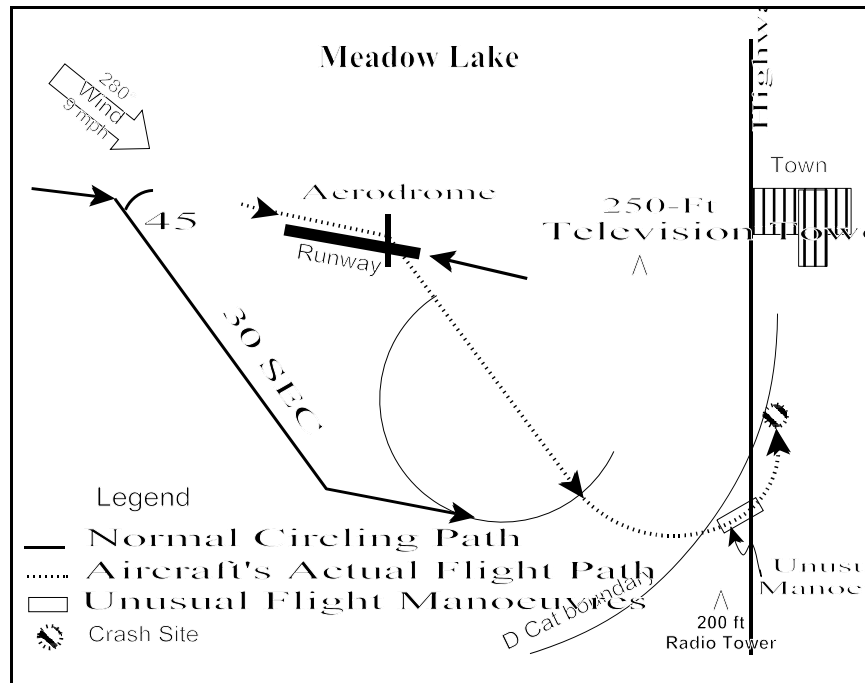
**Figure 2 -  
Circling Approach**

The circling approach procedure that the crew had practiced during the latest simulator training session is similar to the one depicted by the solid flight-path-line in figure 2. That procedure is consistent with standard circling procedures depicted in the AIP and the Transport Canada *Instrument Flight Procedures Manual* (TP 2076E). However, on the day of the accident, the aircraft began the circling procedure overhead the aerodrome and followed the flight path indicated by the dotted line on figure 2. That flight path took the aircraft outside the category D obstacle clearance area and into the vicinity of the 200-foot high radio tower. The abrupt rolling manoeuvres that were observed by ground witnesses occurred as the aircraft was approaching

the northbound highway which leads into the town of Meadow Lake. These witness accounts indicate that the event was of short duration and involved several steep-banked attitudes in both directions. Based on one witness's description of the aircraft's nose movement to the left while it was established in a steep right-banked attitude, it is possible that the aircraft was also subjected to a negative g force.
