AVIATION OCCURRENCE REPORT

CONTROLLED FLIGHT INTO OBSTACLE AND TERRAIN

**KEEWATIN AIR LIMITED
SWEARINGEN MERLIN II C-FFYC
THOMPSON, MANITOBA
01 JUNE 1994**

REPORT NUMBER A94C0088

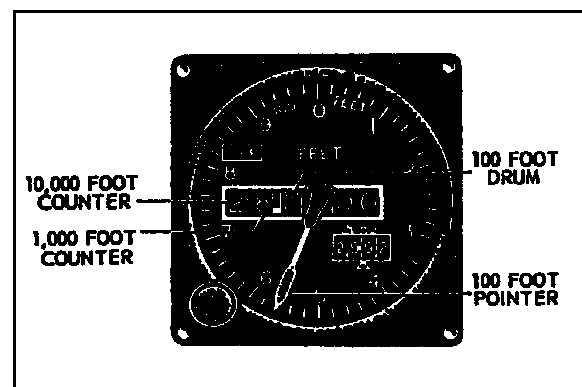
Figure 1
Counter-Drum/Pointer

The altimeter installed on the left side of the instrument panel employs a combination counter-drum/pointer display of the general type shown in Figure 1. Essential altitude information is presented to the pilot as a digital display, through the combined readings of the counters and the drum. A needle-

shaped pointer, which is geared to the inner drum, rotates around a central pivot point on the circular dial and indicates an altitude change of 1,000 feet for each revolution. This pointer acts as a vernier for the hundreds drum, and also provides altitude trend information.

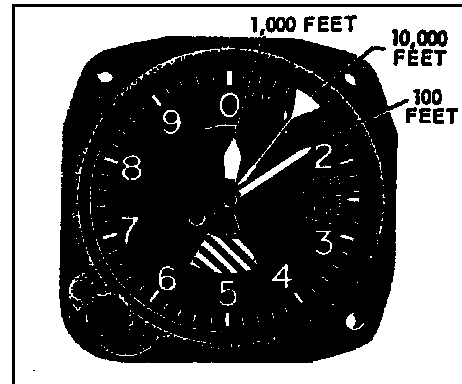
Figure 2
Three-Needle Display

The altimeter installed on the right side of the instrument panel uses an older style three-needle display similar in design to the altimeter mounted in the company's Piper Navajo aircraft, as shown in Figure 2. Essential altitude information is presented to the pilot by use of three separate needle-shaped pointers which sweep a graduated circular scale and give the following information:

- a. a long thin pointer with an inverted triangle at the outer end displays tens of thousands of feet;
- b. a short, broad pointer displays thousands of feet; and,
- c. a long, medium pointer displays hundreds and lesser units of feet.

No direct information is available to determine the PNF's activities during this portion of the approach. However, it is known that the right-hand navigational instruments and altimeter were not accurately set. The implication is that the PNF was not using his instruments to actively monitor the approach, and that he may have been occupied accomplishing some other duty or function. It is also possible that the PNF was anticipating visual meteorological conditions for the final approach and did not anticipate a need for his navigational instruments.
