**LOSS OF SEPARATION/ RISK OF COLLISION**

**BETWEEN  
CANADIAN REGIONAL AIRLINES  
AEROSPATIALE ATR-42-300 C-FQCP  
AND  
CANADIAN REGIONAL AIRLINES  
AEROSPATIALE ATR-42-300 C-GICY  
TIMMINS AIRPORT, ONTARIO 10 nm SW  
31 MAY 1994**

**REPORT NUMBER A9400137**

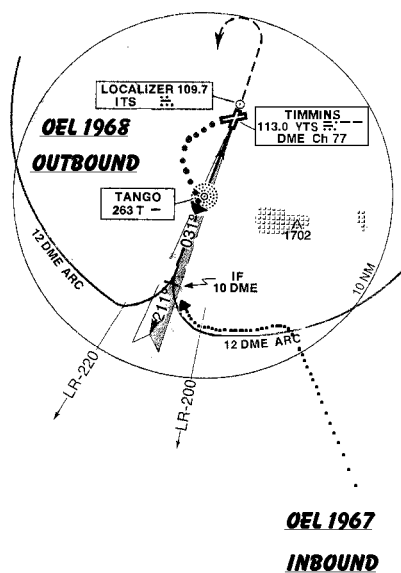
Approximate Flight Paths of OEL 1967 and OEL 1968

The ACC controller based his traffic separation plan on the mistaken premise that OEL 1967 was going to proceed northeast of the airport on the 12 DME arc approach for runway 21, and therefore would not conflict with OEL 1968 departing the area to the southwest. Given that OEL 1968 had originally planned to depart on runway 21 and an approach to runway 03 would be downwind, it would not have been abnormal for the crew of OEL 1967 to plan an approach to runway 21 as the ACC controller thought. Despite several conversations with the crew of OEL 1967 concerning their intention and subsequent instructions to fly the ILS arc approach to runway 03, the ACC controller did not recognize the severity of the developing traffic conflict. Since there was no radar coverage, he did not have any visual radar target cues on his indicator module (IM) to assist him in recognizing the risk of collision scenario developing. In addition, neither crew were able to anticipate the impending traffic conflict since they shared a common radio frequency with the ACC

controller for only about 45 seconds prior to the TCAS warnings. Consequently, when OEL 1967 was cleared to the Timmins airport for a straight-in ILS approach to runway 03 and commenced a descent from 5,000 asl while inbound and in close proximity to the 210-degree VOR radial, a significant risk of collision existed with OEL 1968 which was outbound on the 210-degree VOR radial and cleared from 4,000 to 17,000 feet asl. In effect, the two aircraft were closing head on in cloud at six miles and transiting through each other's flight path until their TCAS II RA warnings were activated. The immediate and prompt action by both crews to follow their respective TCAS II commands alleviated the risk of collision that existed between the two commuter aircraft.
