**AVIATION OCCURRENCE REPORT**

**LOSS OF PROPELLER IN FLIGHT  
AND CABIN DEPRESSURIZATION**

**INTER-CANADIEN  
ATR 42-300 C-GIQV  
VAL D'OR, QUEBEC 53 mi SE  
13 MARCH 1994**

**REPORT NUMBER A94Q0037**

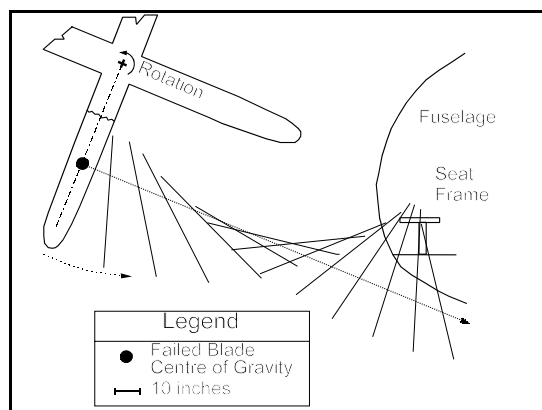
Figure 1 - Blade Trajectory

The top of the No. 2 blade punctured the fuselage as the blade passed on its trajectory toward and beneath the aircraft. A vertical cut measuring 104 cm by 2.5 cm was observed between stations 9157 and 9333 on the right side of the fuselage. The seat adjacent to the vertical cut was partially cut. Two landing gear hydraulic lines mounted under the floor were slightly bent. (See Figure 1 - Blade Trajectory.)

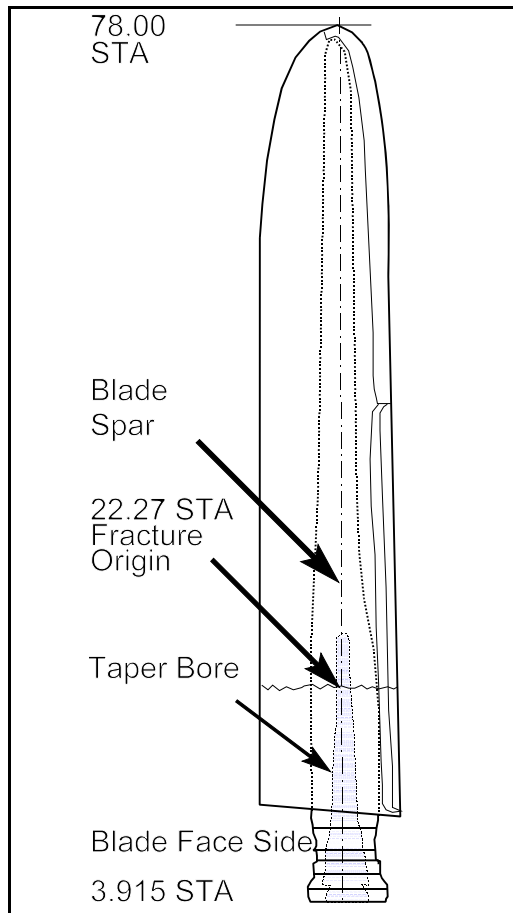
**Figure 2**  
**No. 2 Blade**

The propeller was found on the frozen surface of the Cabonga Reservoir, Quebec. The No. 1, 3 and 4 blades were twisted and their surfaces showed substantial damage. The No. 2 blade (serial number 856922) was fractured at station 22.27. The tip of the No. 2 blade was not found.

The fracture surface showed fatigue marks originating in the spar bore on the face side of the blade. Approximately 80 per cent of the fracture surface exhibited fatigue cracks; damage on the remainder of the fracture surface was attributable to overload failure. Metallurgical analysis revealed that a corrosion pit 0.1524 cm in the circumferential direction, 0.0762 cm into the material (radial direction) and 0.1447 cm in the axial direction was the point of origin of the fatigue crack. Tensile stresses were greatest on the face side of the bore where the crack originated.

Four other superficial cavities were found in the bore at the same station on the camber side of the blade. The camber side of the taper bore was subjected to high compression stresses in flight.

There were five corrosion pits in the taper bore of the No. 2 blade. Only one of the pits observed had progressed to the point where it initiated the fatigue fracture. This was the only pit on the face side of the blade bore. It is on this side of the blade bore, and at this station, that tensile stresses are greater than at any other point in the bore.
