AVIATION OCCURRENCE REPORT

ENGINE FAILURE - HARD LANDING

**TURBOWEST HELICOPTERS LIMITED
AEROSPATIALE AS350B ASTAR (HELICOPTER) C-FHBG
HIGH PRAIRIE, ALBERTA 62 nm NE
04 APRIL 1994**

REPORT NUMBER A94W0037

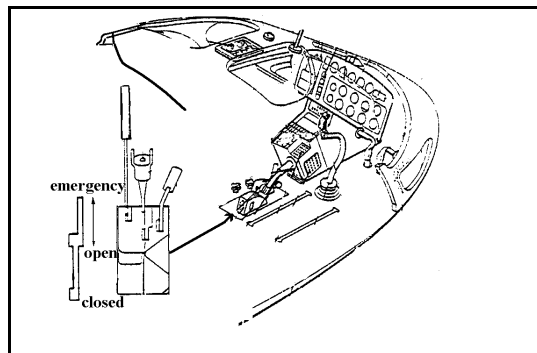
Figure 1
Control Quadrant

The control quadrant is located on the cockpit/cabin floor, adjacent to the pilot's seat. It consists of a rotor brake control, a fuel flow control lever, a start switch, and a fuel shut-off control lever. (See Figure 1.)

The fuel flow control is a flexible control lever located inside a three-position, two-gate slot. The three positions are: "closed," "flight" (or "open"), and "emergency." The full aft or "closed" position shuts off the fuel to the engine; the centre or "flight" position is utilized for normal engine operation; the full forward or "emergency" position supplies fuel to the engine under emergency conditions.

The fuel flow control lever is biased to the left and drops into one of the two "gates." To change the fuel flow control lever position, the lever must be physically moved to the right, to escape the "gate" position that it is in, before it can be moved in either a fore or aft direction. The effort required to physically move this lever to the right is minimal.

When a stretcher patient is carried in the Aerospatiale AS350B helicopter, the patient's right knee is close to the fuel flow control lever. The engineer, realizing the potential hazard of bumping the fuel flow control lever, was assisting the patient with the knapsack when the engine lost all power. It could not be determined who inadvertently moved the fuel flow control lever towards the "closed" position. This action caused fuel starvation to the engine and resulted in a total loss of engine power and a low rotor rpm.

1. The fuel flow control lever was accidentally moved out of the "flight" position, resulting in fuel starvation to the engine and a subsequent loss of all power.
2. The fuel flow lever is not guarded or protected against inadvertent movement.
3. The fuel flow control lever can be moved out of the "flight" position easily.
4. The combination of low altitude, low rotor rpm, high groundspeed at impact, and uneven terrain resulted in an autorotation with substantial damage to the helicopter.
5. The pilot was certified, trained, and qualified for the flight in accordance with existing regulations.
6. The aircraft was certified, equipped, and maintained in accordance with existing regulations and approved procedures.

The floor-mounted fuel flow control lever was inadvertently moved to the closed position, resulting in fuel starvation to the engine, a total loss of engine power, and low rotor rpm.

On 22 September 1994, the TSB forwarded an Aviation Safety Information letter to Transport Canada (TC) regarding the possibility of inadvertent manipulation of the fuel control lever on the AS350B helicopter. TC and industry are investigating the feasibility of installing a control quadrant guard to reduce the likelihood of inadvertent fuel control lever movement.
