## AVIATION OCCURRENCE REPORT

### FUEL CONTAMINATION

**FRONTIER HELICOPTERS  
A DIVISION OF CONAIR AVIATION LTD.  
BELL 206B JETRANGER III (HELICOPTER) C-GLGF  
WATSON LAKE AIRPORT, YUKON 1.8 nm S  
26 JULY 1994**

**REPORT NUMBER A94W0124**

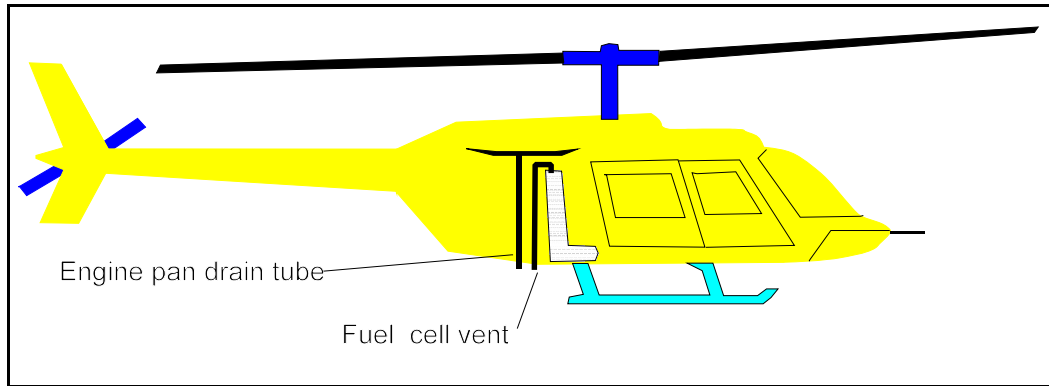
**Figure 1 - B206 Engine Pan Drain and Fuel Cell Vent Tubes**

The Bell 206B is fitted with an engine compartment stainless steel drain tube which discharges fluids overboard from the engine pan. The drain tube routes from the bottom lower centre of the engine pan, horizontally to the right above the baggage compartment, and vertically down the right side of the fuselage to exit approximately three inches aft of the fuel cell vent tube. The drain tube has an outside diameter of approximately ½ inch and protrudes approximately 3 inches from the fuselage. Field reports indicate

that the engine pan drain tube frequently clogs. Foreign material such as bugs, dirt, and small leaves may collect in the engine pan during normal operation and wash into the tube whenever fuel is drained onto the pan from the airframe or engine fuel filters.

The fuel cell vent is an aluminum tube which exits the Bell 206B on the right lower side of the fuselage, aft of the right cabin door and forward of the engine pan drain tube. The outside diameter of the tube is approximately ½ inch, and it protrudes approximately 3 inches from the fuselage skin. There is no check valve in the vent tube to prevent fluids from entering the fuel cell if the tube is back-flushed.

The fuel cell vent tube was not identified externally by label or decal, and there was no requirement for markings to exist. Chapter 11 (Placards and Markings) of the *Bell 206B III Maintenance Manual* identifies that a "FUEL CELL VENT" decal is applicable to the Bell 206B III S/N 3890 and subsequent.

The engine pan overboard drain tube and fuel cell vent tube are easily misidentified where they protrude from the Bell 206B3 fuselage. The tubes are visually similar and are located very close to each other. They are not required to be labelled on the first 3,889 Bell 206 production helicopters. The engine pan drain tube is susceptible to blockage due to the flat routing of the horizontal portion of the tube, the minimal size of the line, and the migration of engine compartment debris.

The pilot had the time and facility available to him on fire standby to wash the helicopter and clean the clogged engine pan drain tube. He was familiar with the problem of a blocked drain tube, as evidenced by his habit of carrying a twisted wire to probe the tube. Scratches on the inside wall of the fuel cell vent tube indicate that he may have probed the vent tube when he was clearing the clogged drain tube. It is probable that he also mistakenly back-flushed the fuel cell vent tube, instead of the drain tube, with the available water hose and thereby introduced water into the fuel system.

The operator has issued a technical memorandum requiring that all drain lines and vent lines on company Bell 206 helicopters be identified. In addition, the memorandum states that a drain line that is blocked must be removed for cleaning or flushed from the top down to the exit. The memorandum also contains the following warning: "UNDER NO CIRCUMSTANCES IS IT PERMISSIBLE TO BACK FLUSH ANY LINE, AS THIS COULD CAUSE CONTAMINATION OF A SYSTEM."

On 09 September 1994, the TSB forwarded an Aviation Safety Advisory to Transport Canada (TC) suggesting that TC require that the fuel vent and engine drain tubes on all Bell 206 helicopters be clearly identified. TC has indicated that a Service Difficulty Advisory will be released to inform operators of the hazards of backflushing vent lines, and recommending that a warning decal be installed near the fuel vent tube outlet. An article on this issue was published in the 4/94 edition of the TC safety publication *Maintainer*.

Bell Helicopter Textron has indicated that a new Technical Bulletin will be released to permit operators of JetRangers with serial numbers prior to 3890 to use the "Fuel Cell Vent" decal if they so desire. Also, on 19 January 1995, the manufacturer released Operations Safety Notice OSN-GEN-95-26 to all operators of Bell helicopters. This OSN addresses improper washing techniques, and
