## AVIATION OCCURRENCE REPORT

### WIRESRIKE

GOVERNMENT OF CANADA, CANADIAN COAST GUARD  
BELL 206L (HELICOPTER) C-GCHN  
MARGAREE RIVER, NOVA SCOTIA  
25 FEBRUARY 1995

REPORT NUMBER A95A0040

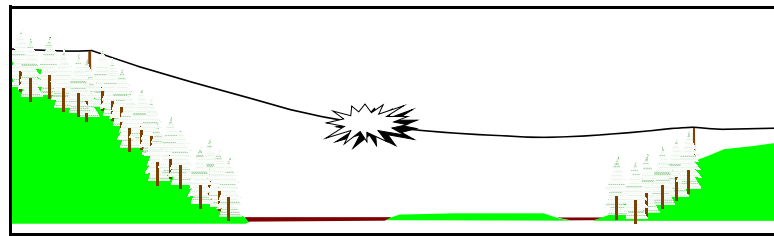
**Figure 1 - Location of Power Line**

The power line was greyish-white in colour and provided little contrast with the ice-covered surface of the river and the higher snow-covered terrain in the background.

The power line was suspended from poles on either side of the river. Both of the supporting poles were surrounded by tall evergreen foliage and dense deciduous trees, and the cut-line normally associated with hydro lines had been overgrown with vegetation.

The power line was not marked, nor was it required to be marked in accordance with existing regulations. In addition, the power line was not depicted on aviation navigation charts.

Following the erection of the new power line, investigators overflew the area at the approximate altitude flown by the accident helicopter. It was determined that, even with optimal vision and under ideal visibility conditions, the line and its support structure were extremely difficult to detect due to the camouflaging effect of the surrounding terrain and vegetation.

When overflown at an approximate altitude of 300 feet, the wire itself remained virtually invisible; however, the wire's support structure and the associated cut lines were visible on either side of the river.

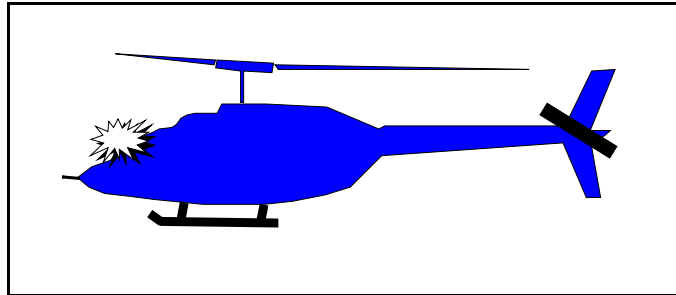
**Figure 2 - Helicopter/Power Line Contact**

The helicopter was in a level attitude, about 70 feet above the river and at about the midpoint of the width of the river, flying at an estimated airspeed of 80 knots, when it struck the power line.

The power line contacted the front of the helicopter in the area of the bottom of the main windscreen. The power line broke in two places: where it contacted the helicopter and where it joined onto the western pole.

The broken section of the power line made contact with one main rotor blade and was then thrown forward. It was found 1,063 feet from the initial point of the power line contact.

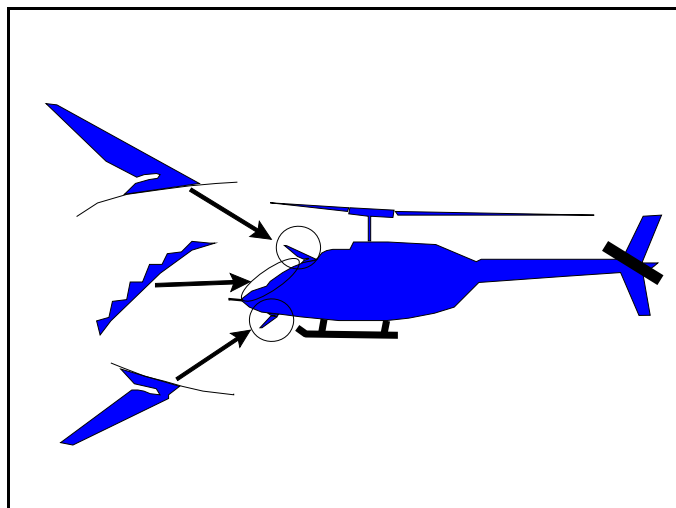
**Figure 3 - Wire Strike Protection System**

A WSPS is available for the Bell 206L helicopter under approved Supplementary Type Certificate (STC) SH4083SW. The system is engineered to prevent entry of a wire into the cockpit area, reduce the possibility of flight control damage during a wire strike, and decrease the chance of wires becoming entangled in the landing gear. The WSPS manufacturer states that the system has been demonstrated at angles up to 45° and at speeds as low as 4 mph, and that it is effective against multiple wire strikes.

The system comprises three components: an upper and a lower cutter/deflector, and a windshield deflector/guide. Each is equipped with a high tensile steel sawtooth edge. The windshield deflector/guide serves to move the wire over the cockpit area and into the cutters.

The helicopter was not equipped with a WSPS, nor was one required by regulation.

As ACAC 0020 recommends, the installation of WSPS equipment on helicopters engaged in low-level operations can only enhance the safety of the operation.
