**AVIATION OCCURRENCE REPORT**

**CONTROLLED FLIGHT INTO TERRAIN**

**CARGAIR LTEE  
CESSNA 172N C-GBZG  
ST. PAULS INLET, NEWFOUNDLAND  
22 JULY 1996**

**REPORT NUMBER A96A0134**

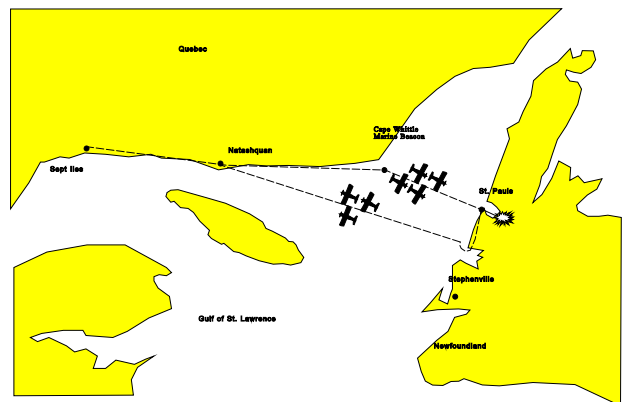
The aircraft in the group used the radio frequency 122.9 MHz as a common communication frequency. The last radio contact with the pilot of C-GBZG was about 30 miles west of St. Pauls Inlet, when he responded to a general remark made by another aircraft group member on their communication frequency. Ten miles from shore, the pilot of the lead aircraft announced his position and stated that he would be descending. The group organizer, who was piloting the aircraft in third position, reported that, as he descended below 1,000 feet asl over St. Pauls Inlet, he could see steeply rising terrain just beyond the inlet that became obscured by cloud cover. He turned his aircraft to the right, to a southerly heading following the first two aircraft. He then observed C-GBZG enter cloud, on what appeared to be the en route heading and at an altitude about 500 feet higher than his aircraft.

He called the pilot, instructing him to turn immediately; however, repeated attempts to contact the aircraft were unsuccessful. The three remaining aircraft continued to within 33 miles of Stephenville where the ceiling deteriorated to 500 feet agl. They executed a turn to the north, over the water, and returned to Natashquan.
