AVIATION OCCURRENCE REPORT

LOSS OF CONTROL - SPIRAL

CESSNA 150 C-FQZC

REPORT NUMBER A96W0178

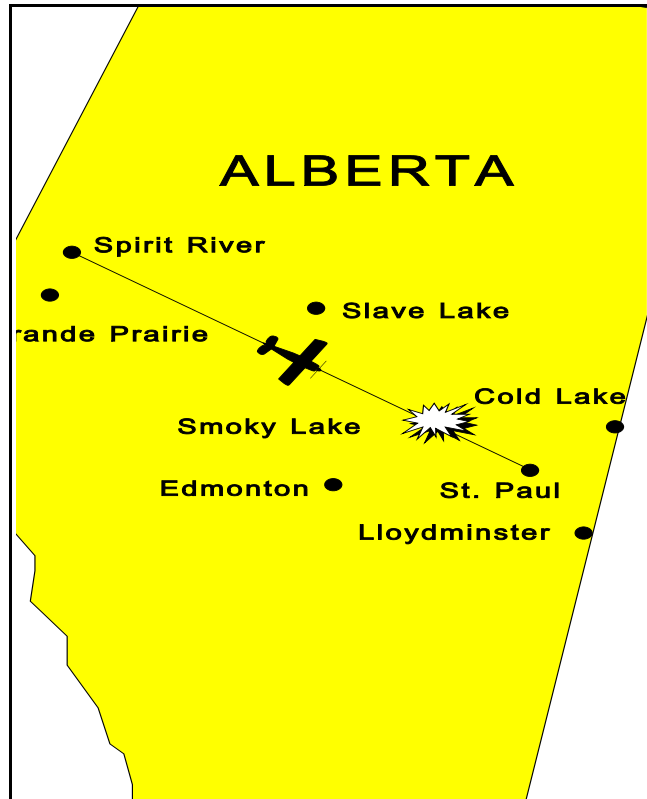
At the time of the occurrence, a quasi-stationary maritime cold front extended from a low pressure system in northwestern Alberta and crossed the northeastern portion of the province. The flight planned route from Spirit River to St. Paul crossed the cold front in the vicinity of Smoky Lake. The weather conditions along the route went from clear skies with a few clouds around the Spirit River area, to VFR ceilings within 60 to 90 nm west of the cold front, to low ceilings with poor visibilities in rain and fog in the vicinity of the cold front. To the east of the cold front, VFR stratocumulus ceilings were reported across much of the region.
