AVIATION INVESTIGATION REPORT

A97F0059

UNCONTAINED ENGINE FAILURE

BOEING 767-375ER C-FTCA

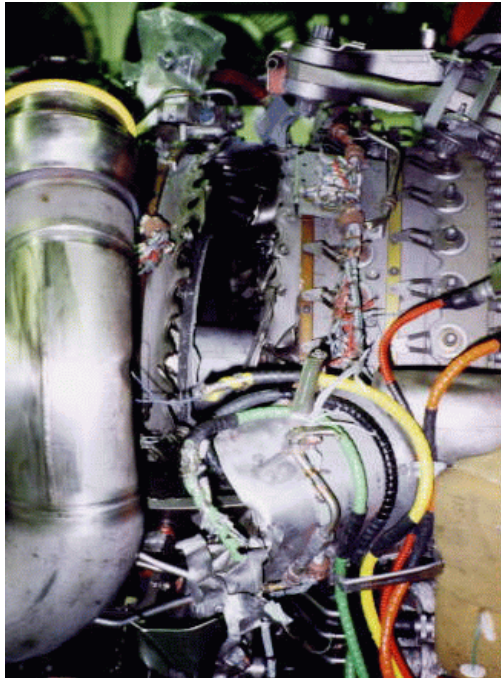
Approximately 30 kilograms of rotating hardware from the left engine HPC and the compressor case was found on the ground near the aircraft. Debris had penetrated the left-engine casings, inboard reverser, and the translating cowls. A 1.5-inch long puncture was found in the fuselage adjacent to the left-wing root, just forward of Station 720, but no engine debris penetrated the passenger cabin. The left-hand high-speed (inboard) aileron had three punctures in the lower skin.

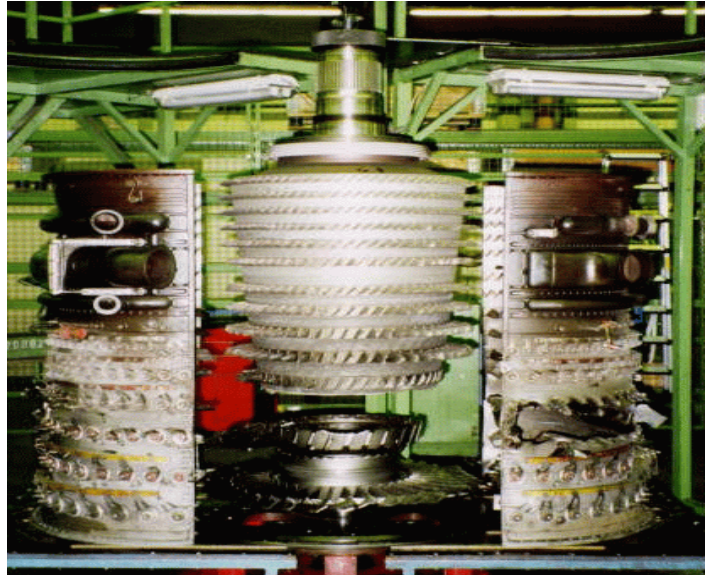
Inspection of the engine by maintenance personnel in Beijing established that the third stage had broken away from the HPC spool. Several pneumatic and electrical components on the outside of the engine had been damaged by material exiting the engine and by fire. An engine teardown conducted at the Motoren- und Turbinen-Union (MTU) facility in Hannover, Germany, revealed that there was some damage to the internal rotating structure of the engine. The engine's inlet gearbox bearing was fractured, causing a disconnect of the engine accessory drive, which includes the main engine fuel pump. Rub marks from the fan blades were observed in lower portions of the abrasible fan shroud, the result of a period of unbalanced operation as the engine was failing.

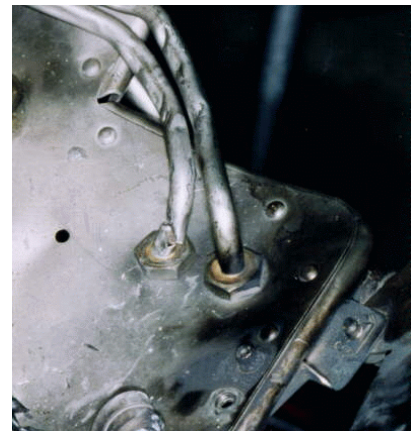
The fire damage was limited to the left side of the engine. It was determined, during the engine teardown conducted in Hannover, that the source of the fire was a fuel-servo line used to actuate the LPT active clearance control valve. Debris leaving the compressor punctured the fuel-servo line and sprayed fuel, which then ignited (see Figure 4).

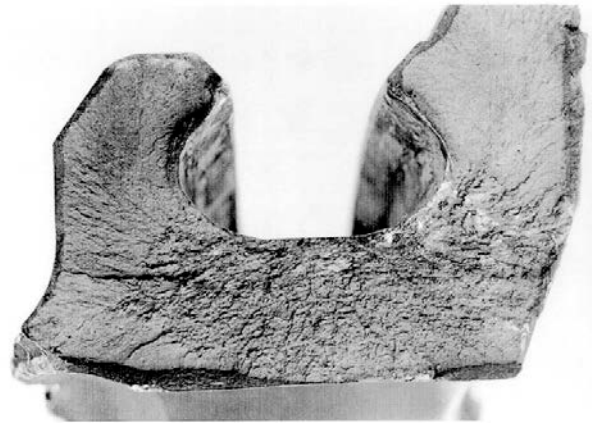
One mating half of the fatigue fracture was mechanically damaged but, after cleaning, was usable for preliminary examination of fractographic features. The cleaning removed aluminium debris smeared onto the fracture surface. Preliminary scanning-electron microscope (SEM) examination revealed faceted fracture topography interspersed with patches of fatigue striations (shown in Figure 6). The fatigue crack area covered an oval region extending from the slot bottom nearly through the thickness of the hub. The approximate size of the fatigue crack was 14 millimetres (mm) deep and 21 mm across or about 45 per cent of the third-stage cross-section.

The exact origin of the fatigue was not determined, but it was estimated to be subsurface, in the vicinity of the slot bottom, near the point of radius transition. The transition radii of the occurrence

The fatigue fracture of the HPC spool initiated in the third stage near the dove-tail slot bottom. The exact origin of the cracking was not determined, but it was subsurface in the vicinity of the change of machining radii toward the aft end of the slot bottom. This is an area subject to relatively high stresses, of the order of 75 per cent of minimum yield strength for the Ti 6242 alloy used in the spool. The failure of the third stage of the HPC spool caused the uncontained failure of the engine, followed by the secondary damage and the ensuing fire.

Engineering tests performed on the failed third stage showed that the fracture surface was faceted with interspersed areas of classical striations. At the time of the failure about 45 per cent of the third-stage cross-section had been pre-cracked. The remainder of the material failed suddenly in overload as take-off thrust was applied to the engine.

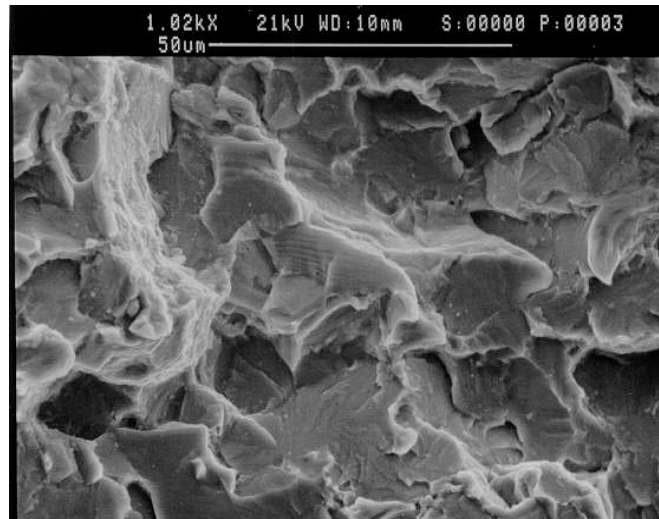
An attempt was made to count the number of striations in the fatigue area, but this was very difficult because the striations were irregular in shape, ran in many directions, and were interspersed with faceted areas. One estimate of the number of striations was about 800. It was not possible to estimate the time (cycles) of the crack propagation based on a striation count. The engine manufacturer indicated that faceted-type failures were typical of fatigue in Ti 6242. However, the NTSB in its investigation of another fatigue failure due to a "hard alpha" inclusion noted that the fatigue zone had a typical striated pattern. The manufacturer also indicated that propagation rates were accelerated within the segregate.

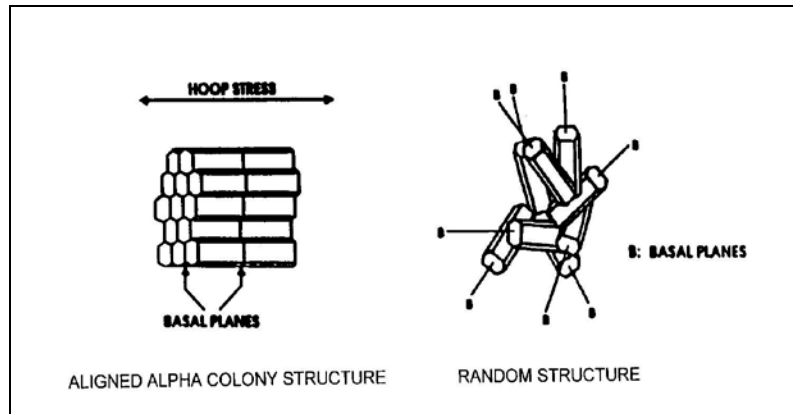
According to the engine manufacturer, materials that are susceptible to DTF are those with aligned alpha “colonies” (Figure 8). This aligned structure causes reduced resistance to stress and allows for the initiation of cracks.

portion of the third-stage spool pieces. It was determined that the alpha volume fraction in the band was about 70 per cent, as compared to 50 per cent in the matrix. The tests indicated that the alpha colony structures in both areas were similar. Qualitatively, the alpha colonies in the anomaly band appeared larger and less randomized than in the matrix portion. According to the engine manufacturer, the orientation tests indicated that because of the low alpha volume and the randomized grain structure, the matrix material had low susceptibility to DTF associated with other failure events. GE also indicated that the high alpha fraction and the influence of elevated oxygen content in the anomalous band “could be conducive to dwell time fatigue type initiation, however the elevated oxygen levels could also have resulted in more traditional initiation mechanisms.”

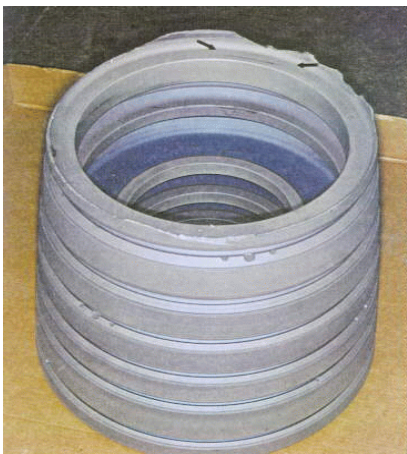
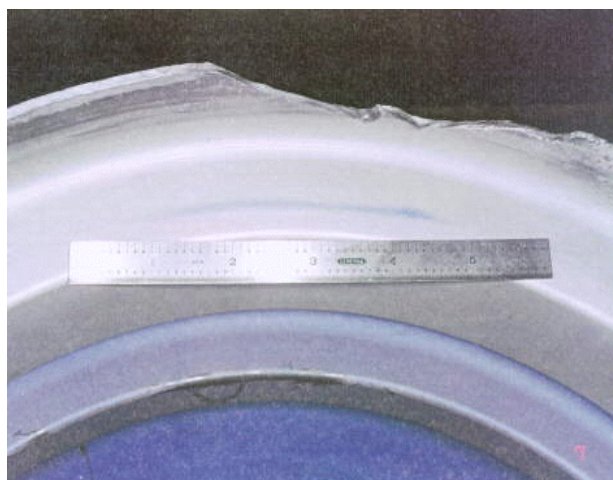
The remnant of the event 3-9 HPC spool was inspected using ultrasonic, eddy current and blue-etch anodizing (BEA) NDI. A complete immersion ultrasonic inspection of all the bore features was conducted with “no relevant indications” detected. A complete eddy current inspection of the bore revealed numerous surface indications that were assessed as damage resulting from the failure of the spool. Immersion ultrasonic and eddy current inspection of the forward webs, and the forward web-to-bore transition radii of stages 6, 7, 8 and 9, did not show any “relevant indications”. The front and aft faces of the fourth-stage bore showed evidence of segregated material similar to that found in the region of the fracture (Figures 9 and 10). The position of the segregate was such that BEA of the finish-machined spool would have revealed its presence. Eddy current NDI conducted by the engine manufacturer was not able to detect the segregated material.

BEA is capable of detecting the oxygen-rich microstructure, but at the time of manufacture the finished parts did not undergo such tests. Based on the location of the oxygen-rich segregate, which was surface-breaking in some areas of the HPC spool, BEA of the machined part would have revealed the presence of the oxygen-rich microstructure and would likely have caused the spool to have been rejected. BEA NDI has been part of the manufacturing process for HPC spools since 1991.

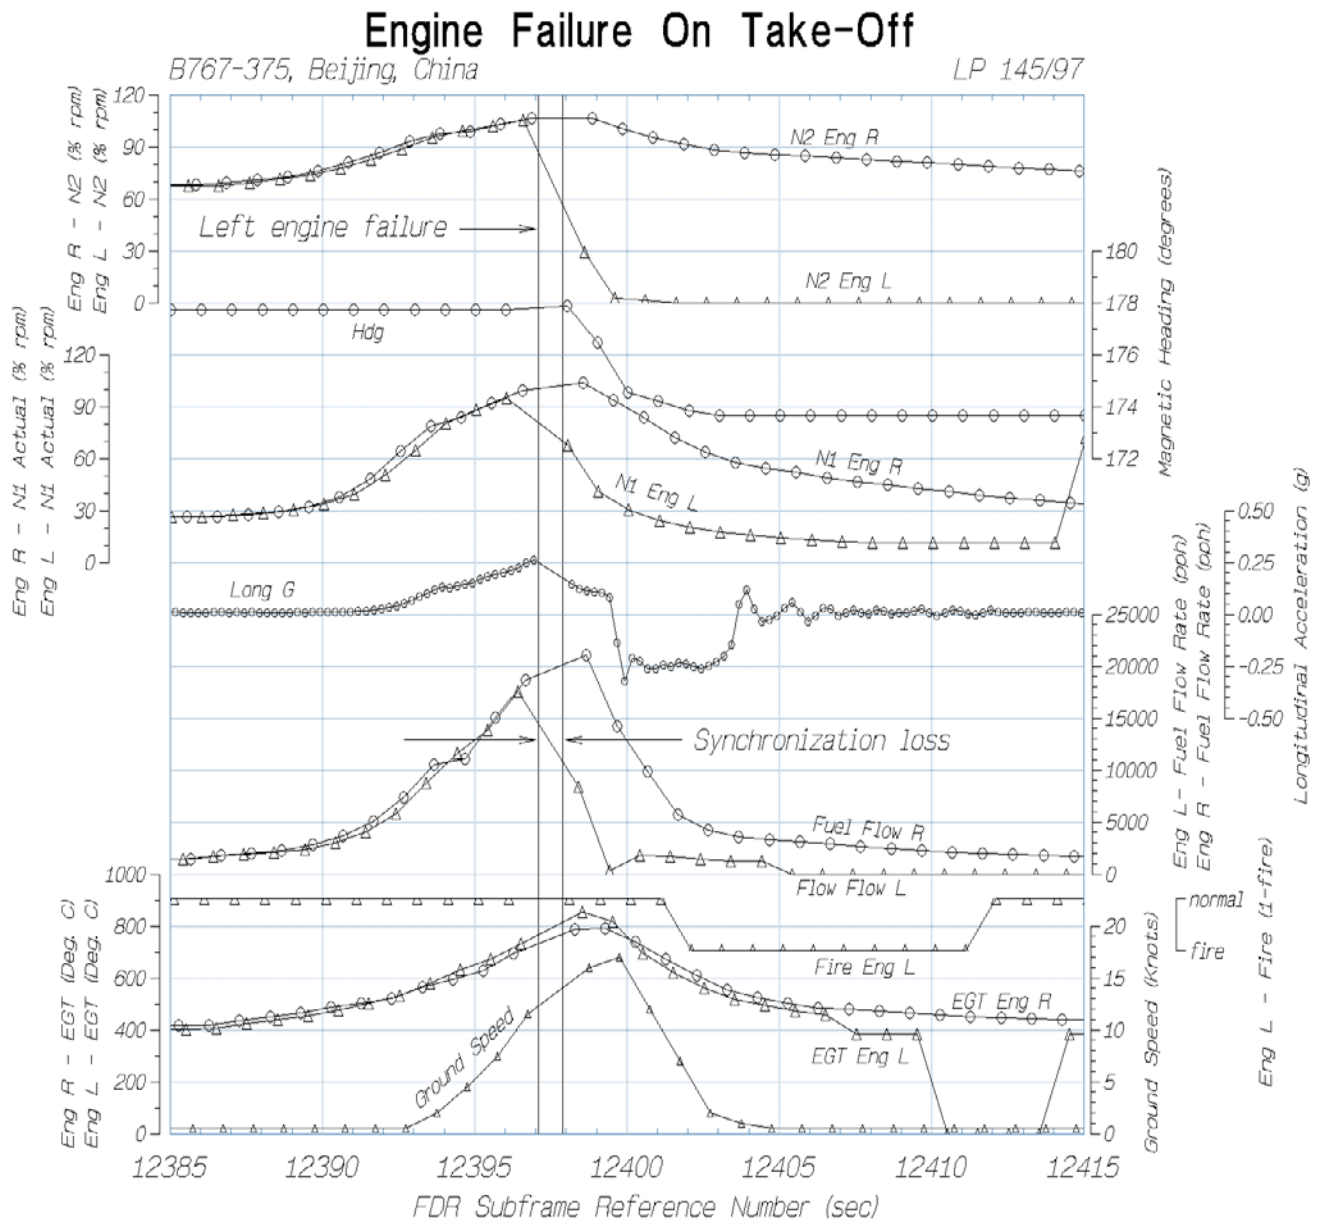
Appendix A - Flight Data Recorder Plot

Analysis of the UFDR showed that, at a point approximately six seconds into the take-off roll, the UFDR signal lost synchronization for a period estimated to have been as long as four seconds. It was determined that the failure of the left engine occurred at this point. The loss of synchronization was probably the result of a voltage transient related to the engine-driven electrical system at the moment of the engine failure.

At the time of the engine failure, the rotor speeds of both engines were nearly equal and had reached estimated values of 100 per cent N1 and 107 per cent N2. The recorded value of left-engine exhaust gas temperature (EGT), 0.4 seconds prior to the engine failure, was approximately 730 degrees Celsius, about 25 degrees above the interpolated temperature value of the right engine. Following the synchronization loss, the left-engine failure was further indicated by rapidly decreasing left-engine rotor speeds and a rapid four-degree heading change towards the side of the failed left engine. The maximum recorded left and right EGTs after the left engine had failed were approximately 850 degrees and 790 degrees Celsius, respectively.

Within 1 ½ seconds of the engine failure, the right engine was throttled back (from 104 per cent N1, possibly higher) and, about one second later, the brakes were applied. Approximately five seconds after the engine failure, as the aircraft slowed to a stop, the left-engine fire discrete indicated fire in the left engine for about 10 seconds. A few seconds later, the fire discrete indication occurred once again for about another 10 seconds.

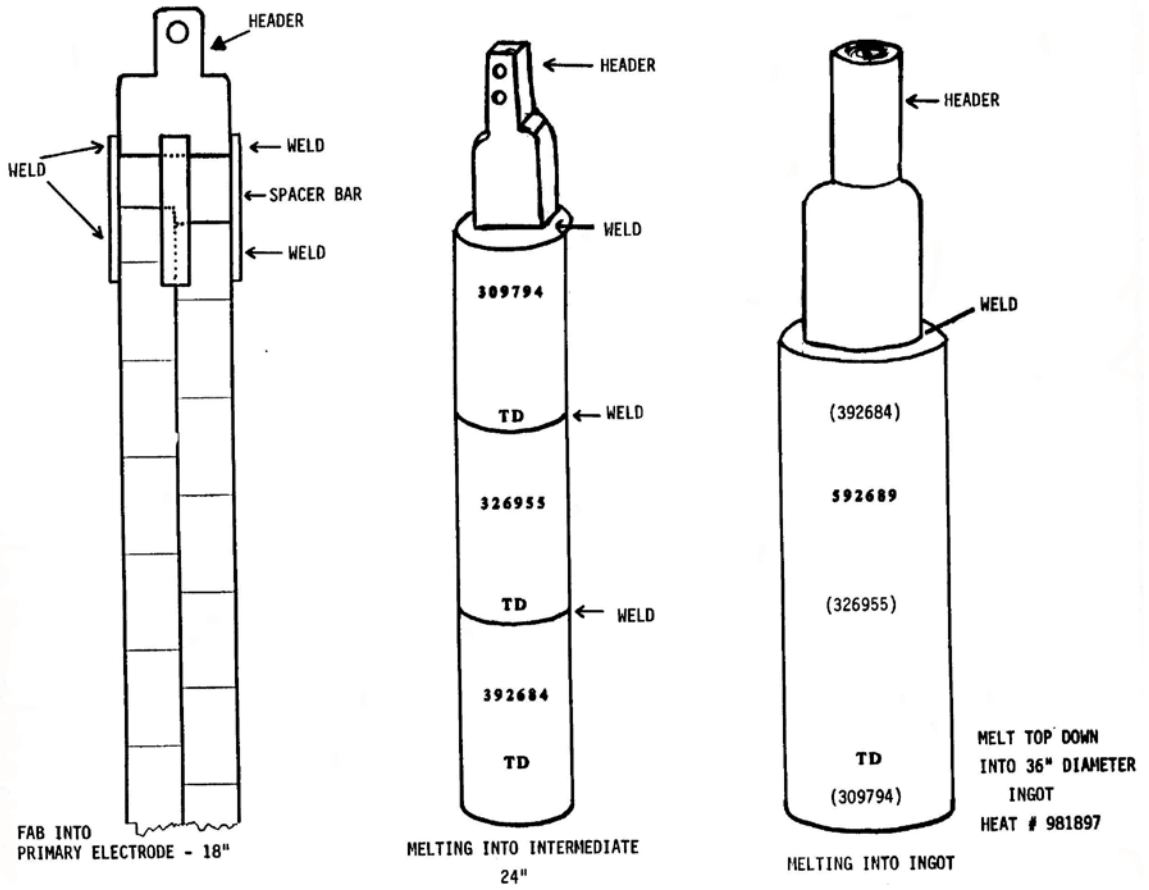
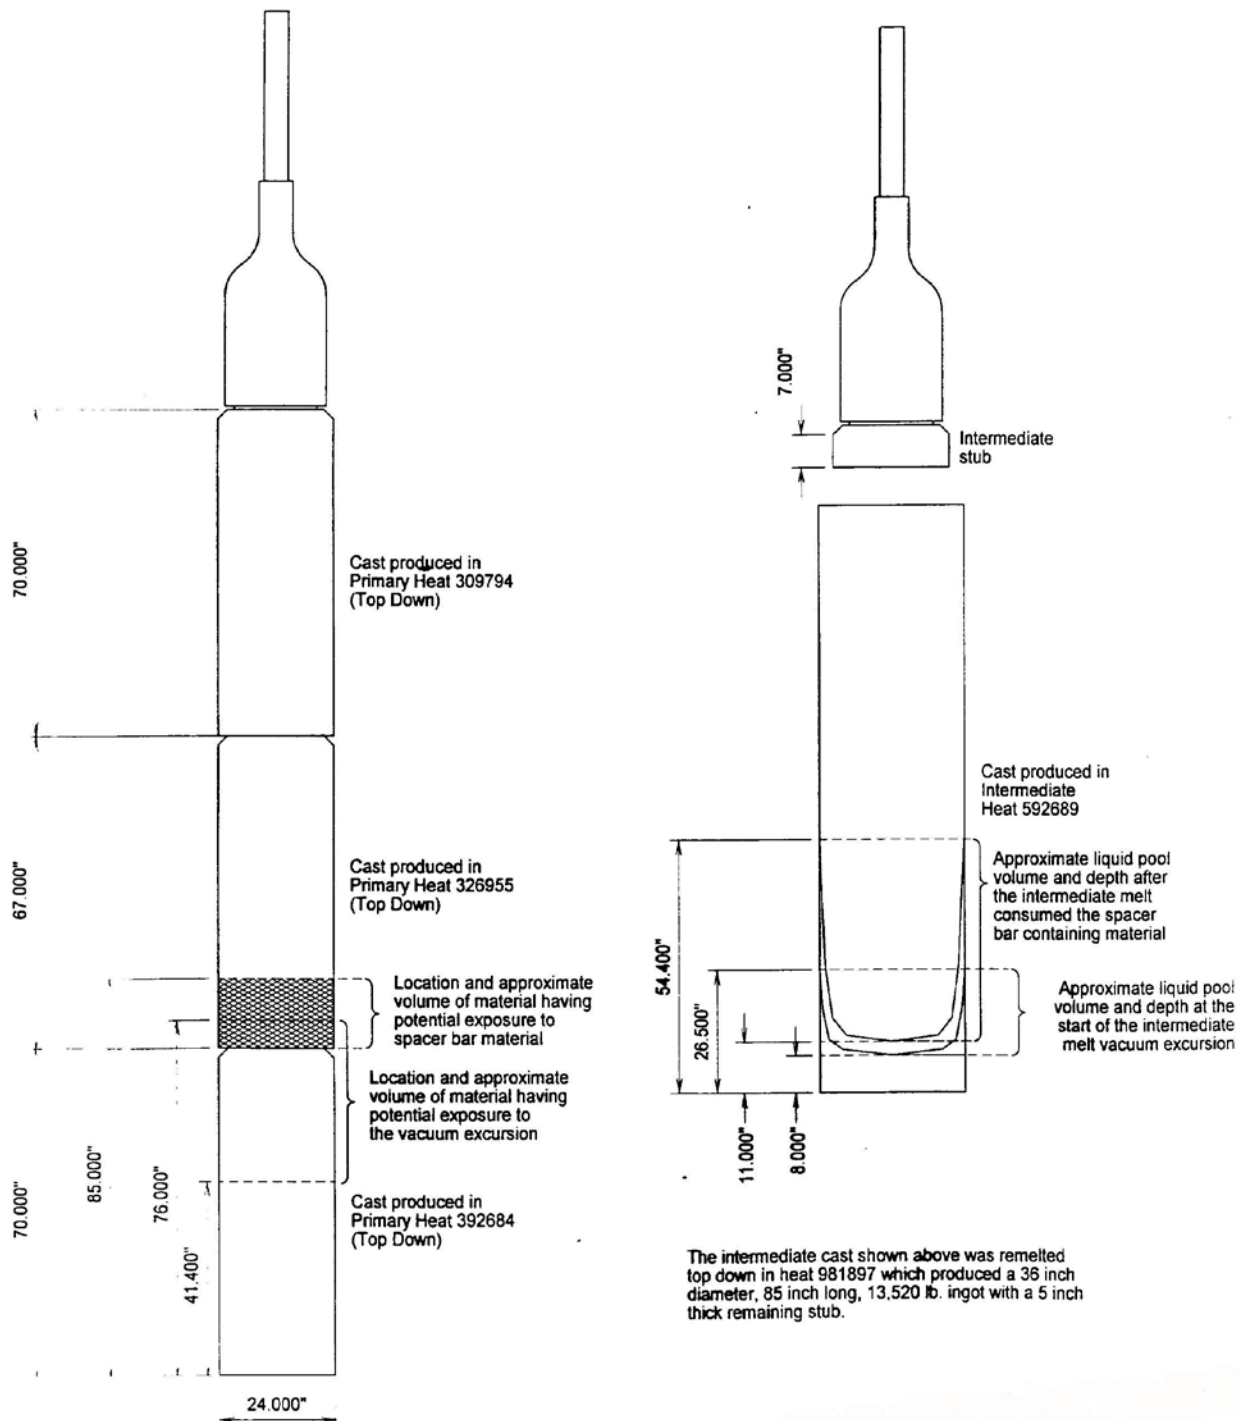
Appendix B1 - Manufacturing of Titanium

After reviewing the melt records, RMI provided an estimate of where in the ingot any material affected by a water leak or the spacer-bar melt-in may have pooled. These diagrams, included in Appendix B, show the estimated position of the two suspect materials prior to the intermediate melt and the estimated position of the material after the intermediate melt. For the final melt, the intermediate cast was inverted before re-melting, and the material affected by a water leak and spacer-bar melt-in would have melted down into the final ingot. It was not possible to predict where the affected material would be in the final ingot, and it now has to be assumed that the entire ingot was suspect.
