AVIATION OCCURRENCE REPORT

IN-FLIGHT BREAKUP

CESSNA A185F C-GCTI
SEPT-ÎLES, QUEBEC 21 nm N
17 FEBRUARY 1997

REPORT NUMBER A97Q0032

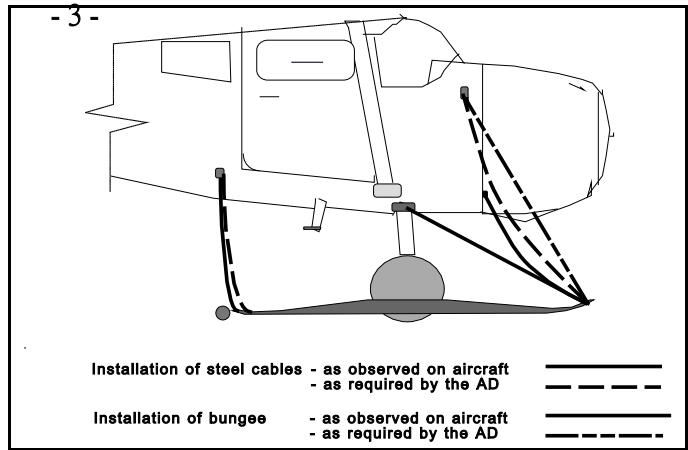
Examination of the aircraft showed the right wing had red and black transfer marks from the right ski. The marks on the wing extended from the leading edge to the main spar, and there were also marks on the wing strut. Aft of the wing spar, there were tears caused by instantaneous overload. The wing attachment was still fastened to the carry-through structure. The carry-through structure failed in overload. The left wing also failed in overload, and it carried with it the rest of the carry-through structure. The fuselage separated aft of the seats. Red marks were found on the vertical stabilizer and left elevator.

There were transfer marks of white paint on the right ski. The metal plate screwed to the ski tip and used to attach the bungee and steel cable was torn off. The bungee failed near the fitting at the ski tip. The steel cable presented a typical form of failure in overload.

The four engine mount brackets failed in instantaneous overload. One of the blades had two indentations near the tip. The first indentation, close to the blade tip, was deep and of a diameter consistent with that of the cable attached to the ski tip. The second indentation was consistent with the metal plate normally screwed to the ski tip. As a simulation, the engine was temporarily replaced in its normal position. This simulation established that the cable attached to the right ski tip was severed by the propeller.

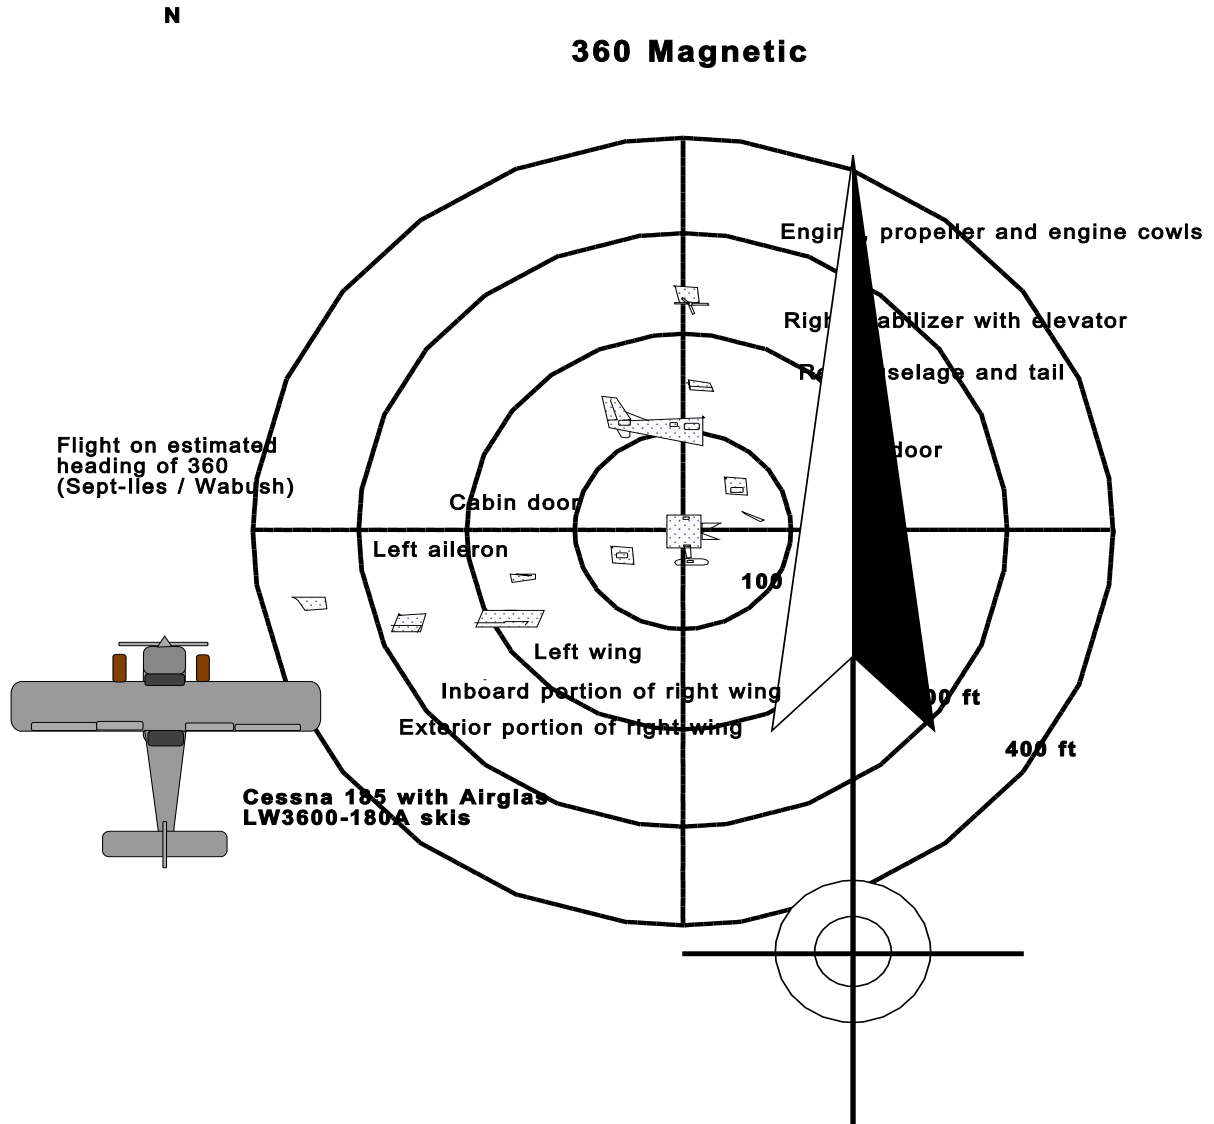
Appendix A - Wreckage Distribution Diagram

With the exception of the right landing gear, which was found on 20 May 1997, all major components of the aircraft were found in the first few days of the investigation. The aircraft was shipped to the TSB Engineering Branch for detailed analysis. The distribution of the parts on the ground and the lack of any evidence of forward speed indicate that the aircraft broke up in flight. The wreckage distribution diagram is at Appendix A.
