AVIATION INVESTIGATION REPORT

A98O0214

IN-FLIGHT MAIN ROTOR BLADE SEPARATION

BELL 47-G2 (HELICOPTER) C-FODS

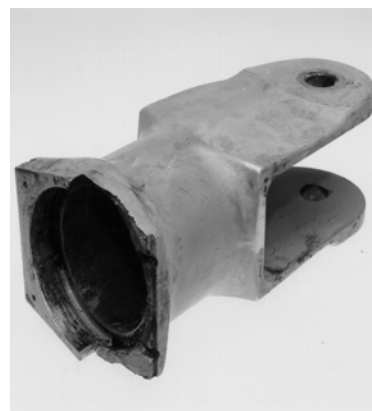
Figure 1 - Failed Blade Grip

The main rotor head, mast and transmission assembly, with the yellow blade attached, as well as the blue blade with the portion of the failed grip attached, were transported to the TSB Engineering Laboratory for examination. Heavy deposits of grease were present in and adjacent to the bore of the failed blue blade grip. The blue blade grip was removed from the blade for further examination. Examination of the components of the blue blade grip attached to the main rotor blade showed no pre-separation deficiencies and both the main rotor radial outboard and duplex bearings were found to be in good condition. Removal of the yellow blade from the grip and disassembly of the yellow blade grip from the main rotor hub revealed the same presence of heavy deposits of grease in and adjacent to the bore of the blade grip, and the bearings were in good condition. It was noted that a quantity of water was dislodged upon disassembly of the yellow blade grip from the main rotor hub.

Extensive pitting was found on the surface of both the bottom of the thread roots and the adjacent surfaces of the threads. Fatigue crack origins were found to be coincident with the stress concentrations provided by the individual pits. The presence of pitting was also confirmed by the micro-sections; although, due to the thinness of the anodized layers and difficulties in retaining the edges during specimen preparation, it was less clear whether the pitting had preceded the anodizing step of the component manufacture. Some metallographic evidence would suggest that this was indeed so, and more recent work by the manufacturer would tend to confirm this conclusion.

The blue main rotor blade separated in flight as a result of fatigue cracking initiated in the rotor blade grip's internal threads at the last complete outboard-most thread. Failure occurred instantaneously as the crack grew to critical dimensions under normal service loading. Cracks found in the yellow main rotor blade grip were similar yet less advanced.

The threads in both the Serial Number A100 and A68 grips were found to conform with the standard UN fine thread form, although the root radii were much smaller than those for an exemplar spare. The sharp root radii coupled with extensive pitting found on both blade grips provide one plausible explanation for the premature fatigue failure of the blue grip. Both sharp root radii and pitting are known stress concentrators which facilitate fatigue crack initiation.

Current inspection requirements for the main rotor blade grips of Bell 47 helicopters may not adequately reduce the risk of structural failure and loss of life. Therefore, the TSB sent an Aviation Safety Advisory to Transport Canada suggesting that they determine whether any Canadian registered Bell 47 helicopters are equipped with main rotor blade grips belonging to the affected batch lots. The TSB suggested the possible need for a fatigue crack examination at an interval that provides a greater margin of safety than the existing inspection cycle.

1. Identify and inspect the Bell 47 helicopter main rotor blade grips from the same batch lots as on the accident helicopter; and
2. Modify Alert Service Bulletin 47-85-12, Rev A, and U.S. Airworthiness Directive 86-06-08 R1 to include eddy current testing.
